Report No. CDOT-DTD-R-94-1

COMPARISON OF THE HAMBURG WHEEL-TRACKING DEVICE AND THE ENVIRONMENTAL CONDITIONING SYSTEM TO PAVEMENTS OF KNOWN STRIPPING PERFORMANCE

Final Report
January 1994

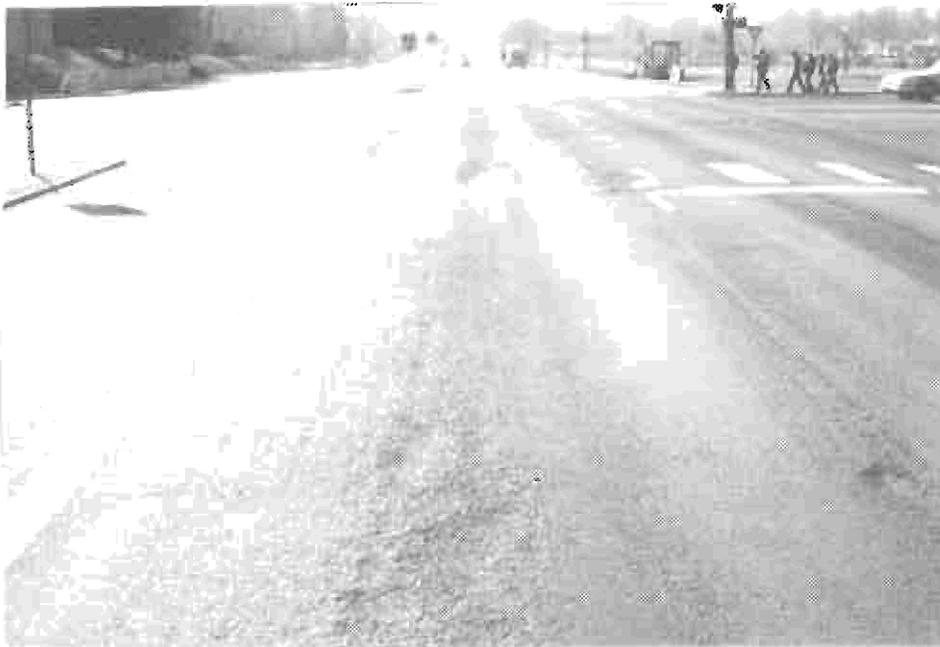
These pavements have received an exceptionally high level of maintenance. Although pavements in this category are still in service after two to five years, their performance is considered unacceptable when compared to their design life. The maintenance required to address problems from moisture damage to the HMA pavements included overlays and significant patching of potholes. A 15-month old pavement that required an overlay on some sections is shown in Fig. 1.

Fig. 1. A "High Maintenance" Mix Experiencing Ravelling After 15 Months.

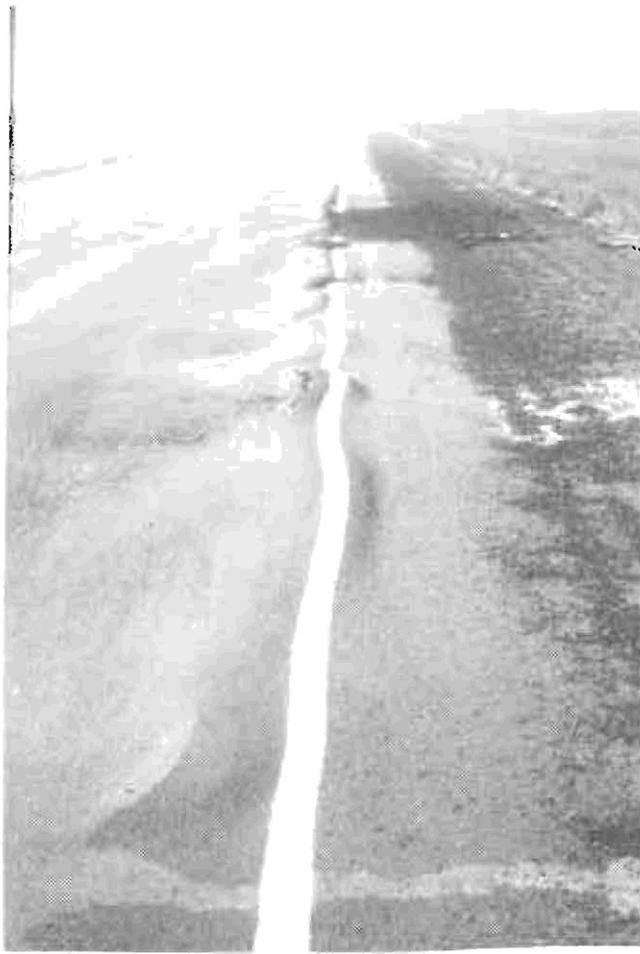
Several pavements in Colorado required complete rehabilitation when less than two years old, and often when less than one year old. The moisture damage was related to a unique pavement design feature, rut-resistant composite pavement, that utilized a plant mixed seal coat (PMSC) as described and evaluated by Harmelink (5). HMA pavements directly below the PMSC exhibited severe moisture damage. The pavement surface (Fig. 2) and a core showing the moisture damage that occurred just below the surface (Fig. 3) are shown for a pavement requiring complete rehabilitation after 12 months. Even though the PMSC was a contributing factor the distress in the underlying HMA, the HMA was still considered to be susceptible to moisture damage since it failed so quickly.

Fig. 2. The Surface of a Pavement Requiring "Complete Rehabililtation" in 12 Months.

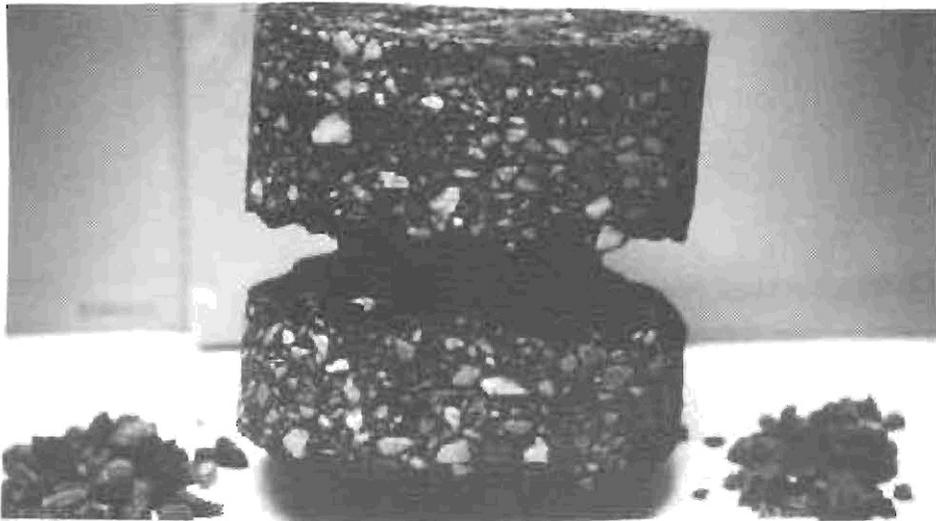
Fig. 3. A Core Showing Stripping Below the Surface from the Pavement in Figure 2.

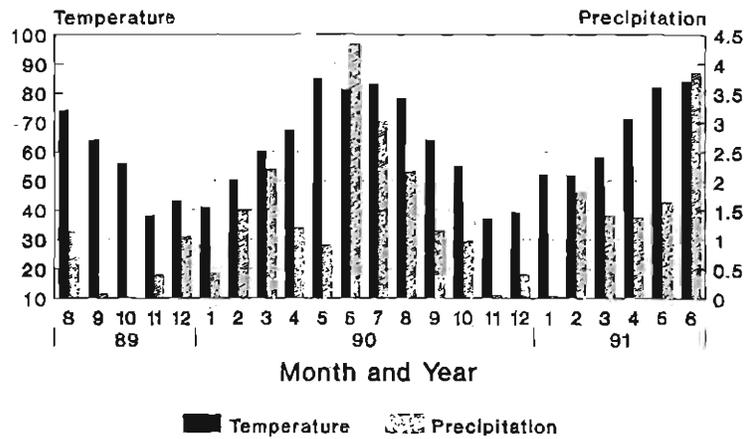
Pavements requiring complete rehabilitation all failed when high levels of precipitation occurred in the hottest part of the summer. The weather conditions were all very similar to that shown in Figure 4. The temperature is the monthly mean maximum temperature, i.e. the average of the daily high temperatures. The precipitation is the total accumulation for the month. The first month and year in each figure represents the end of construction, and the final month and year in each figure represents the time of failure.

Even though all pavements in Colorado are subjected to freeze cycles, the severe moisture damage did not correspond with freezing conditions. The instantaneous failures were directly related to a simultaneous combination of high temperature, high moisture, and high traffic.

Fig. 4. Environmental Conditions for the Pavement at Arriba Requiring "Complete Rehabilitation" After 24 Months.

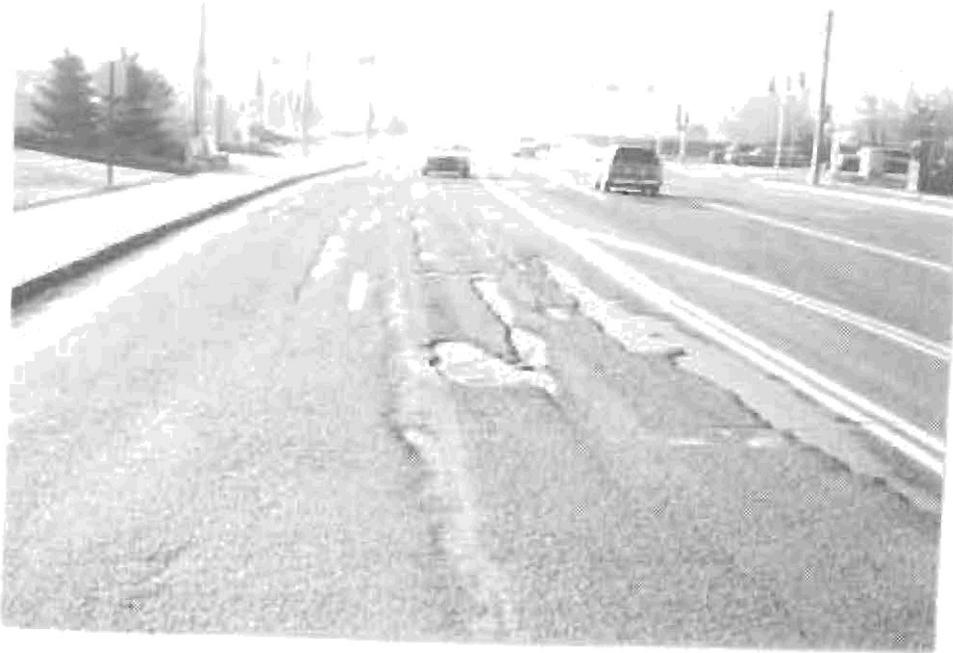
There are several aggregate sources used in HMA pavements that have a notorious history of severe moisture damage. A 6-month old pavement that disintegrated is shown in Fig. 5. Since contractors have not used these aggregate sources on CDOT projects for many years, specific mix designs for the "disintegrators" were difficult to obtain. The mix designs with the aggregate sources thought to be "disintegrators" were reproduced as closely as possible with the help of experienced, long-term employees of the CDOT.

Fig. 5. A Disintegrator After 6 Months.

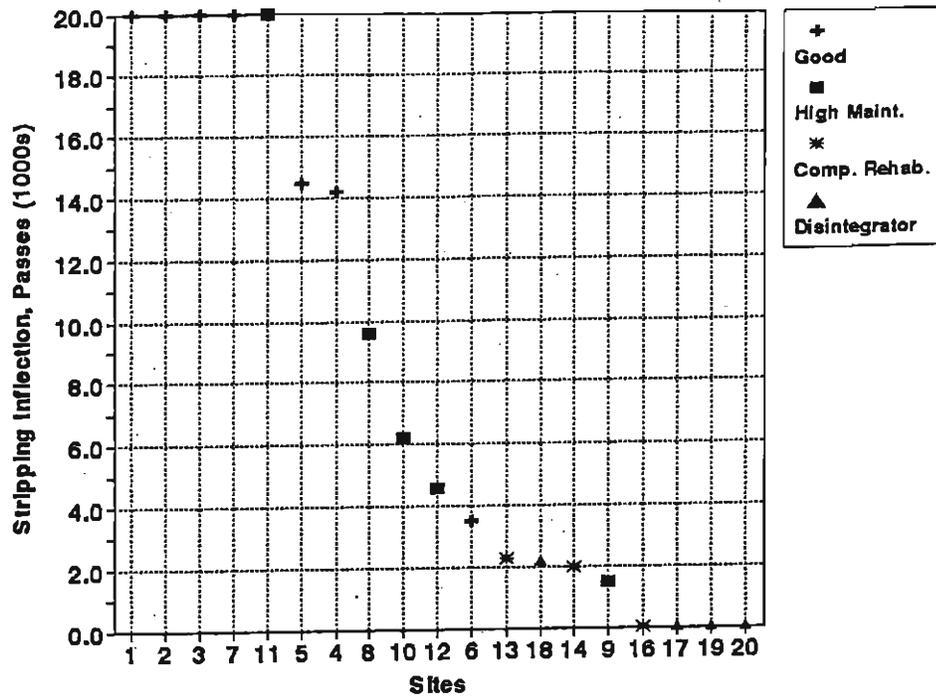
Fig. 12. Ranked Order of the Stripping Inflection Point from the Hamburg Wheel-Tracking Device at 50°C.

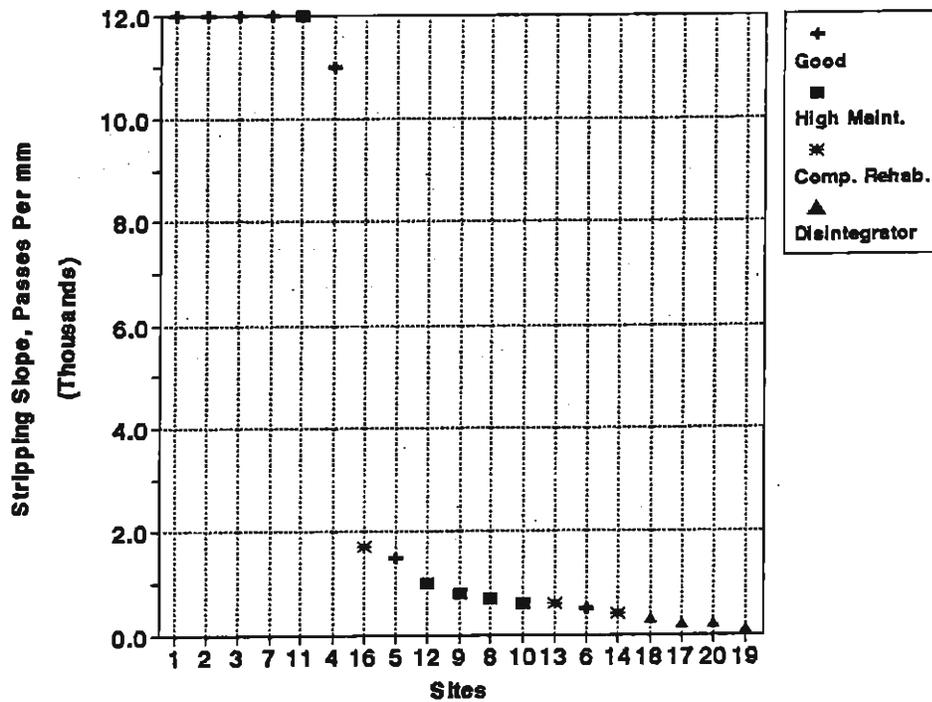
Fig. 13. Ranked Order of the Stripping Slope from the Hamburg Wheel-Tracking Device at 50°C.

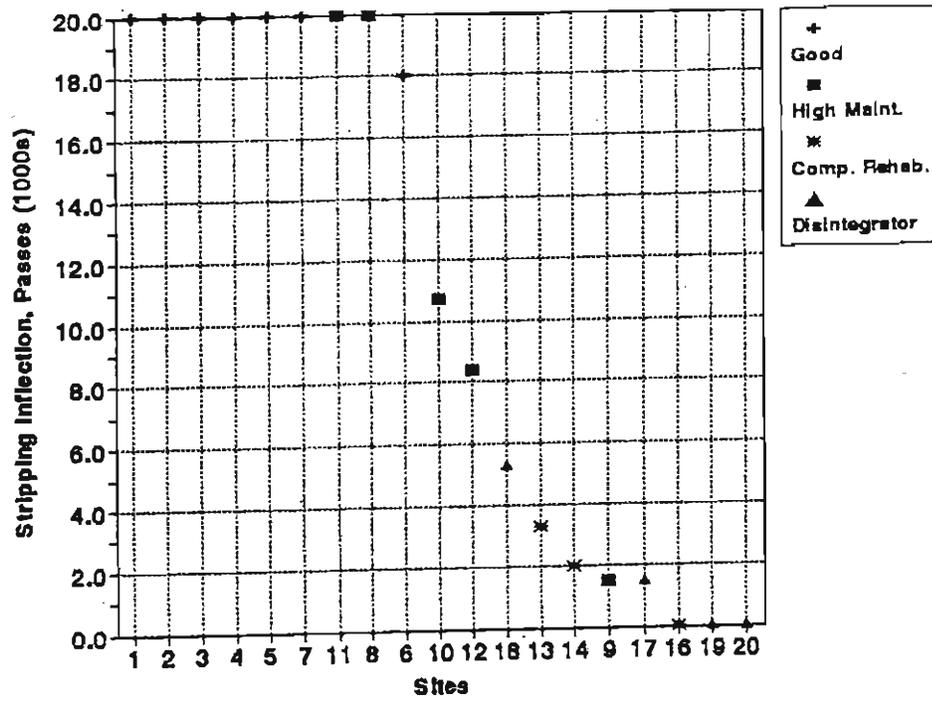
At the 45°C test temperature, a similar relationship can be obtained as shown in Table 10. A ranked order plot of the stripping inflection point and stripping slope is shown in Figs. 14 and 15, respectively, for tests performed at 45°C. Although the stripping slope was not sensitive to the various levels of pavement performance, the stripping slope did distinguish between the sites that performed well and stripped in the field.

At 45°C, the stripping inflection point was sensitive to the various levels of field stripping performance. A rule-of-thumb could indicate a stripping inflection point greater than 18,000 passes would indicate good performance, between 8,000 and 12,000 passes would indicate excessive maintenance, and less than 3,000 would be expected to perform very poorly.

Fig. 14. Ranked Order of the Stripping Inflection Point from the Hamburg Wheel-Tracking Device at 45°C.

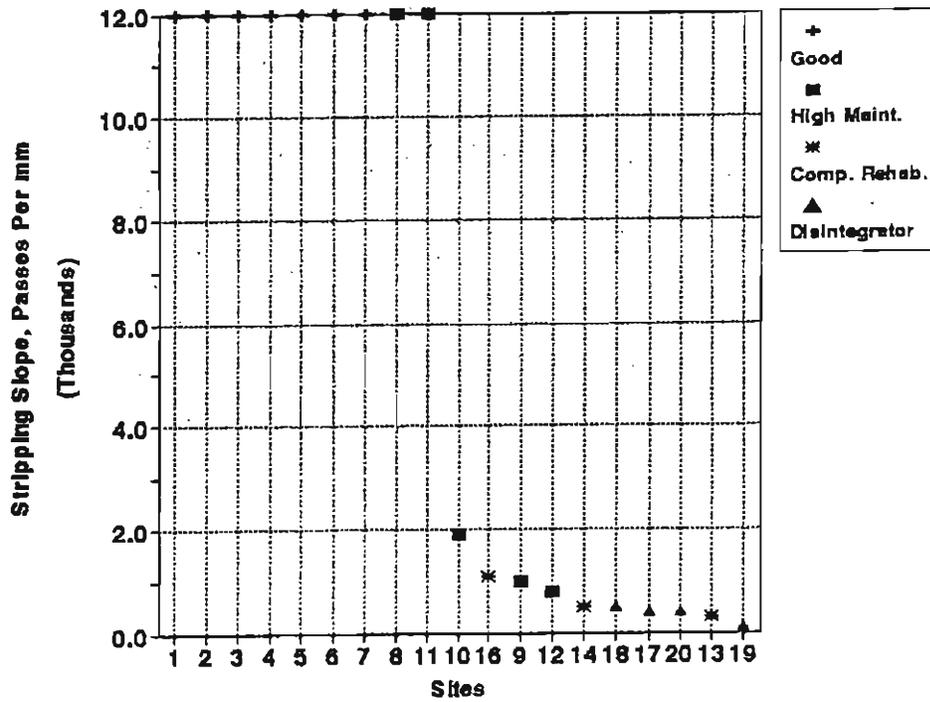
Fig. 15. Ranked Order of the Stripping Slope from the Hamburg Wheel-Tracking Device at 45°C.

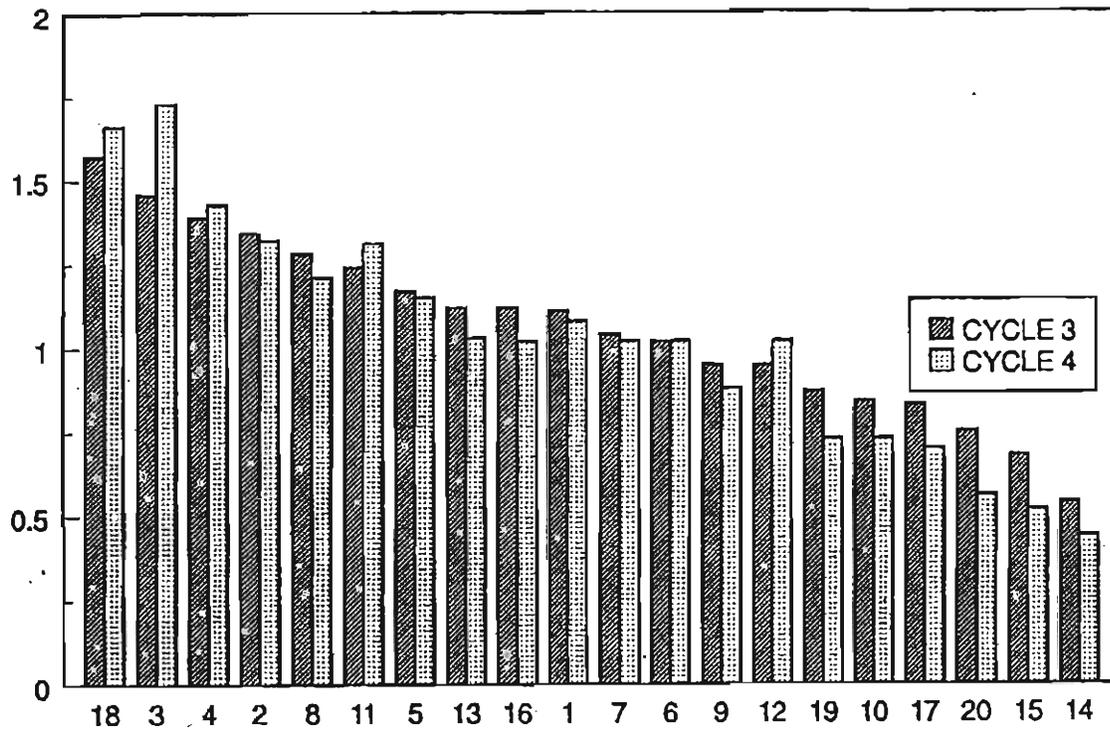
Similar to that for the Hamburg wheel-tracking device, the sites were ranked by order of their laboratory behavior in the ECS test. Figure 16 shows the sites ranked by order of the ECS- M_R ratio after 3 cycles, but also shows the values for after cycle 4 (freeze). This ordering after 3 cycles is the preferred method, and it is suggested that by including the test values after cycle 4, an indication of whether low ratios were caused by aggregate rupture. When the cycle 3 ECS- M_R ratio was less than about 0.75, the corresponding cycle 4 ratio is significantly lower, indicating damage during the freeze cycle.

Fig. 16. Mixtures Ranked by ECS-M_r Ratio After 3 Hot Cycles.

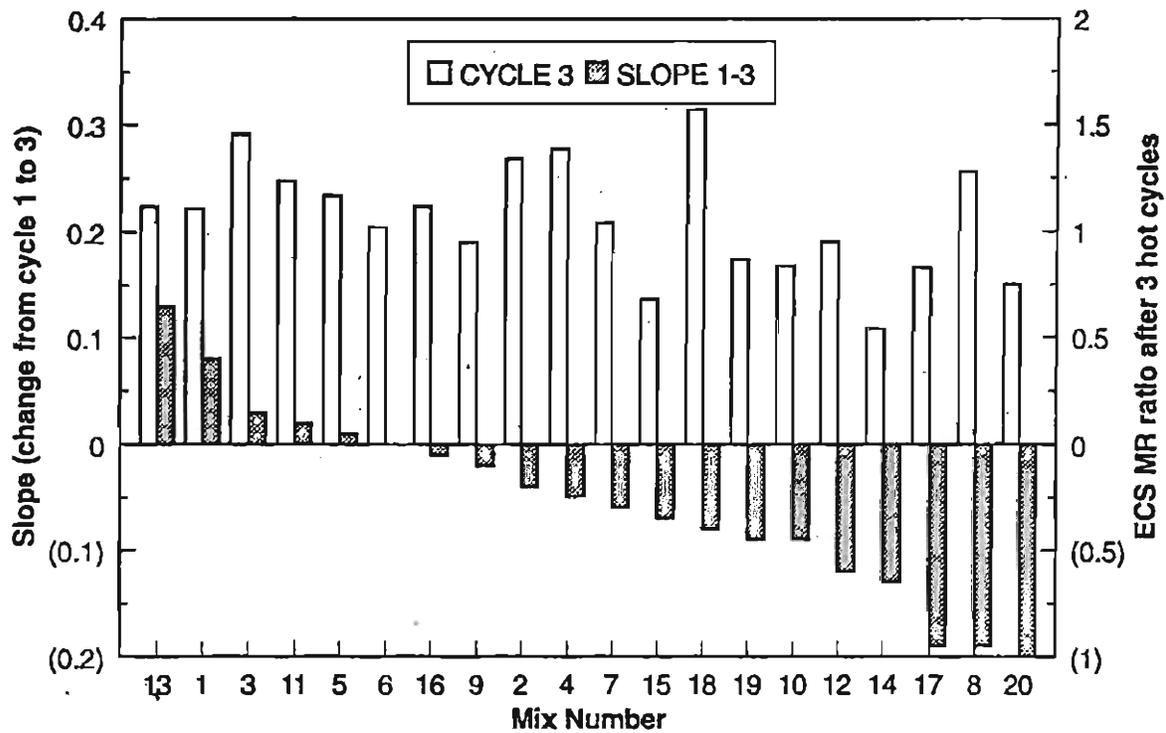
An alternative to Figure 16 is the ranking of sites by slope of the ECS curve between cycles 1 and 3 as shown in Figure 17. A preliminary interpretation of the test results developed in the SHRP work is that negative slopes may indicate the rate at which asphalt pavements will be water damaged, i.e., this slope correlates with expected service life. However it appears that the interpretation should be based on both the ECS- M_R ratio and slope. For example, if a mixture tested in the ECS marginally passed the 0.70 criteria but had a negative slope (1 through 3 cycles), then it would be suspect; it will fail, but not necessarily in the short term.

Fig. 17. Mixtures Ranked by Slope of the ECS Curve Between 1 and 3 Hot Cycles.
