Report No. CDOH-DH-SML-89-11

REACTIVE AGGREGATE IN CONCRETE STRUCTURES

Final Report
September, 1989

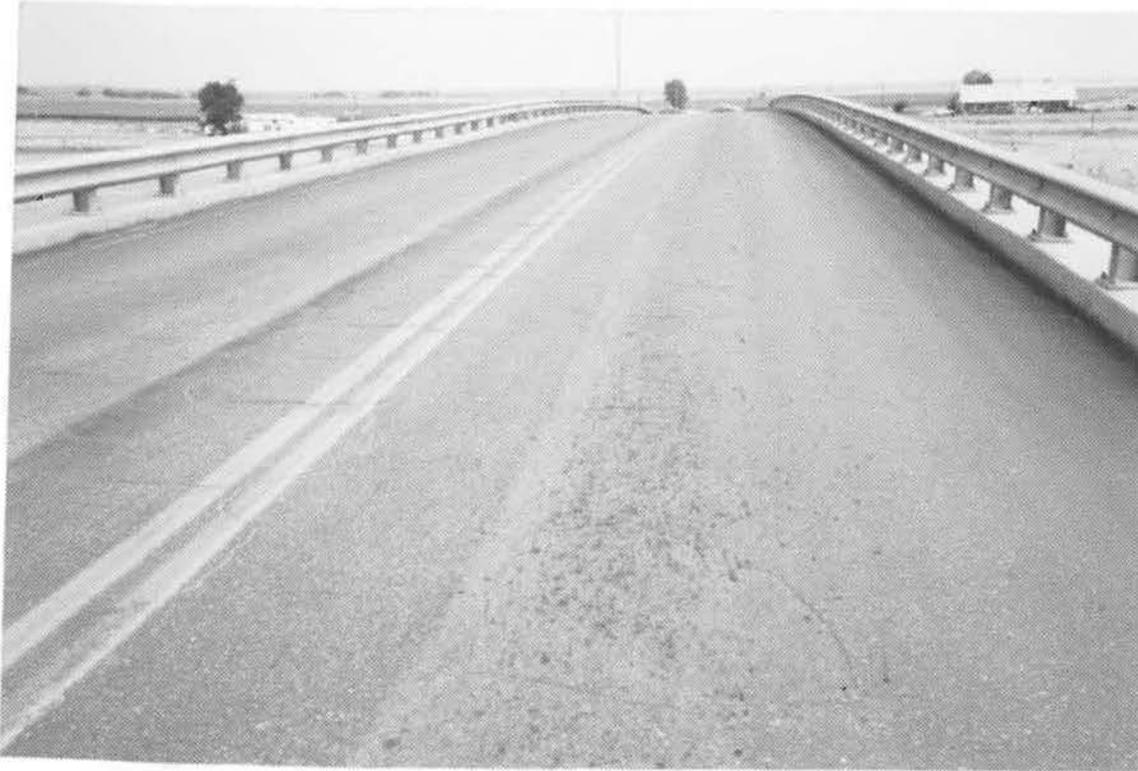
PICTURE #1
STRUCTURE D-19-N,
OVERPASS STRUCTURE
AT ROGGEN
DRIVING LANE

Description: 1959 structure; northbound, some fine map cracking; bottom of deck appears to be in good shape; center pier and cap were repaired with metallic grout.

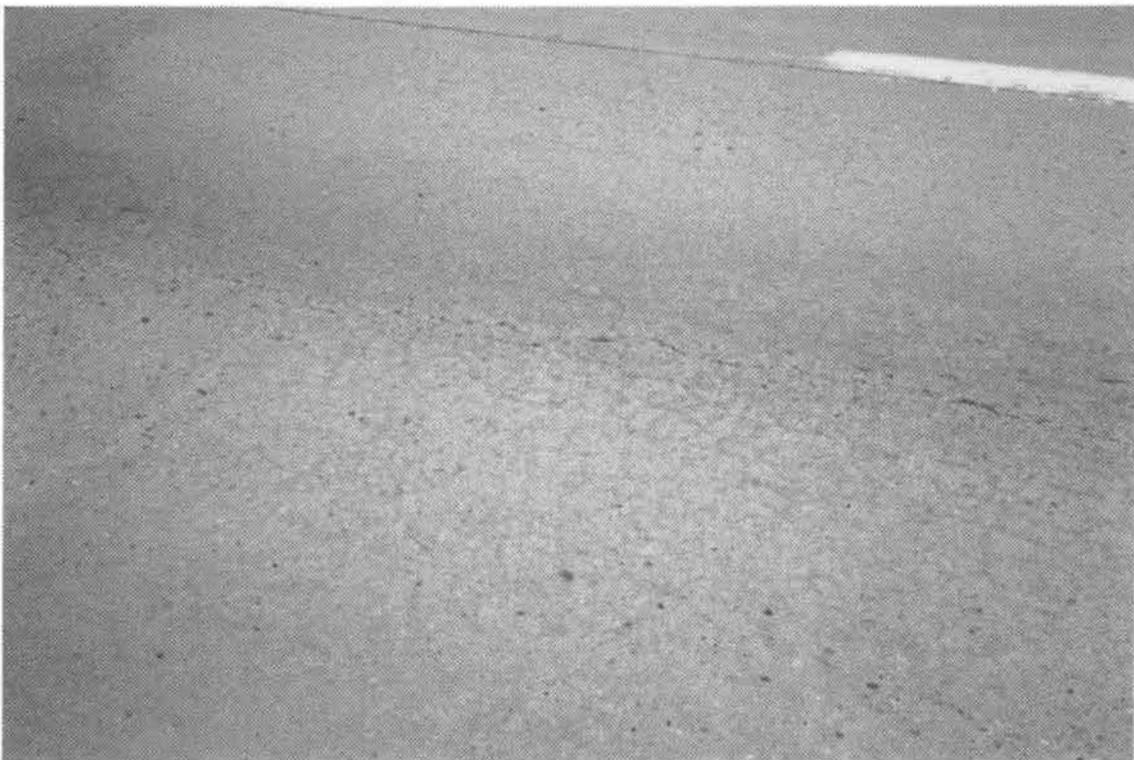
PICTURE #4
STRUCTURE D-20-AC
DRIVING LANE

Description: 1959 structure; parabolic concrete girders; there is some moderate cracking in the pavement; bottom of deck and girders are in fairly good shape; there is some map cracking in wingwall and curb; deck has been overlaid.

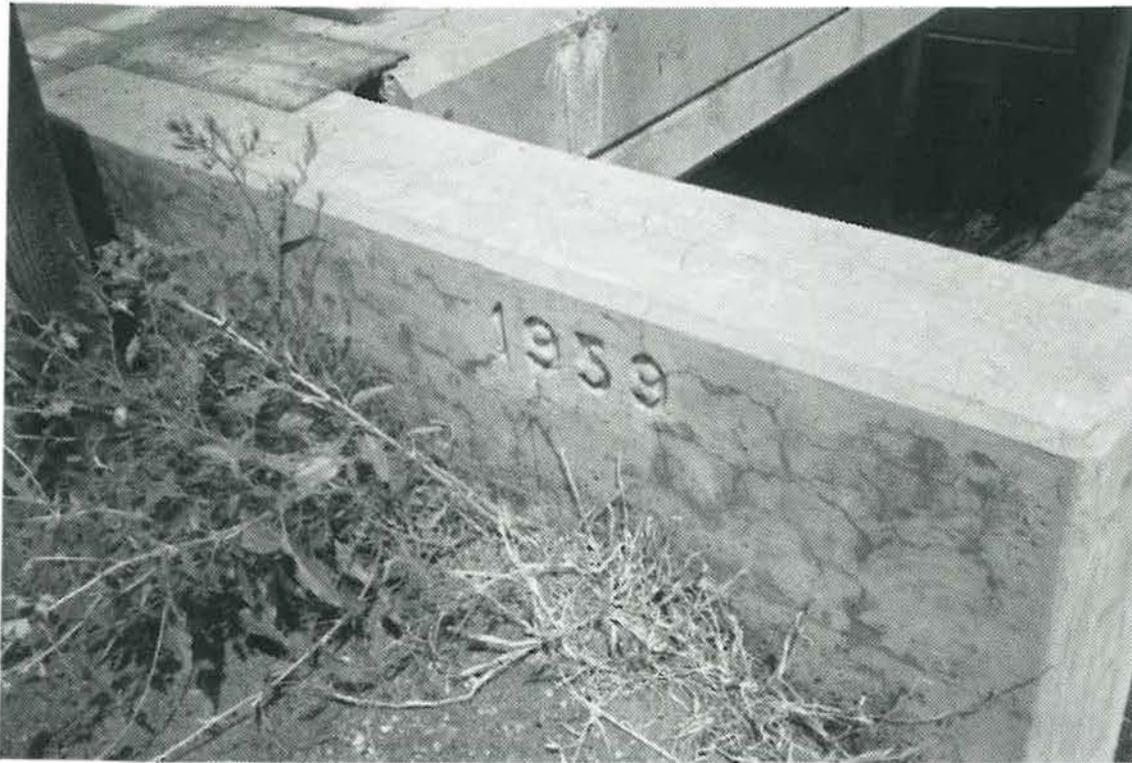
PICTURE #5
STRUCTURE D-20-AC
MAP CRACKING IN
CURB

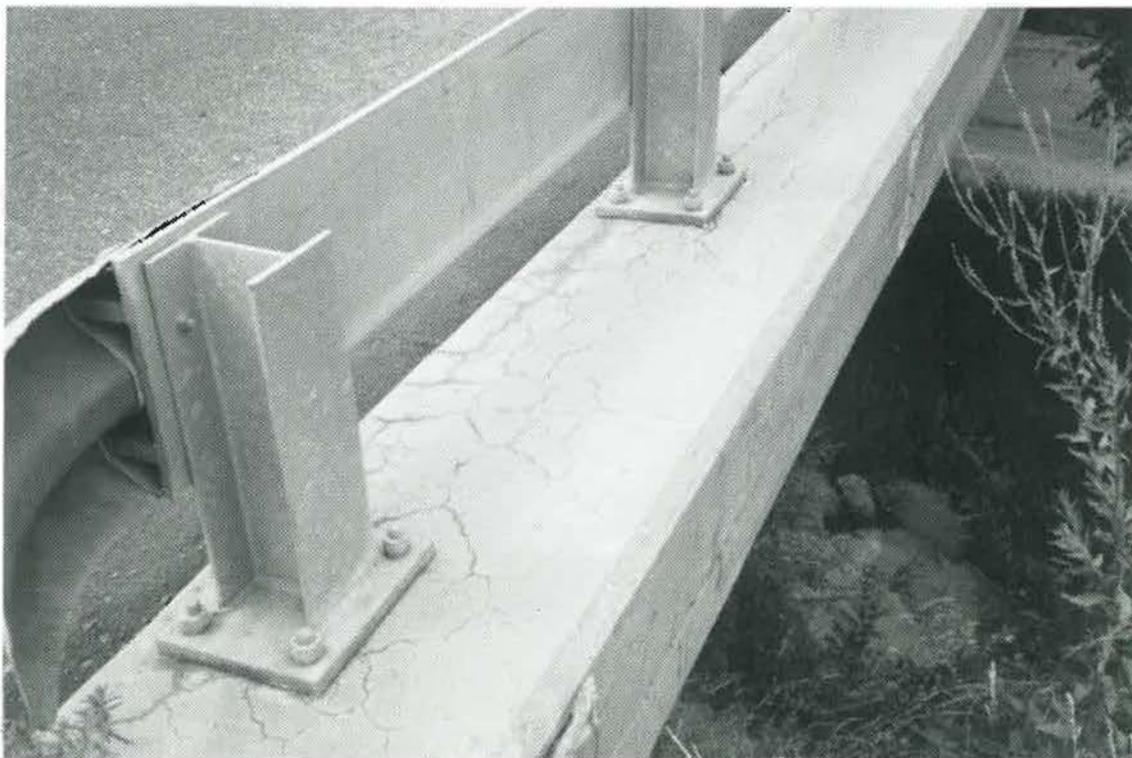
PICTURE #6
STRUCTURE D-20-AE &
D-20-AD, KIOWA
CREEK OVERPASS

Description: there is some moderate to severe cracking in the pavement; moderate cracking in curb; the bottom of the deck and substructure is in good shape.

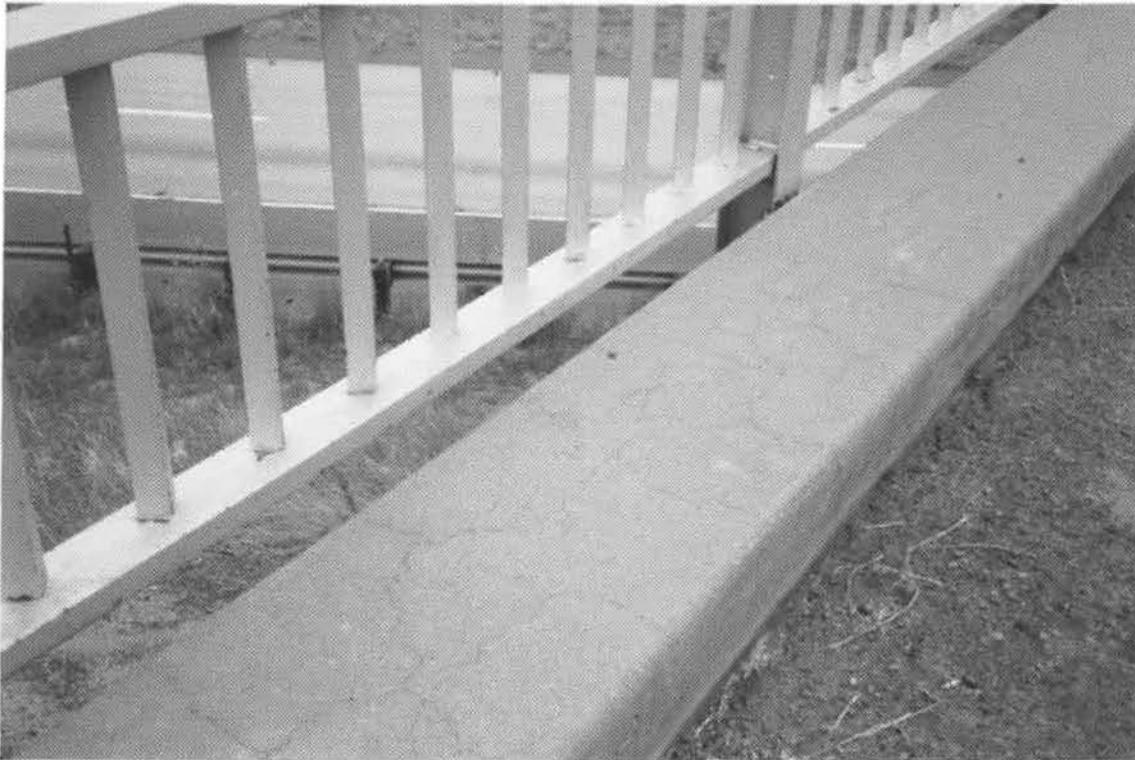
PICTURE #7
STRUCTURE D-20-AG,
COUNTY ROAD

Description: there is some moderate to severe cracking in the pavement; the bottom of the deck is in good shape; minor cracks observed in curb; deck has been overlaid.

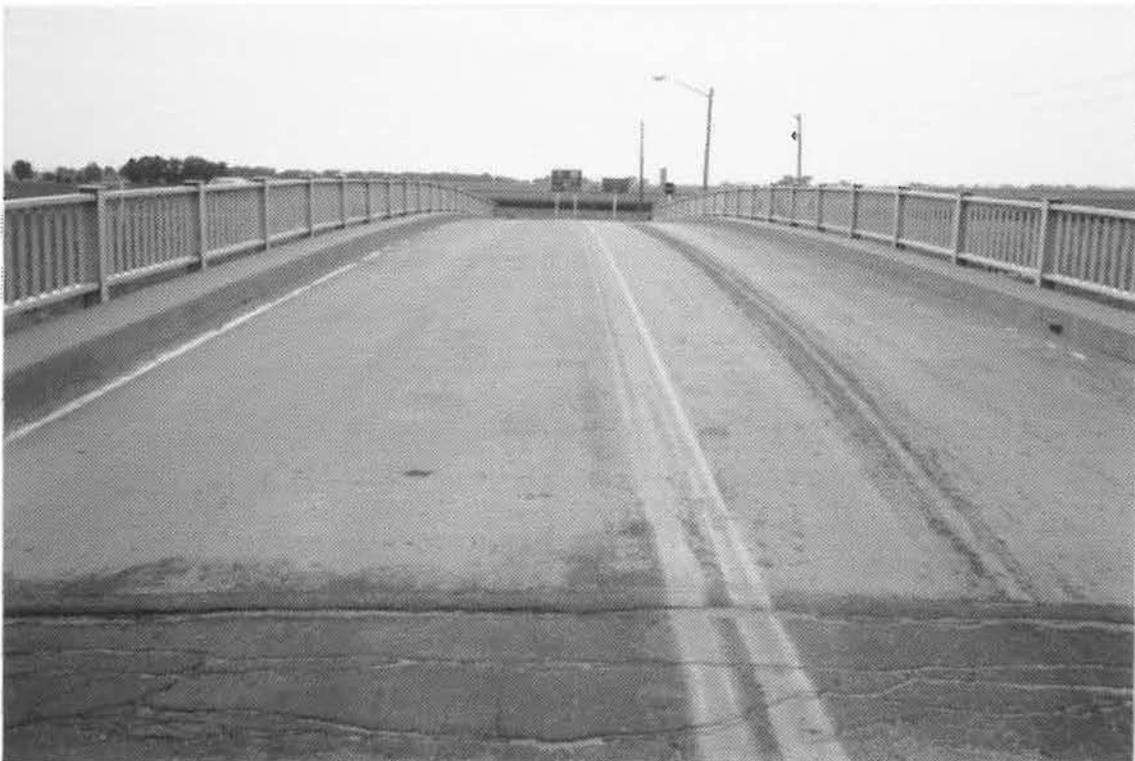
PICTURE #8
STRUCTURE C-21-BC,
COUNTY ROAD
OVERPASS AT TOWN OF
BIJOU

Description; this is a 1959 structure with parabolic arch girders; the bottom of the deck and girders appear in good shape; the deck has been overlaid; there is some minor cracking and some exposed rebars.

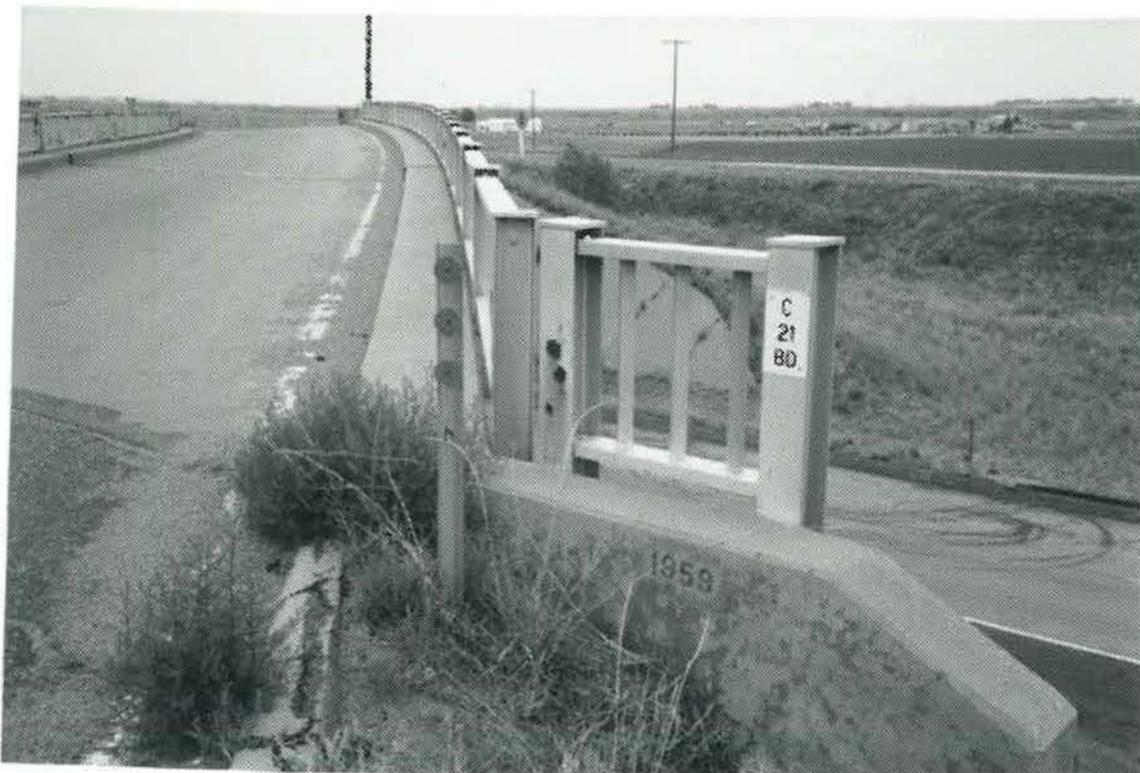
PICTURE #9
STRUCTURE C-21-BD

Description: bottom of deck and girders is in good condition; minor cracking at ends of pier cap directly under expansion device; moderate cracking in curb; original concrete deck in good shape.

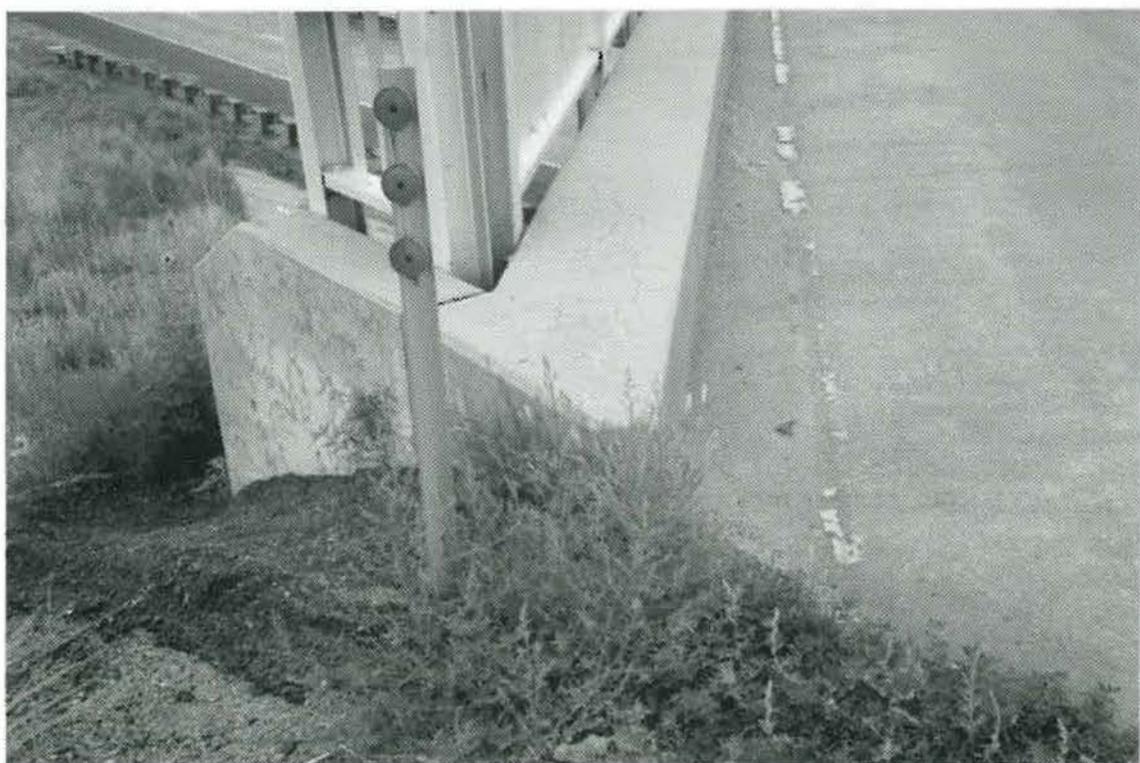
PICTURE #10
STRUCTURE C-21-E &
C-21-B, OVER SH 144

Description: this is a 1959 structure with parabolic concrete girders; there is some transverse cracking in the deck; bridge approach is in bad shape; there are some minor cracks in curb.

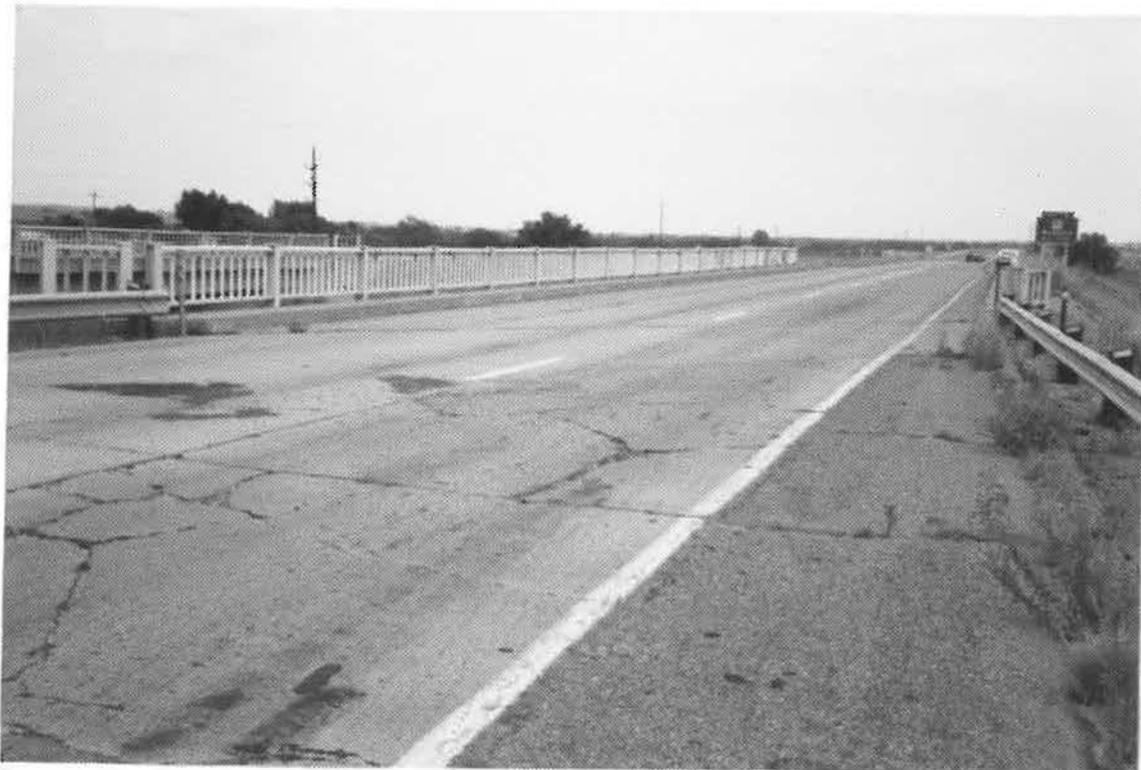
PICTURE #11
STRUCTURE C-21-M &
C-21-I, OVER SH 52
FT MORGAN

Description: this a 1959 structure with parabolic concrete girders; deck has been overlaid; the expansion joint north of NB structure leaks badly.

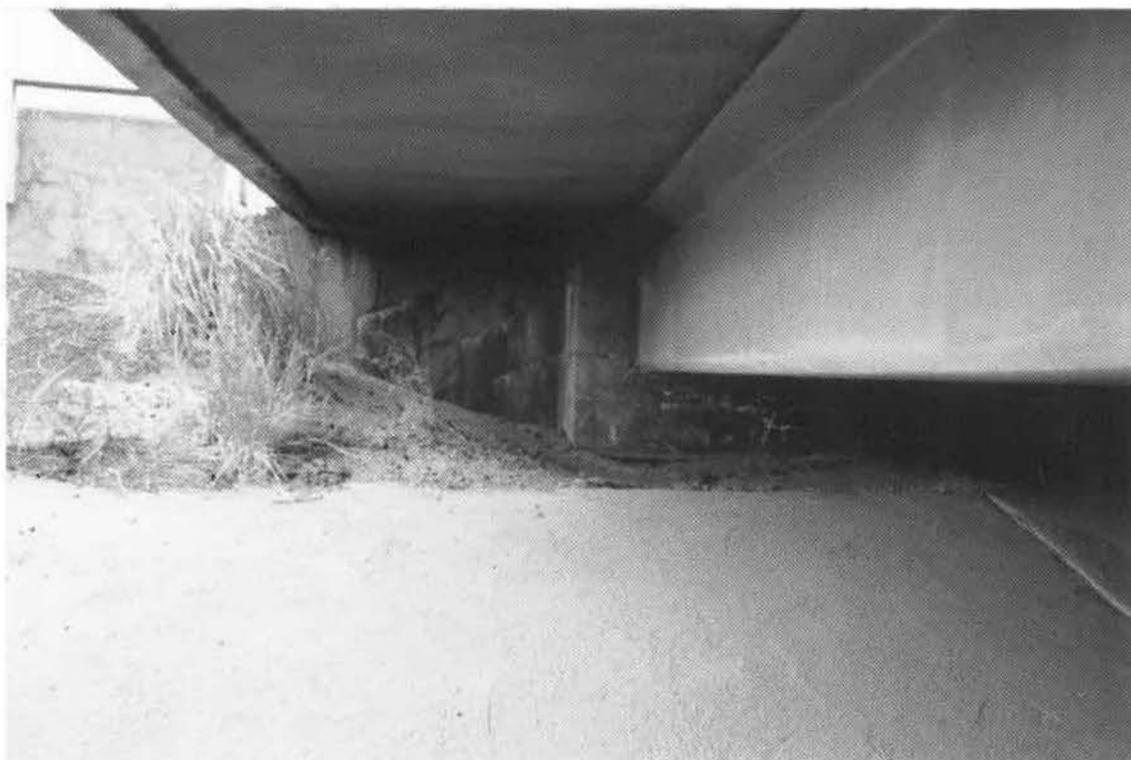
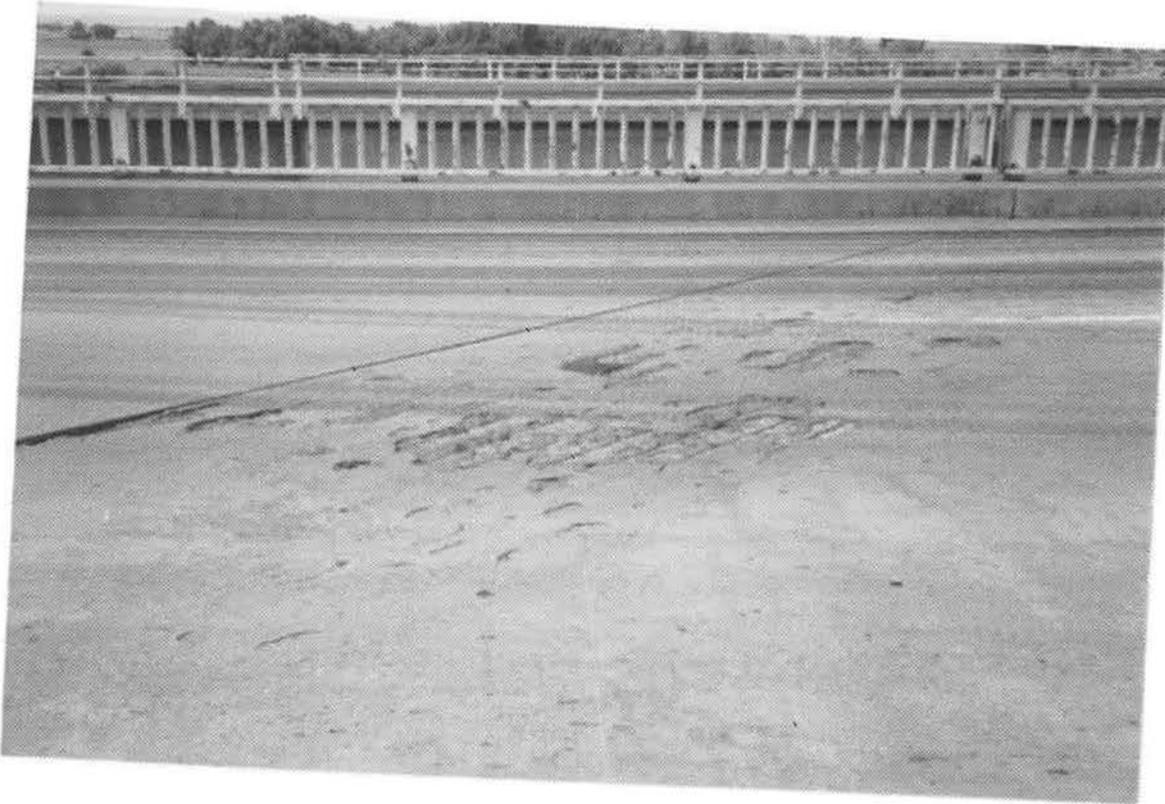
PICTURE #12
STRUCTURE C-22-BE &
BG

Description: 1961/1964 structure; bridge being overlaid today; concrete spalling off the top of the deck, this may be due to lack of clearance above rebars; bottom slab and prestressed girders look ok; the spalling on the pier cap appear to be caused by the leaking expansion joint.

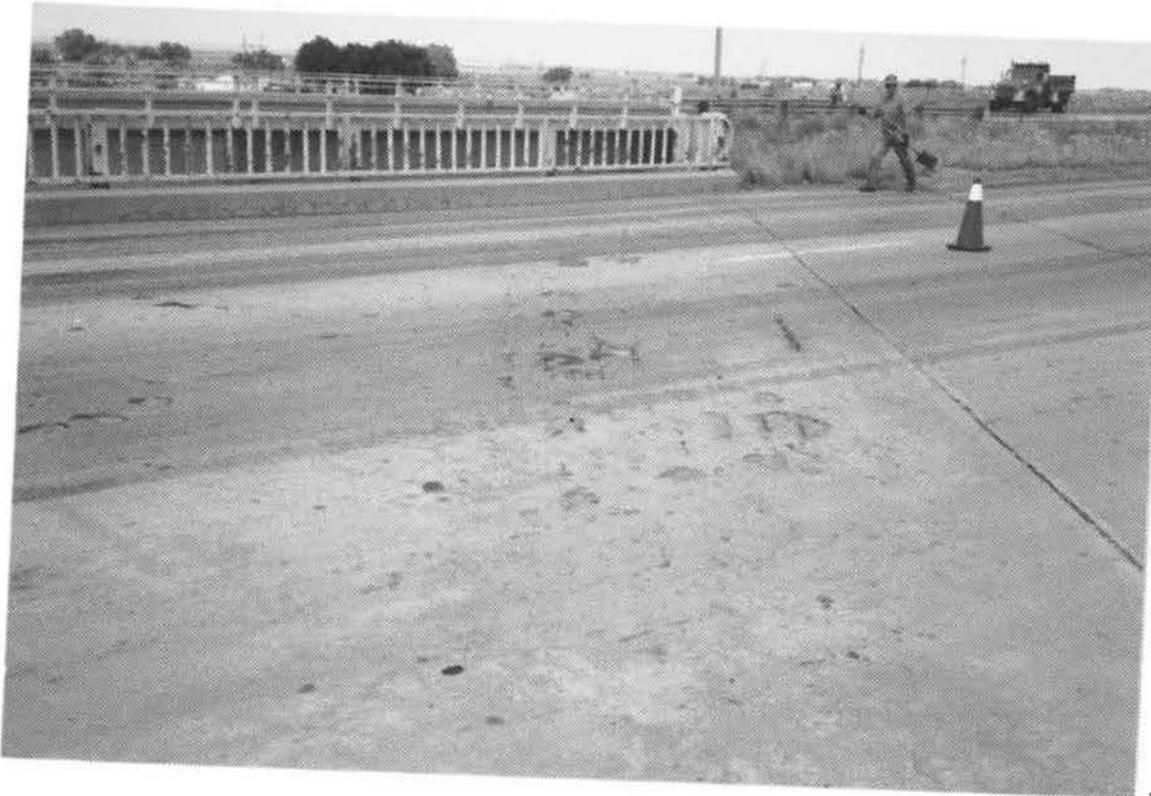
PICTURE #14
STRUCTURE C-22-BL &
C-22-BM,
OVER
COUNTY RD

Description: there is some moderate cracking in the approach pavement; substructure, girders and bottom slab look good; there are some cracks on SE parapet wall in structure BL.

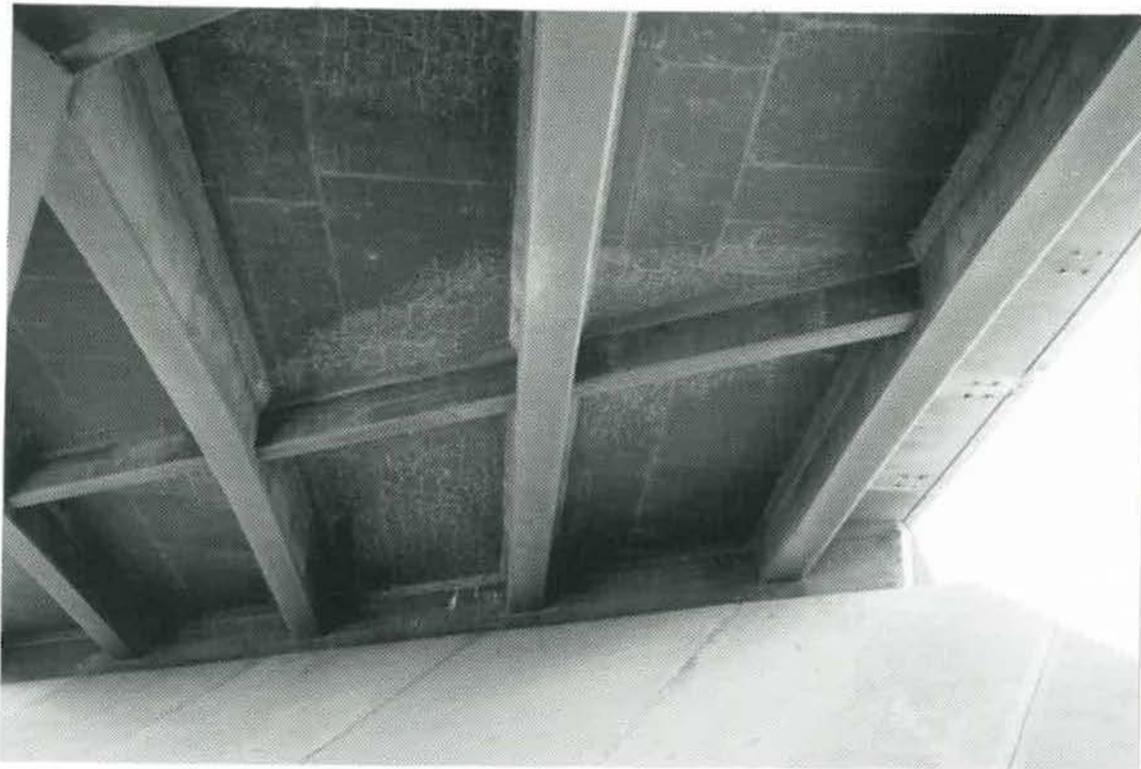
PICTURE #15
STRUCTURE B-23-AR
& B-23-AS, SH 63

Description: 1964 structure; there is some moderate to severe cracking in the approach pavement; the deck has been overlaid; there are some repair patches on the deck.

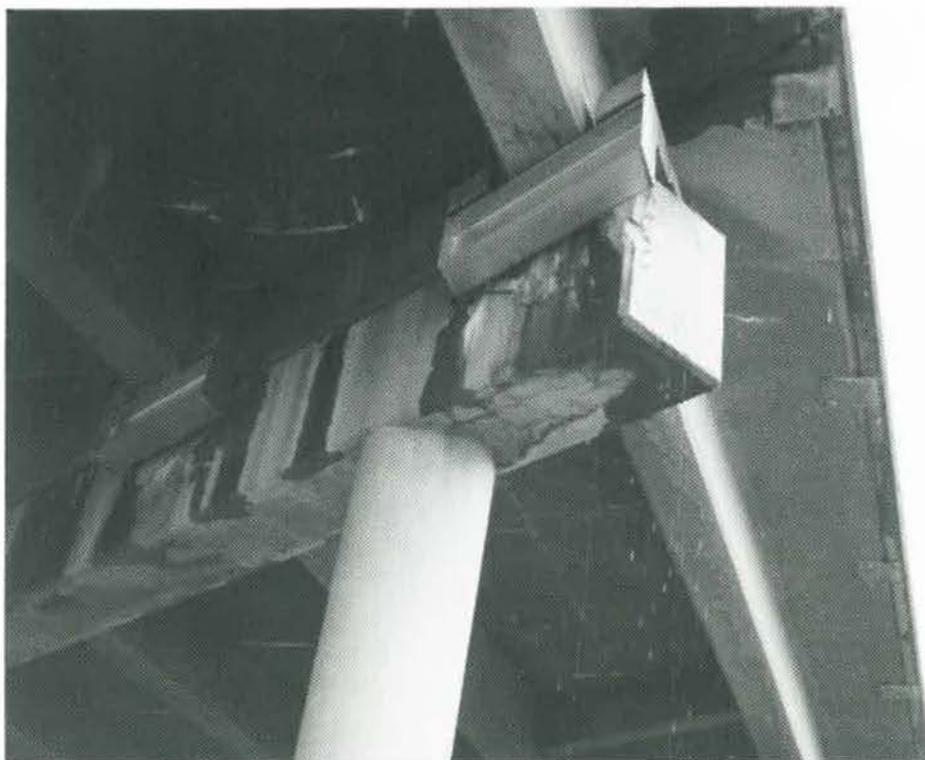
Description: massive leaks at joints; some efflorescence under slab on SB; NB under slab ok; on the NB deck some rebar showing due to spalling, there are a few asphalt patches; there are some severe cracks on the SB deck and some badly corroded rebar showing through. There is also some severe cracking in the approach pavement.

PICTURE #16
A-25-I & A-25-D,
COUNTY ROAD, MP 141
REPAIRED PIER-CAP

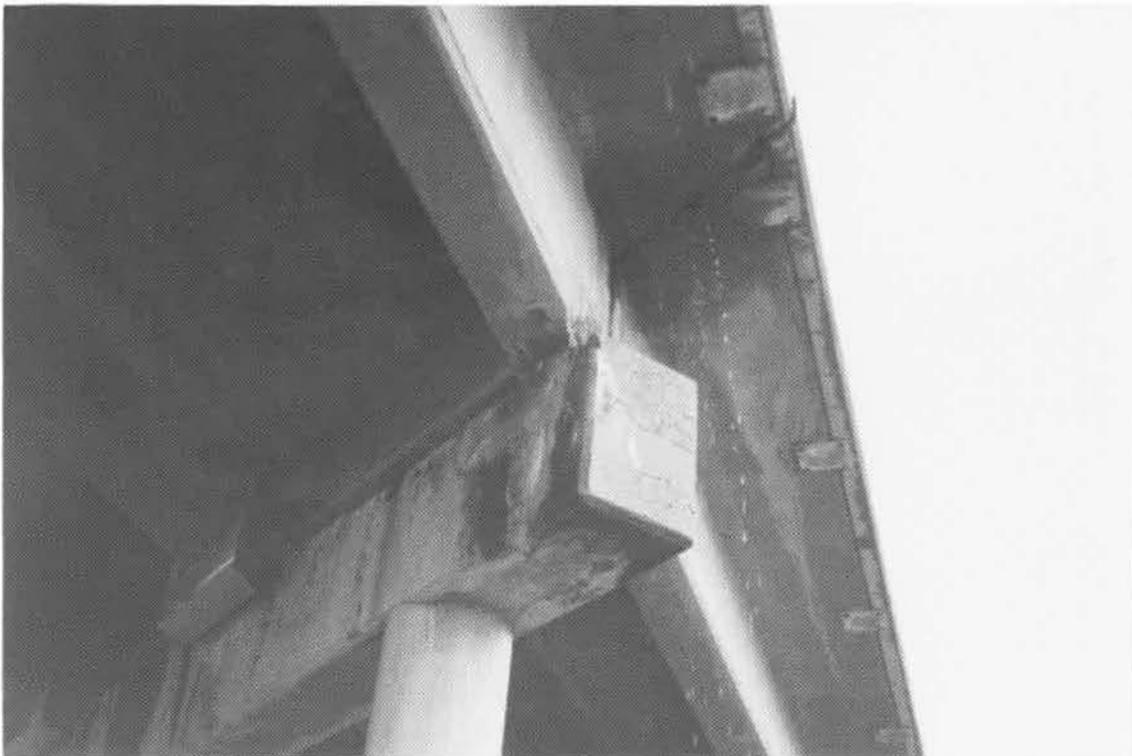
PICTURE #20
B-24-I & B-24-J

Description: 1966 structure; spalling off at the edge of girder.

Sample #3, B-24-J South, Milepost 133.49, exhibits alkali-silica reactivity. Several to many voids in the paste contain silica gel and the reactive aggregate has adjacent voids filled with silica gel. Many reactive aggregate particles have reaction rims. Three pieces of concrete had a few micro-cracks and two had many abundant reactive aggregate present. A total of twenty-five particles from 1/32 to 3/4 inch in size were counted in the six pieces of concrete examined. Three particles of 3/16 to 5/8 inch argillite and one 3/4 inch particle of quartzite were detected.
