The Deep Patch Technique for Landslide Repair

Bassam M. Helwany
Colorado Transportation Institute
4201 East Arkansas Avenue
Denver, CO 80222

Final Report
October, 1994

1. Report No. CTI-UCD-2-94		2. Government Accession No.		3. Recipient's Catalog No.	
4. Title and Subtitle The Deep Patch Technique for Landslide Repair				5. Report Date October, 1994

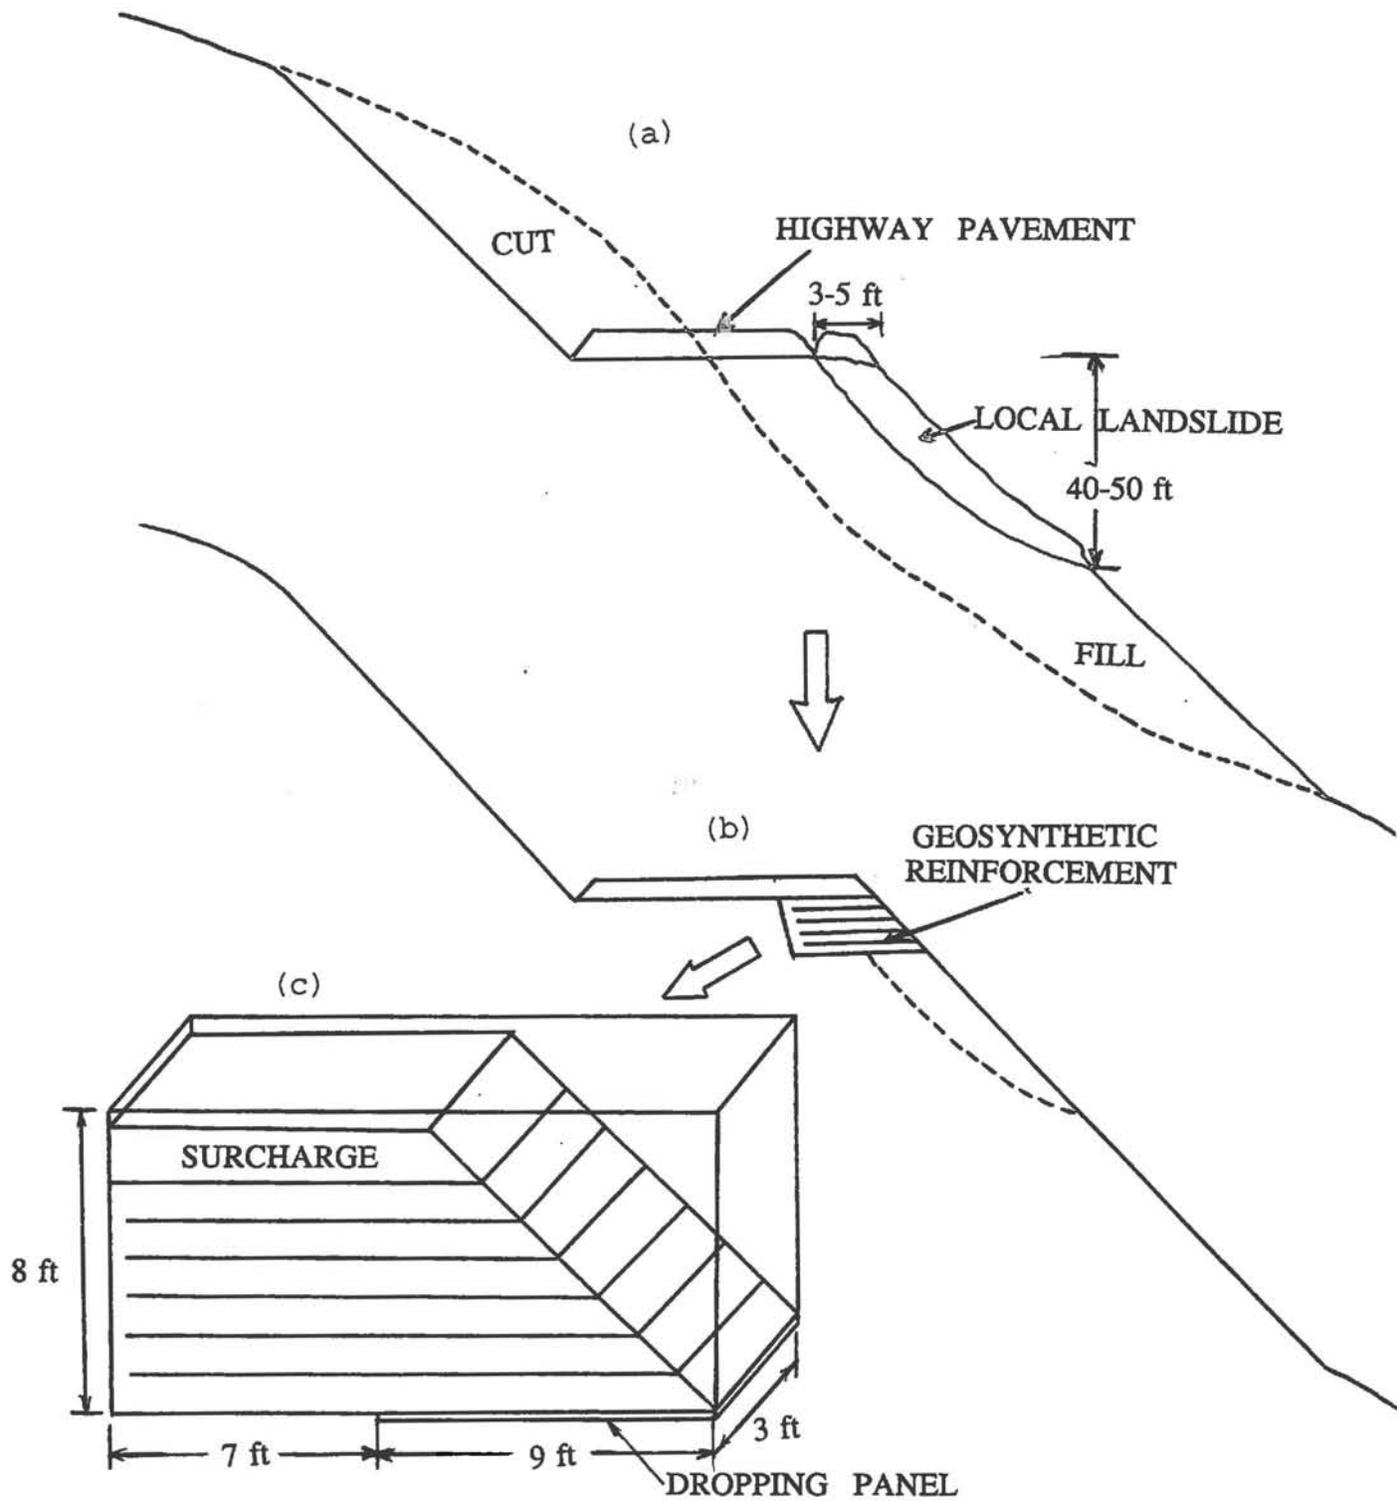
Figure 1.1 Schematic Diagram of the USFS Deep Patch Technique

The USFS deep patch technique is illustrated in Figure 1.1. Figure 1.1(a) depicts a cross-section of a typical highway in a mountain region. Part of the natural slope, which consists of inherently strong soil, is cut to allow for the highway. The loose soil from the cut is used to fill, without compaction, the lower part of the slope to form an extension to the existing foundation.

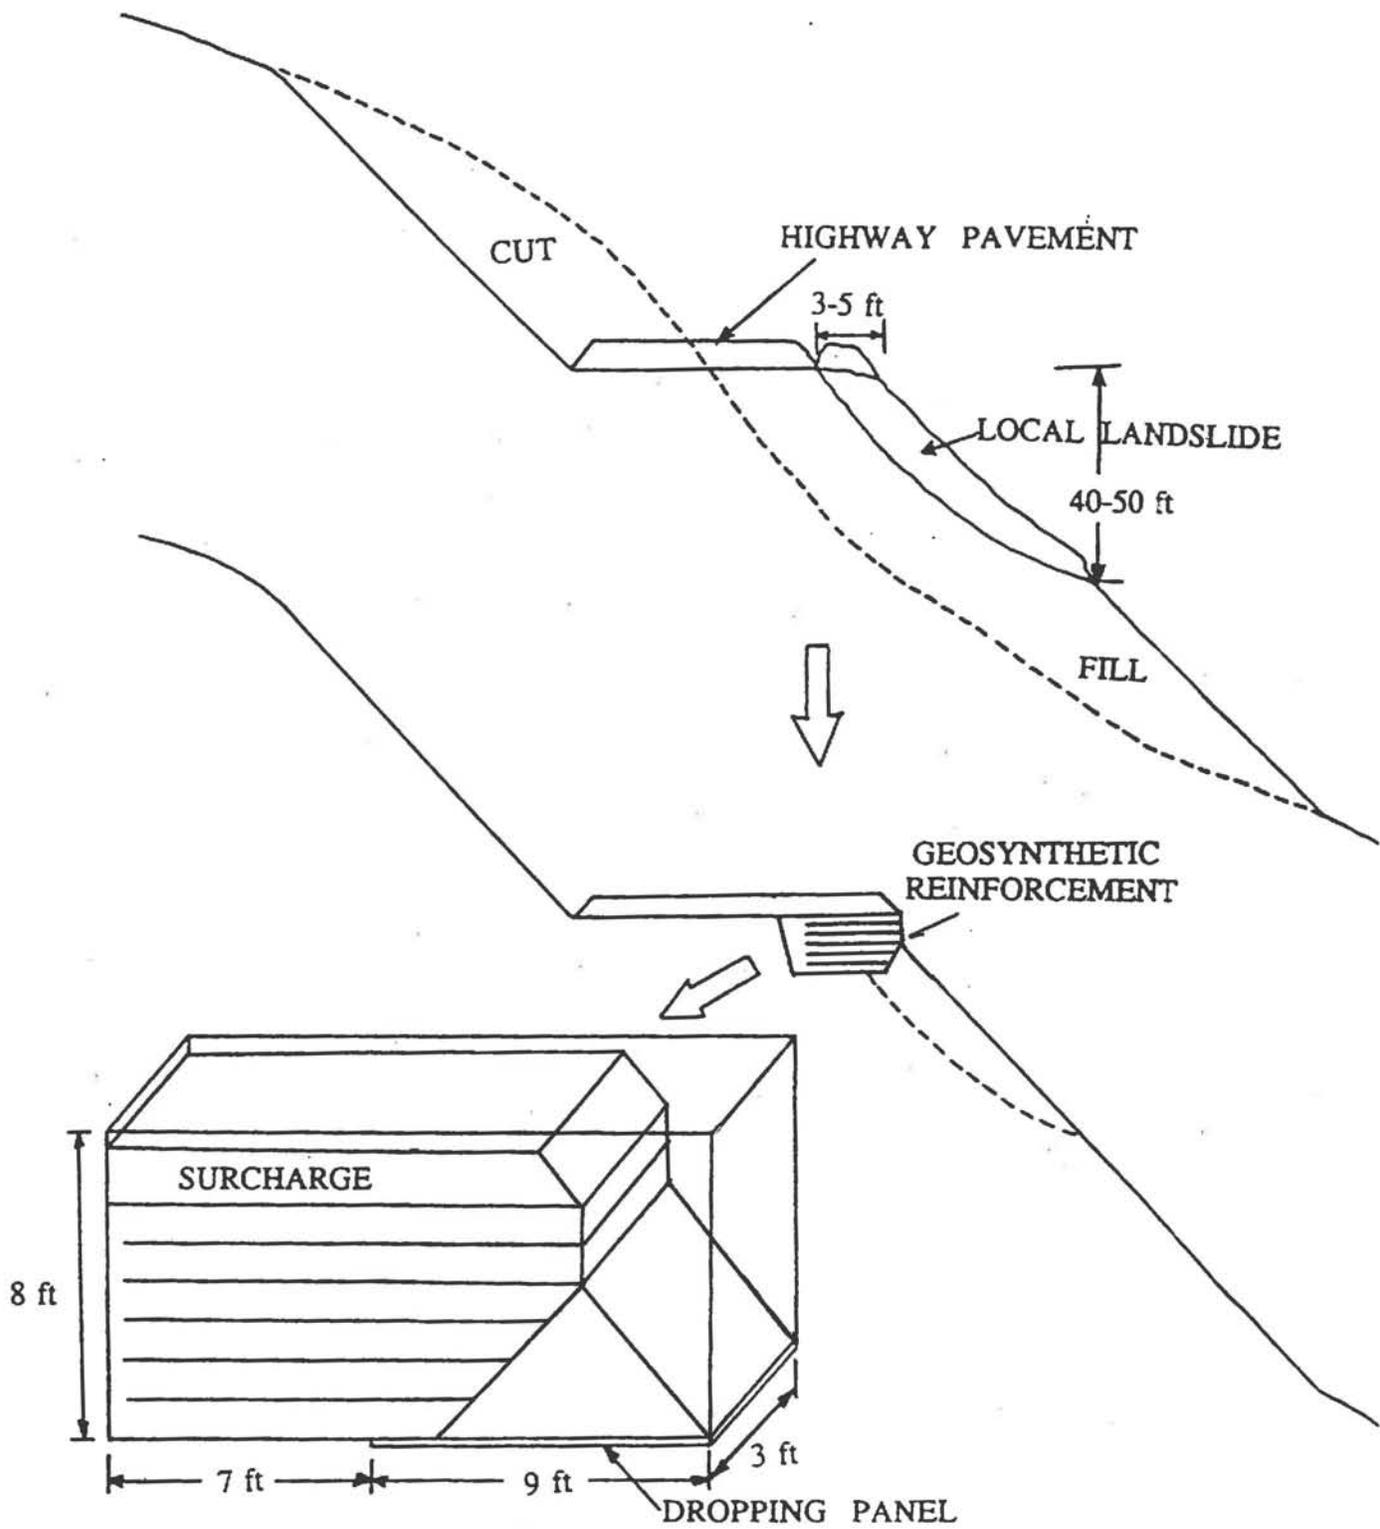
Figure 1.2 Schematic Diagram of the CTI Deep Patch Technique

the CTI deep patch will separate from the repaired slope causing no distress in the highway pavement. The second advantage of using the CTI deep patch technique is its ability to widen the highway of an average of 4 feet as shown in Figure 1.2.

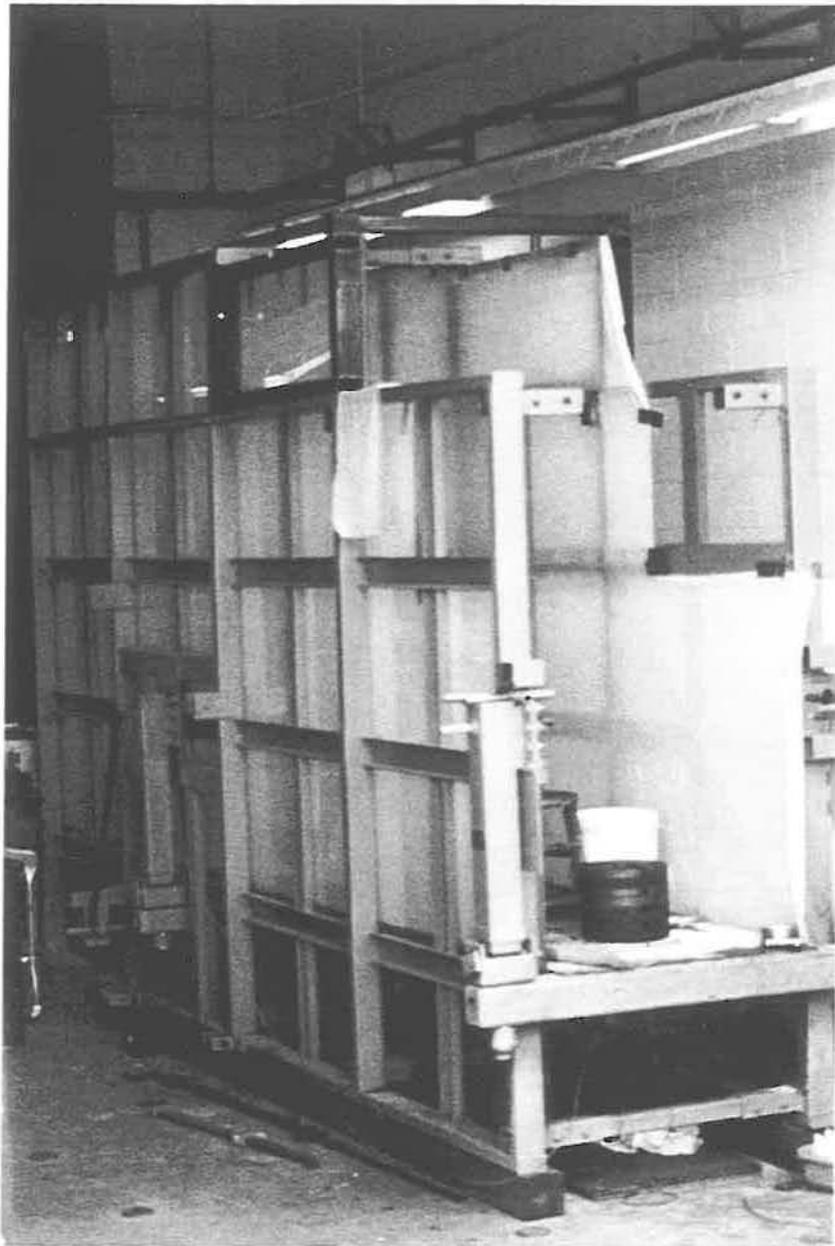
Figure 2.1 The Deep Patch Test Apparatus

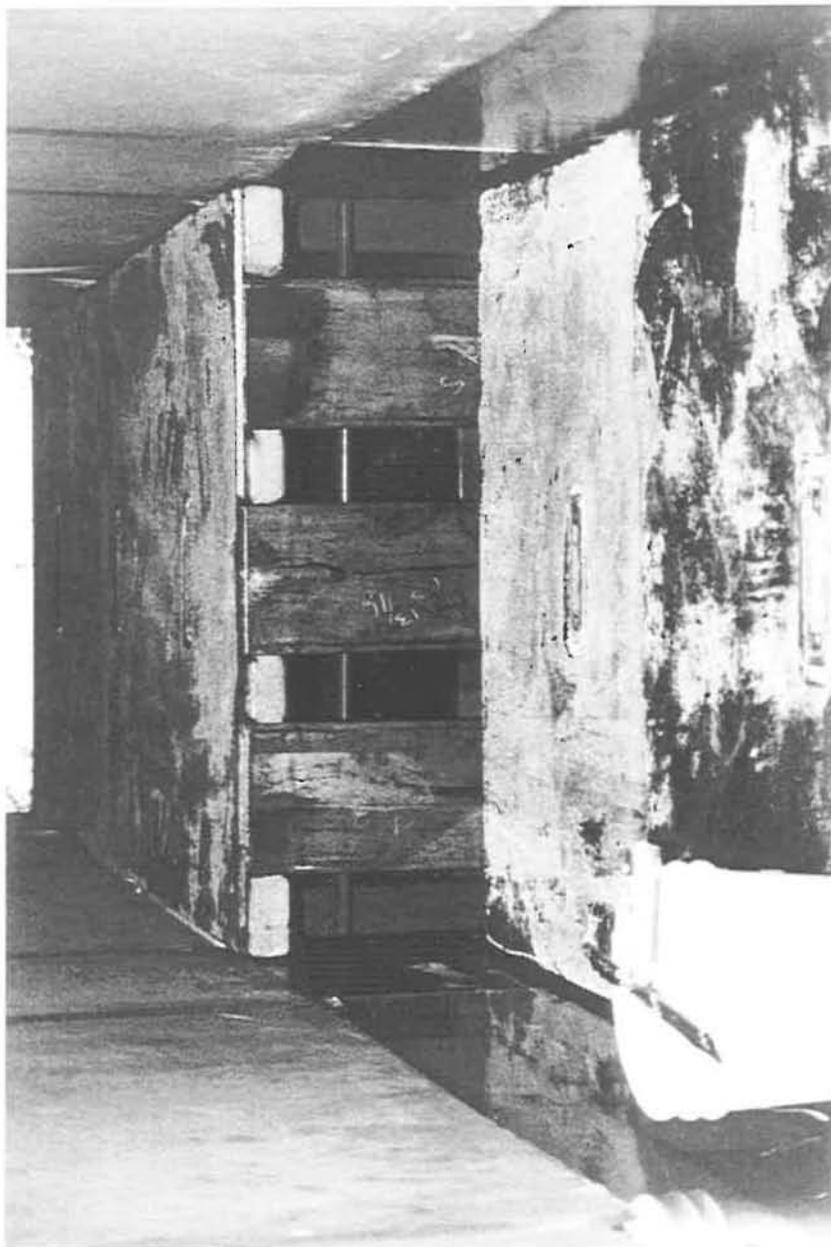
Figure 2.4 The Movable Part of the Bottom Panel at 11 inch Drop

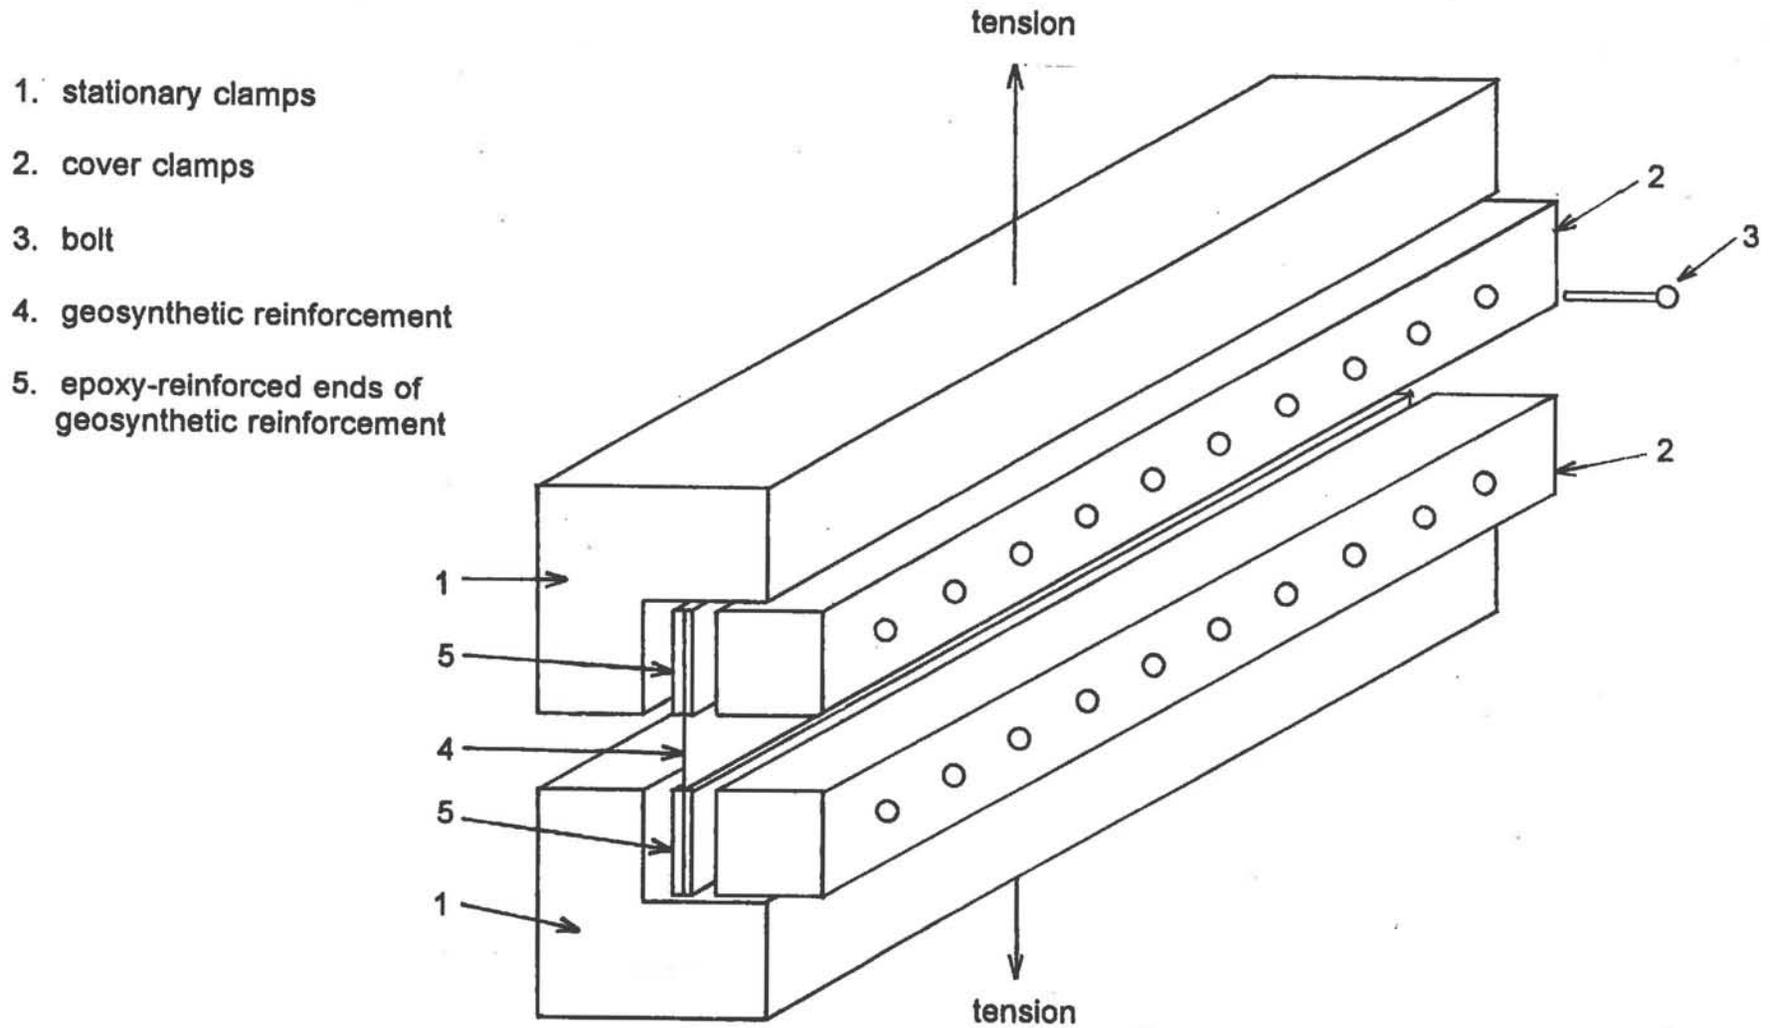
Figure 2.6 Schematic Diagram of the Uniaxial Load-Deformation Apparatus

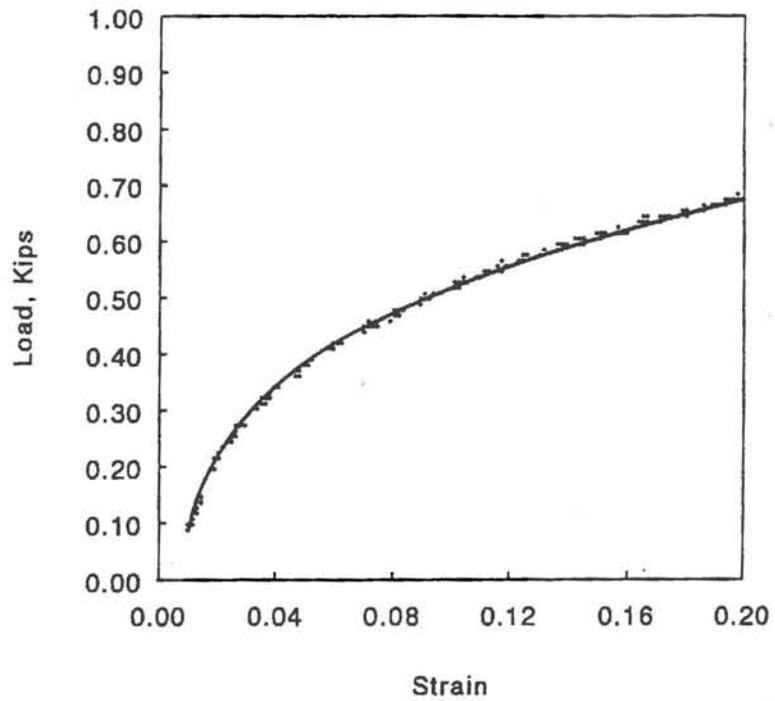
Figure 2.10 Load-Deformation Behavior of the Geotextile Reinforcement

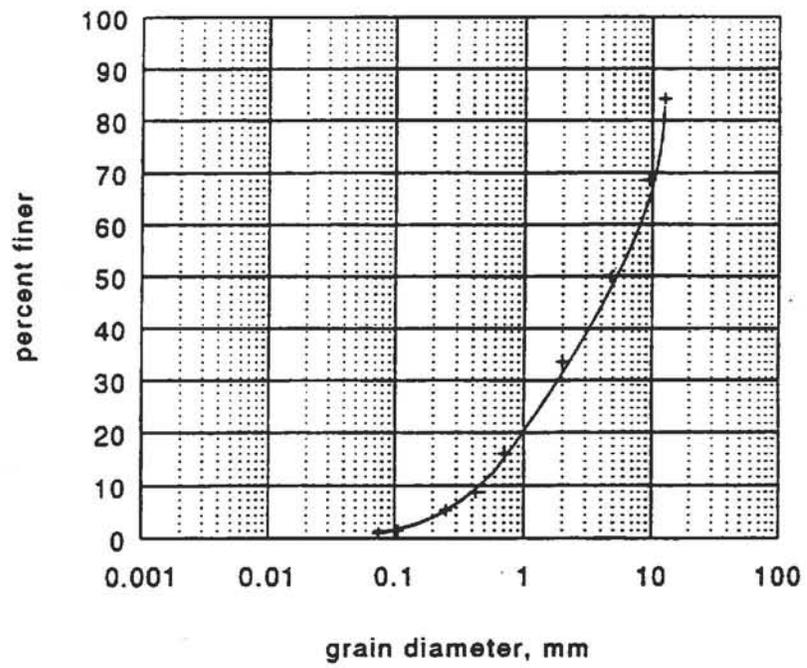
Figure 2.11 Grain Size Distribution Curve of the Gravelly Sand

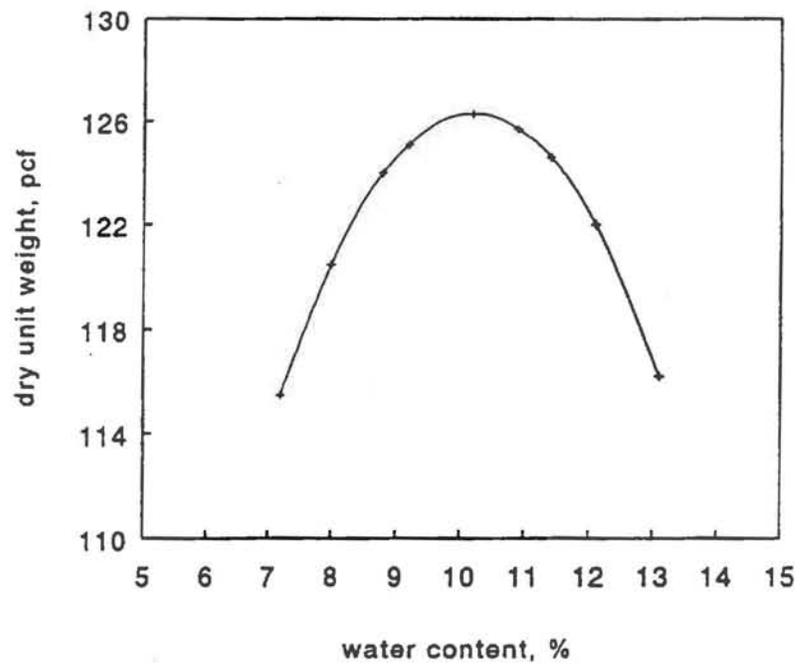
Figure 2.12 Compaction Curve of the Gravelly Sand

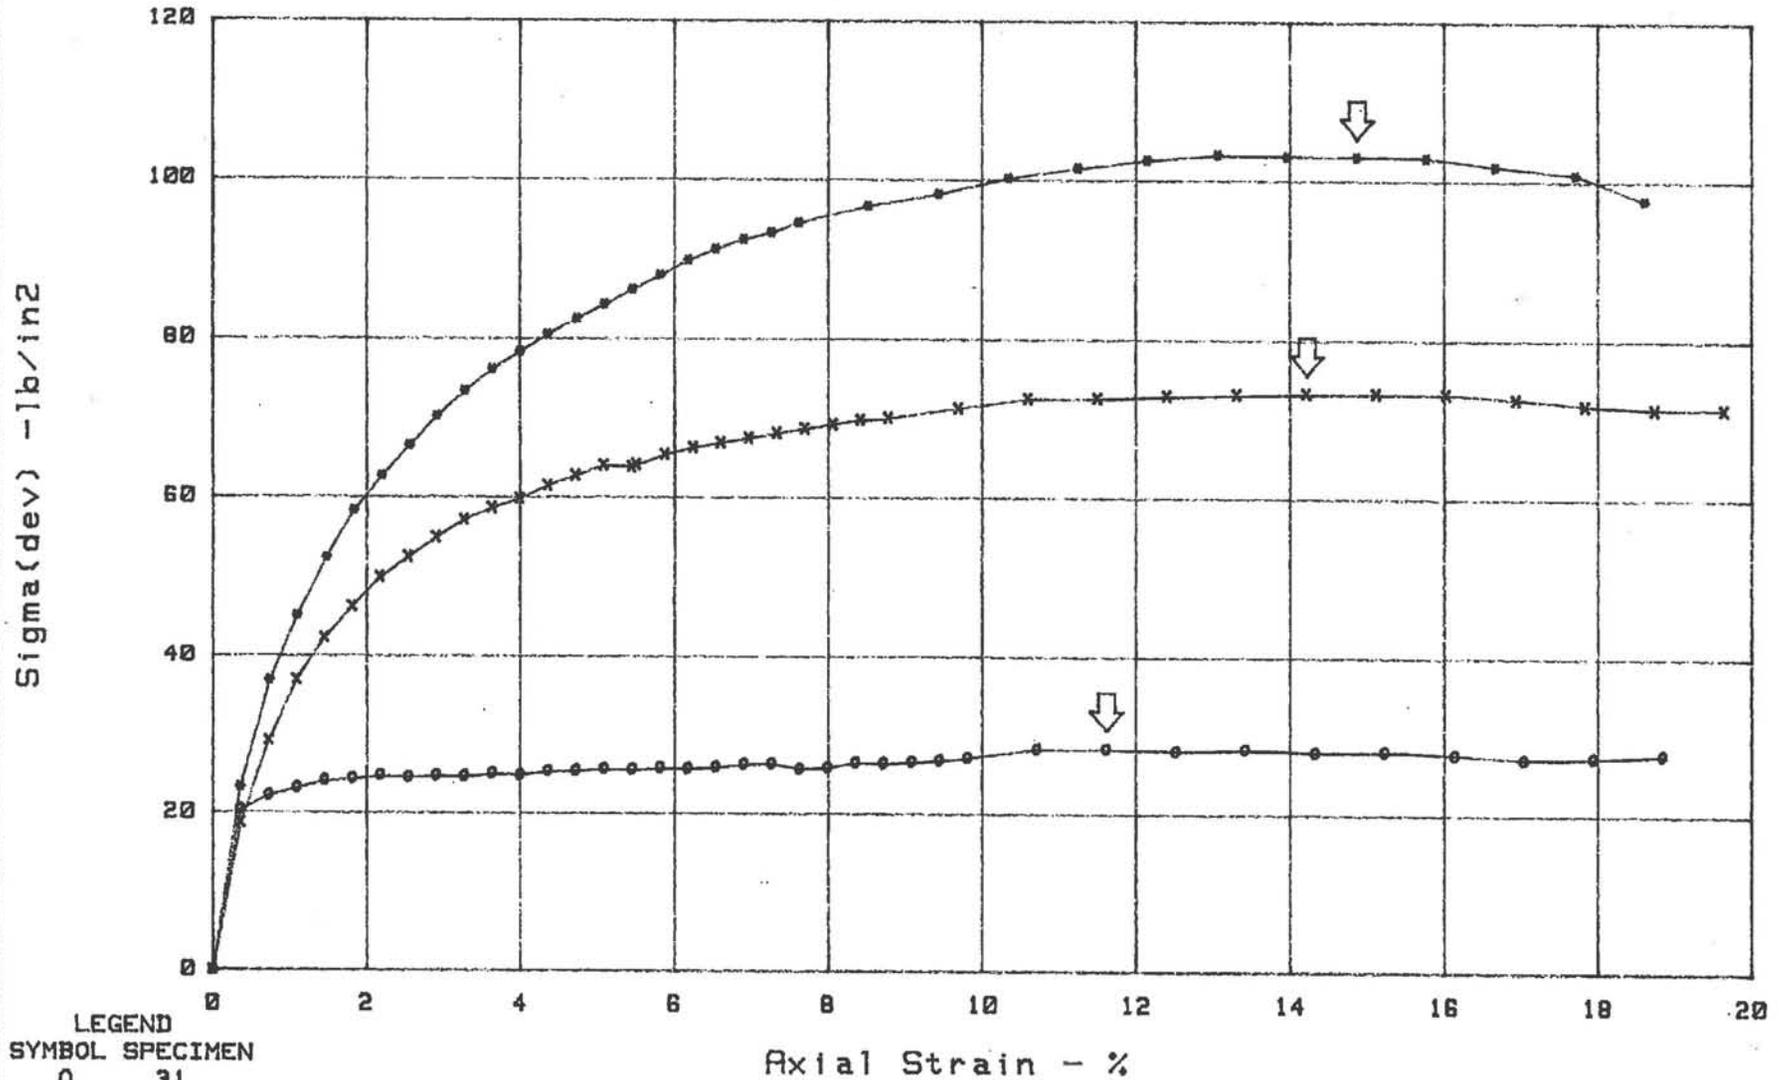
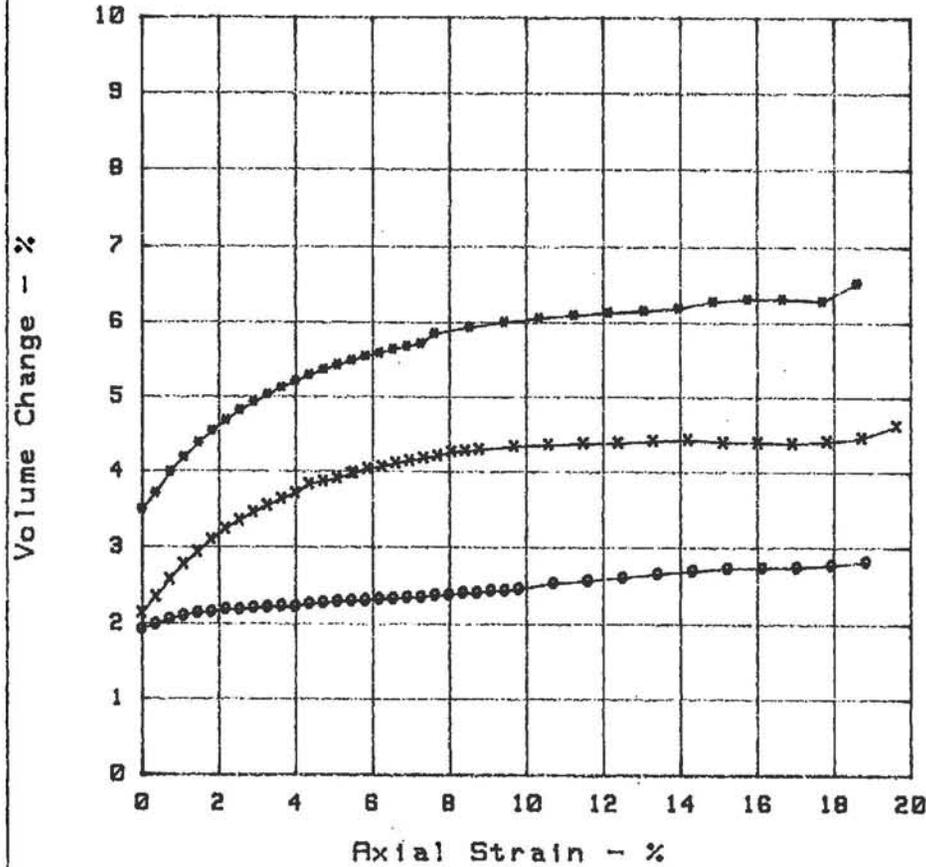
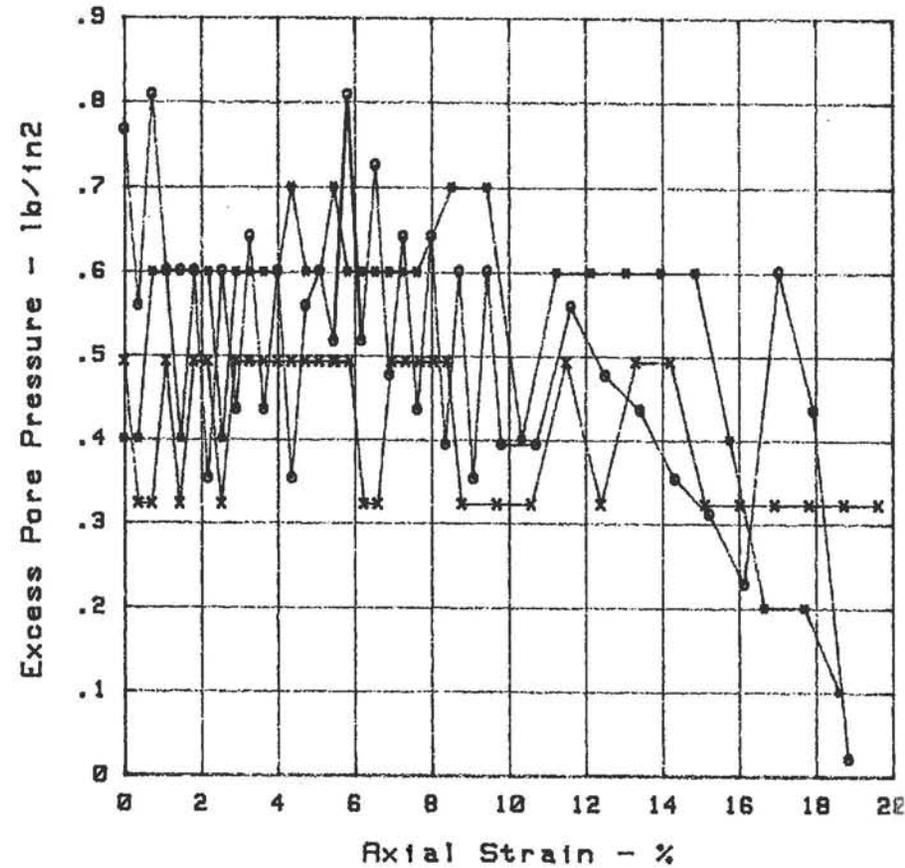
Figure 2.13(a)

Triaxial Compression Test Results for the Gravelly Sand

19.8 KN/m³ (126.0 pcf) at 8.5% water content (similar to the in-situ condition in the deep patch tests). The results of the CD tests are shown in Figure 2.13.

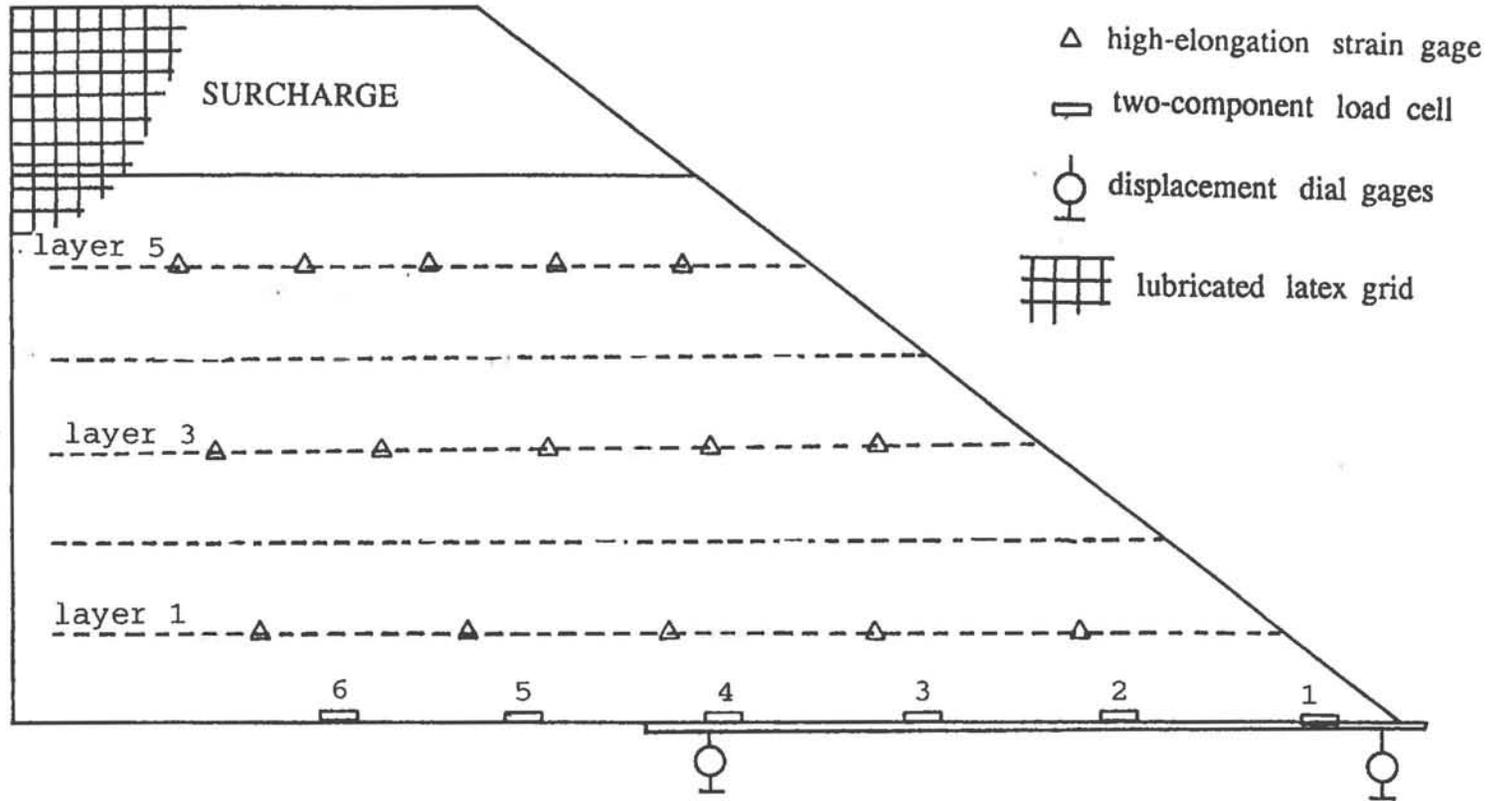
Figure 2.14 Instrumentation of the USFS Deep Patch Test

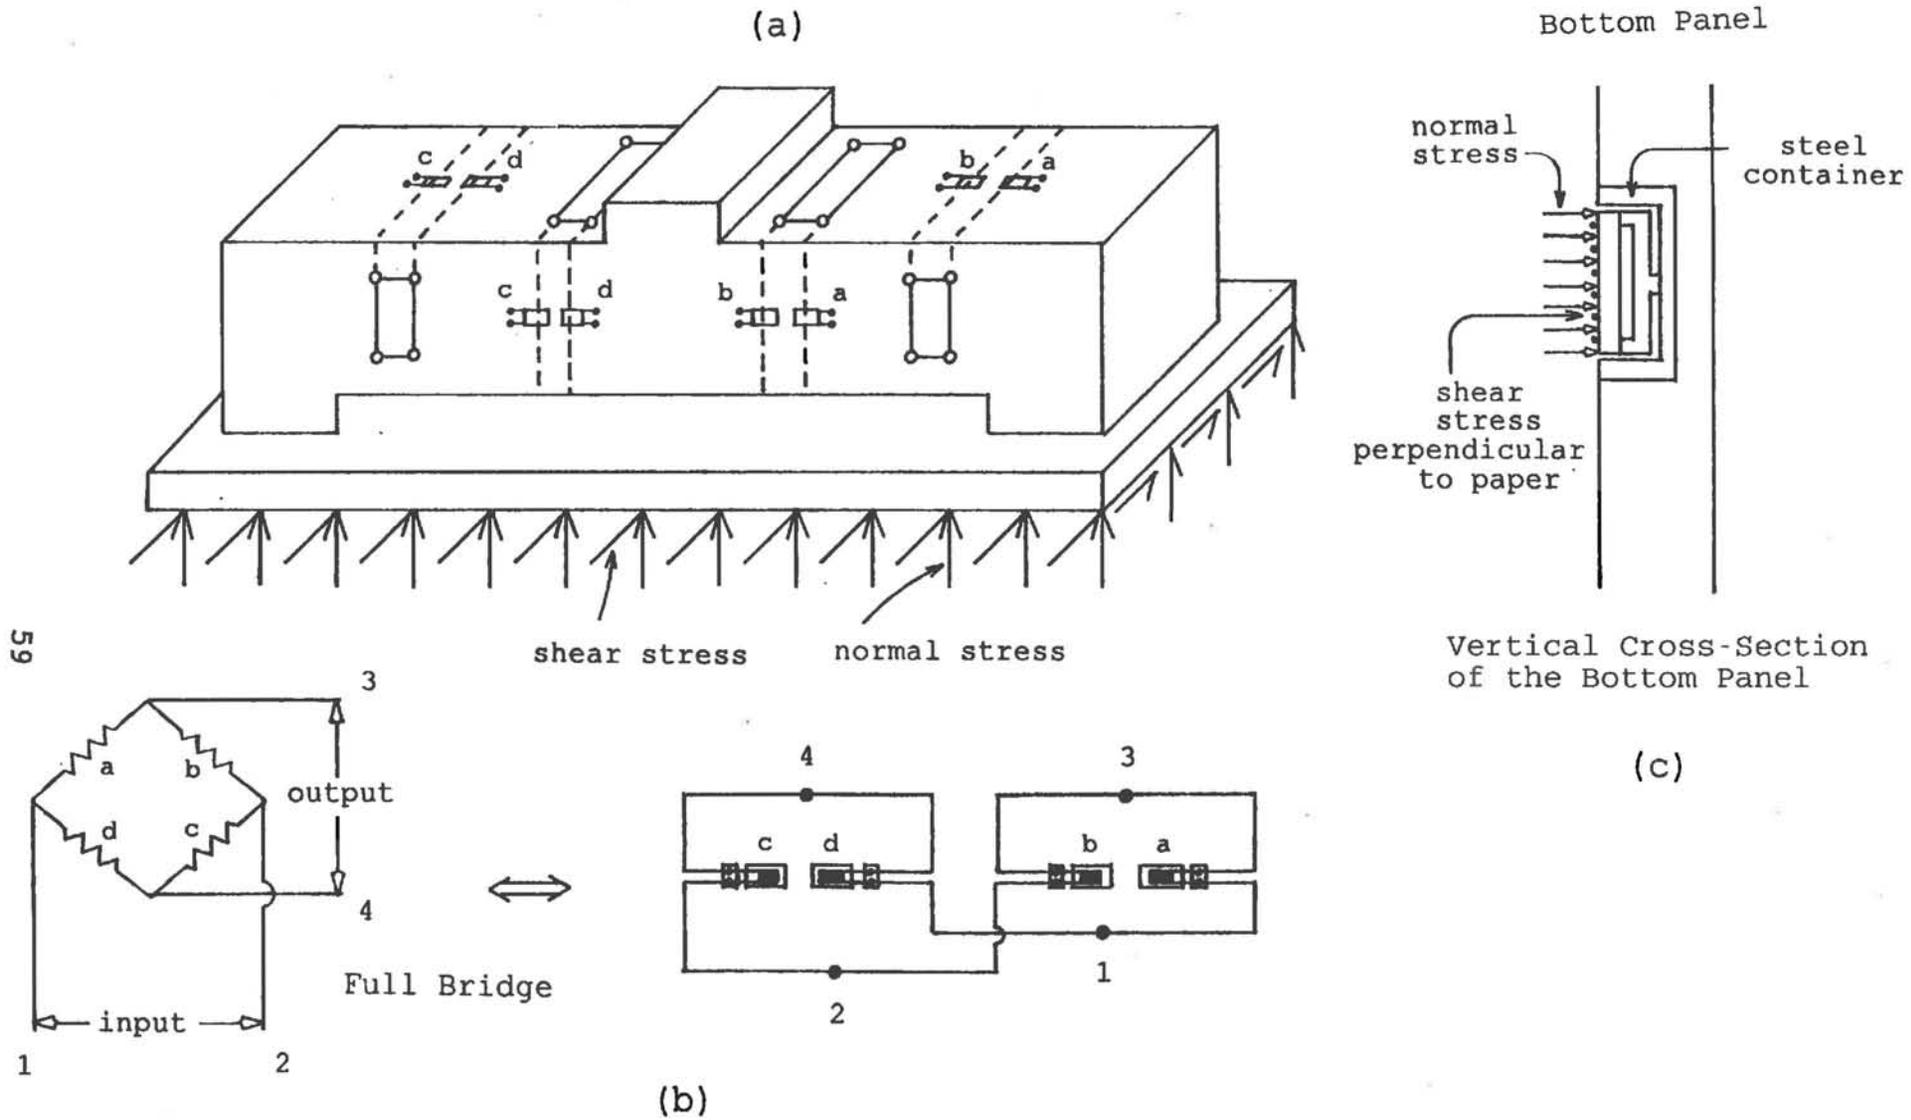
Figure 2.15 Schematic Diagram of the Two-Component Load Cell

A schematic diagram of the load cell is shown in Figure 2.15(a). In the figure, the normal stress applied to the load cell will cause stress concentration at the top (and bottom) of the horizontal cavities. On the other hand, the shear stress applied to the load cell will cause stress concentration at the top (and bottom) of the vertical cavities. Four strain gages arranged in full bridge configuration are set in stress concentration regions resulting from the application of normal stress. Another four strain gages arranged in full bridge configuration are set in stress concentration regions resulting from the application of shear stress as shown in Figure 2.15(a). The method of wiring the full bridge configuration is shown in Figure 2.15(b). Figure 2.16 shows a fully-instrumented load cell.

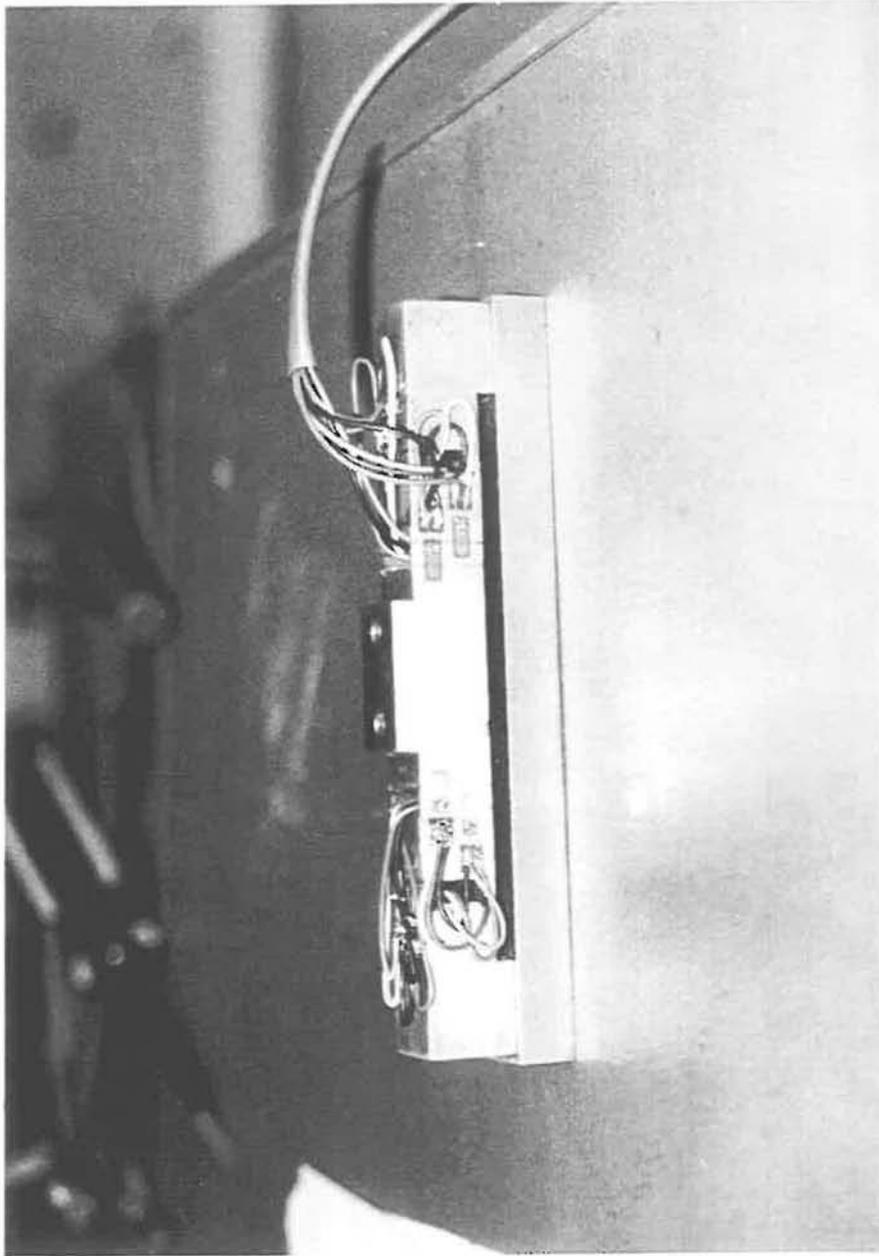
Figure 2.16 Instrumentation of the Two-Component Load Cell

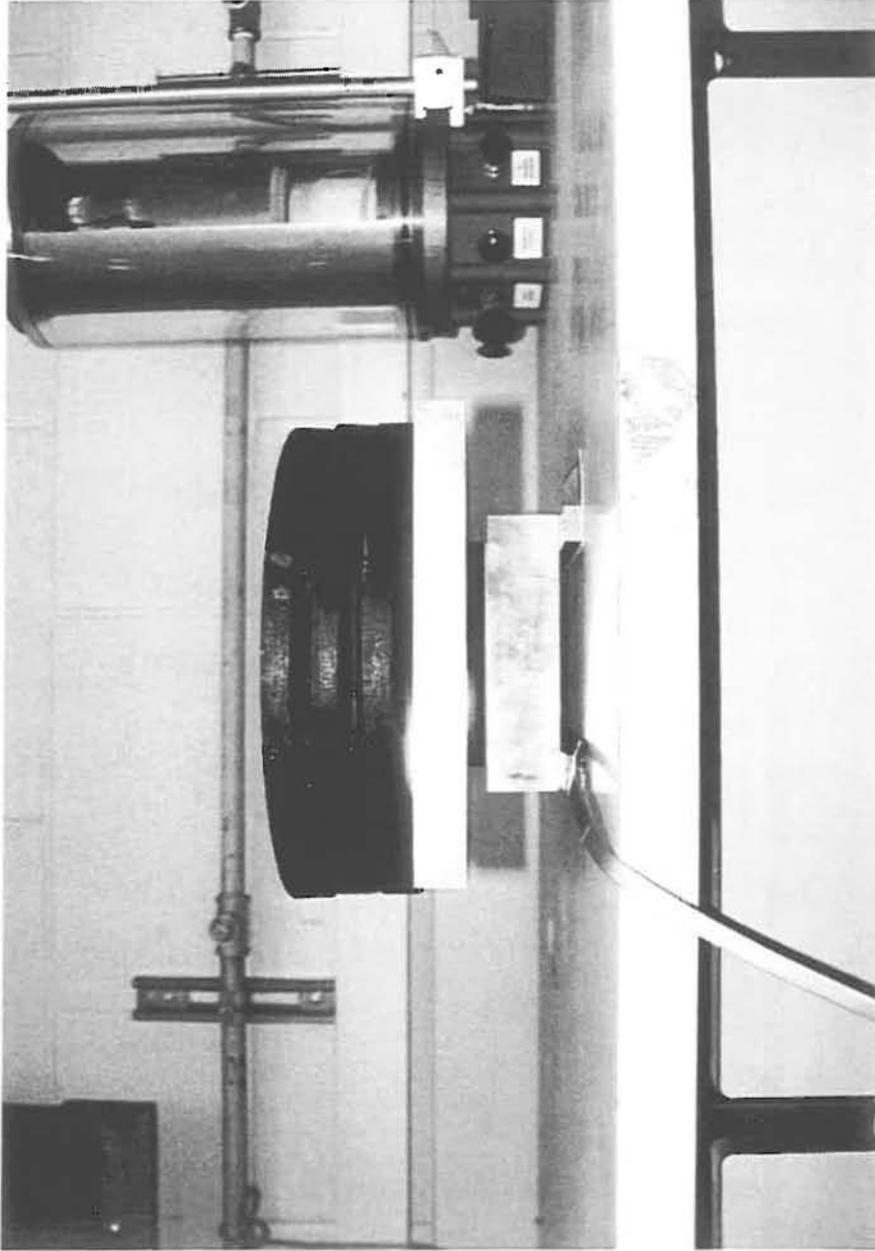
Figure 2.19 Normal Stress Calibration of Load Cell

surface in small increments as shown in Figure 2.19. The calibration curve of normal stresses for load cells 1, 2, 3 and 4 is shown in Figure 2.20. It is noted from the figure that the response of the load cell to applied normal stresses is linear.

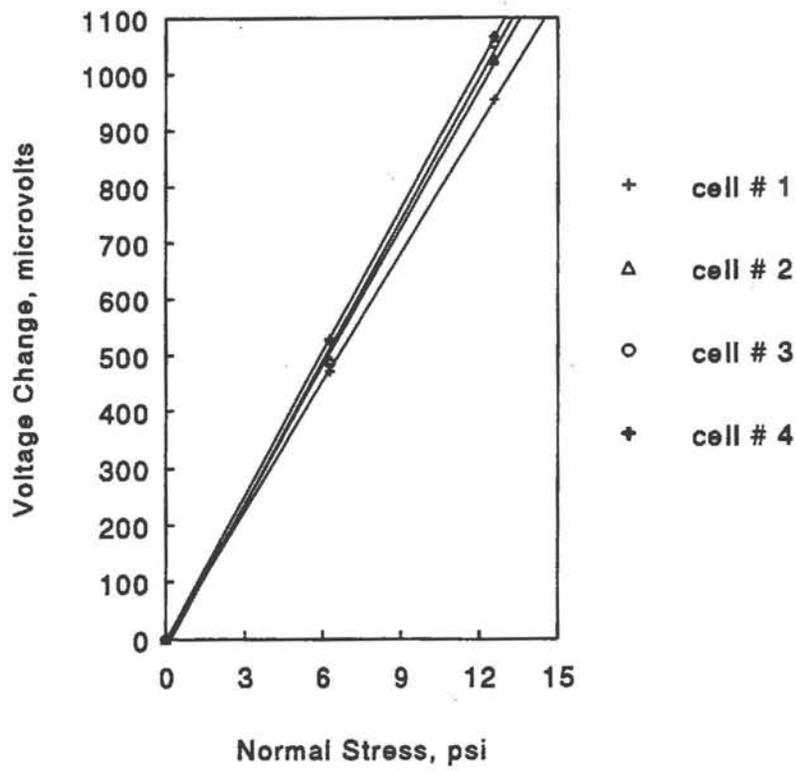
Figure 2.20 Normal Stress Calibration Curves for Load Cell

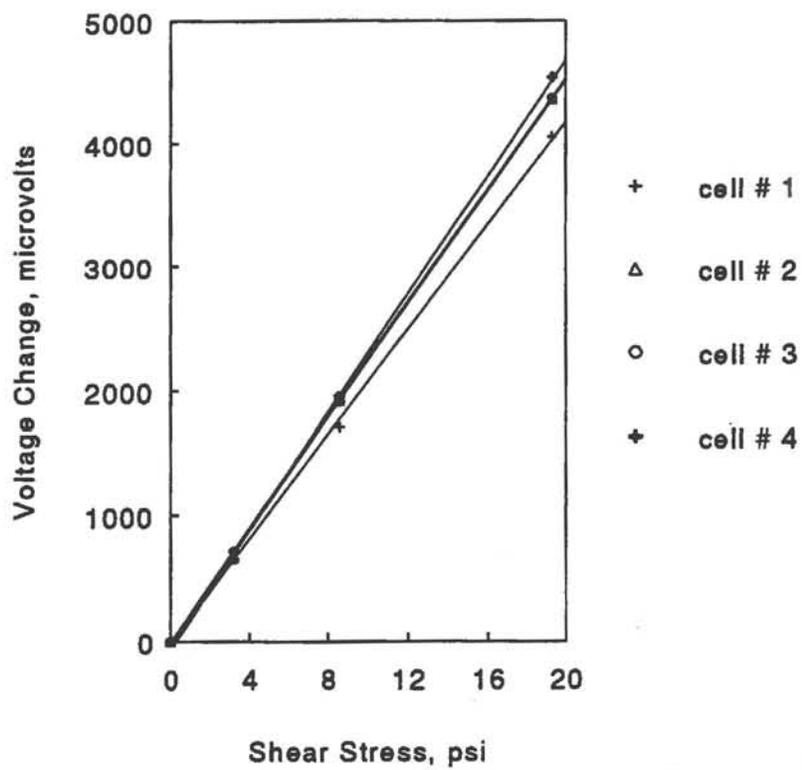
Figure 2.22 Shear Stress Calibration Curves for Load Cell

To calibrate the load cell for shear stress, the load cell was vertically positioned on a flat rigid surface and a vertical dead weight was applied in small increments in the shear direction (parallel to the top surface of the load cell), using a special frame shown in Figure 2.21. The calibration curve of shear stresses for load cells 1, 2, 3 and 4 is shown in Figure 2.22. It is noted from the figure that the response of the load cell to applied shear stresses is linear.

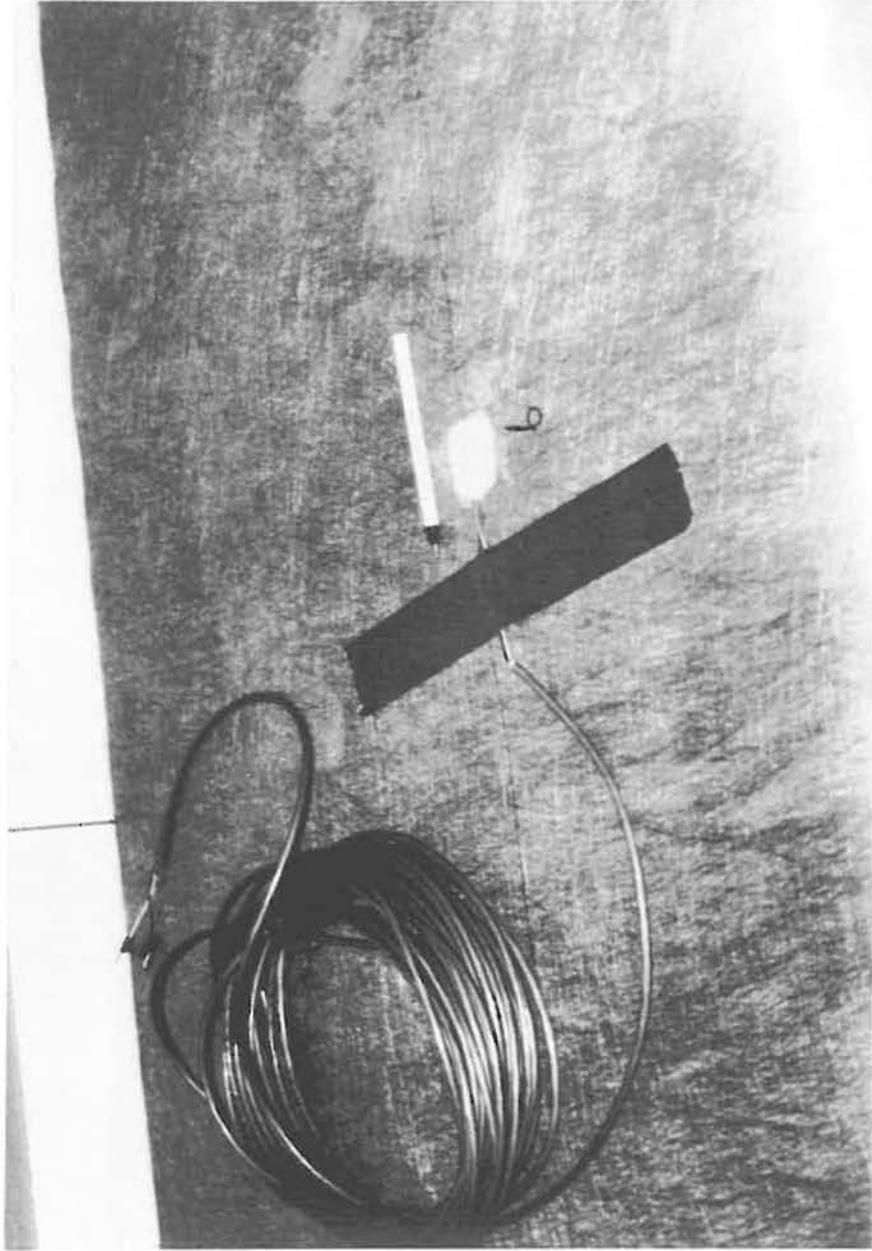
Figure 2.25 Strain Gage Covered with the Protective Mixture

The strain gages were covered with a protective mixture made of wax and petroleum jelly as shown in Figure 2.25. This was necessary to protect strain gages from soil moisture. This procedure has been successfully used by Helwany (1993) in a fully saturated clay.

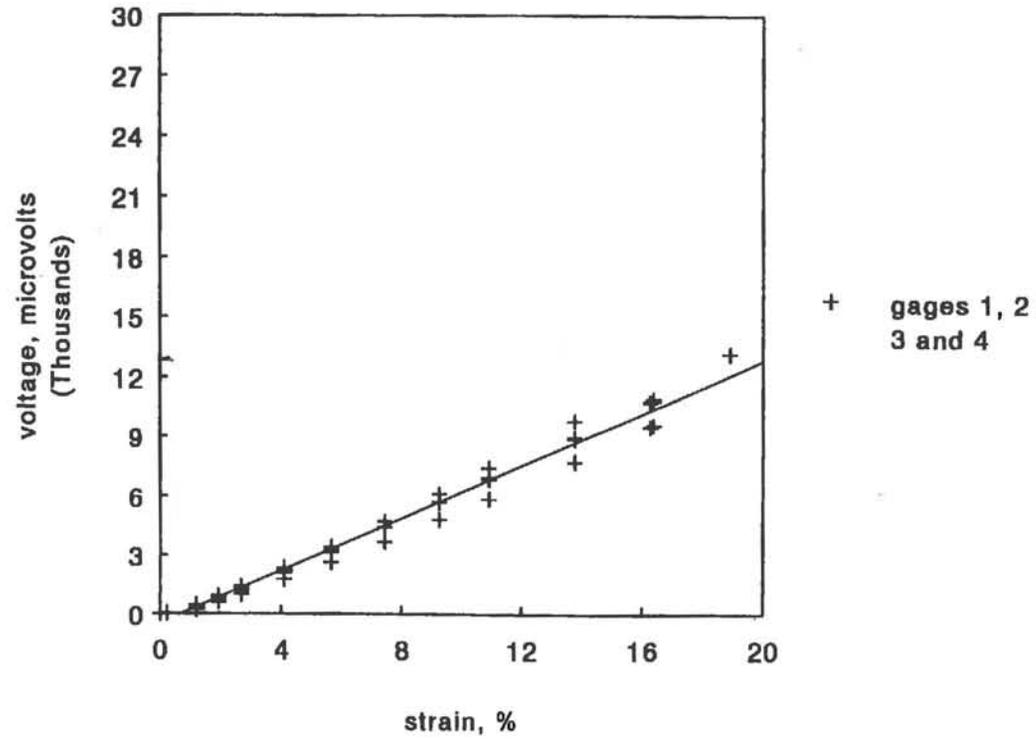
Figure 2.27 Calibration Curve for Strain Gage
