The Deep Patch Technique for Landslide Repair

Bassam M. Helwany
Colorado Transportation Institute
4201 East Arkansas Avenue
Denver, CO 80222

Final Report
October, 1994

1. Report No. CTI-UCD-2-94		2. Government Accession No.		3. Recipient's Catalog No.	
4. Title and Subtitle The Deep Patch Technique for Landslide Repair				5. Report Date October, 1994

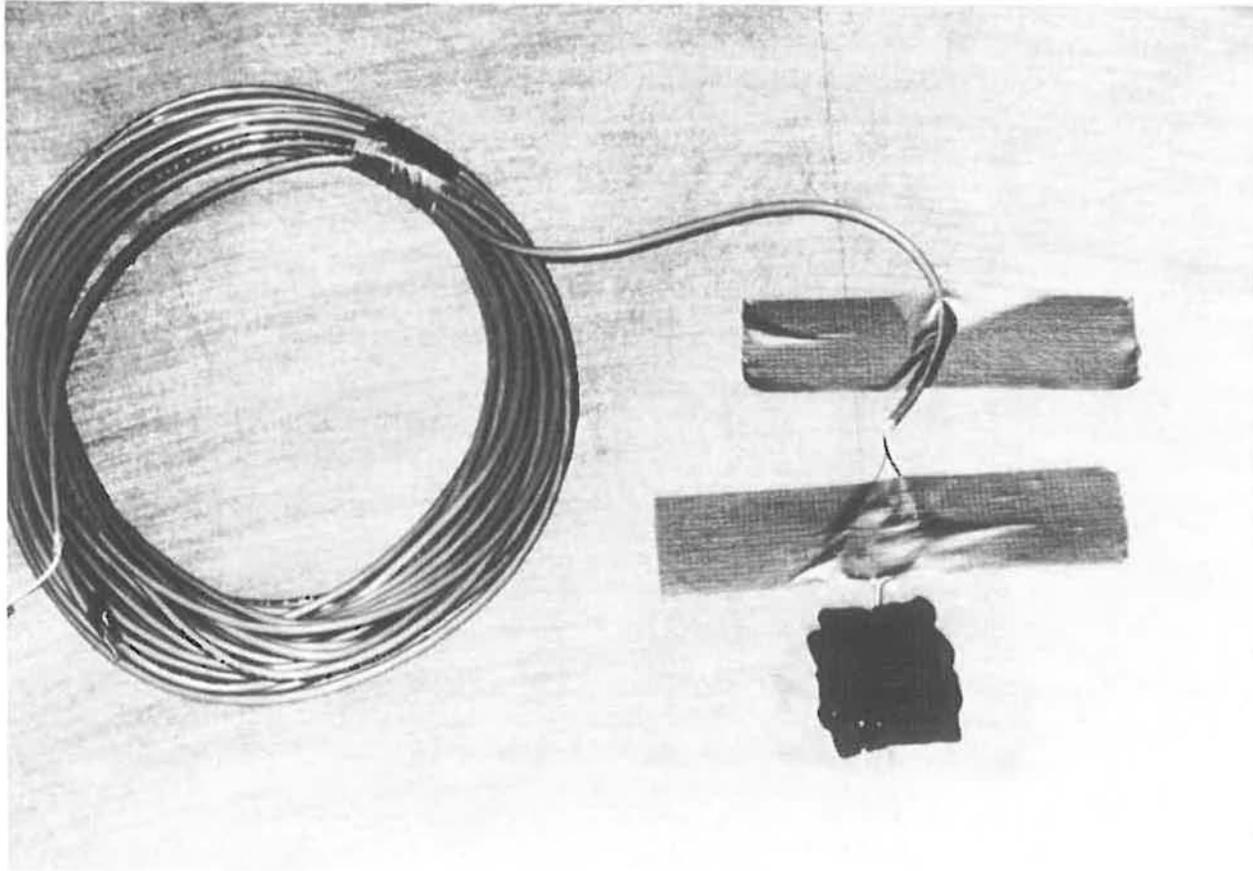
Figure 2.28 Environmental and Mechanical Protection of Strain Gages Using a layer of Neoprene Rubber

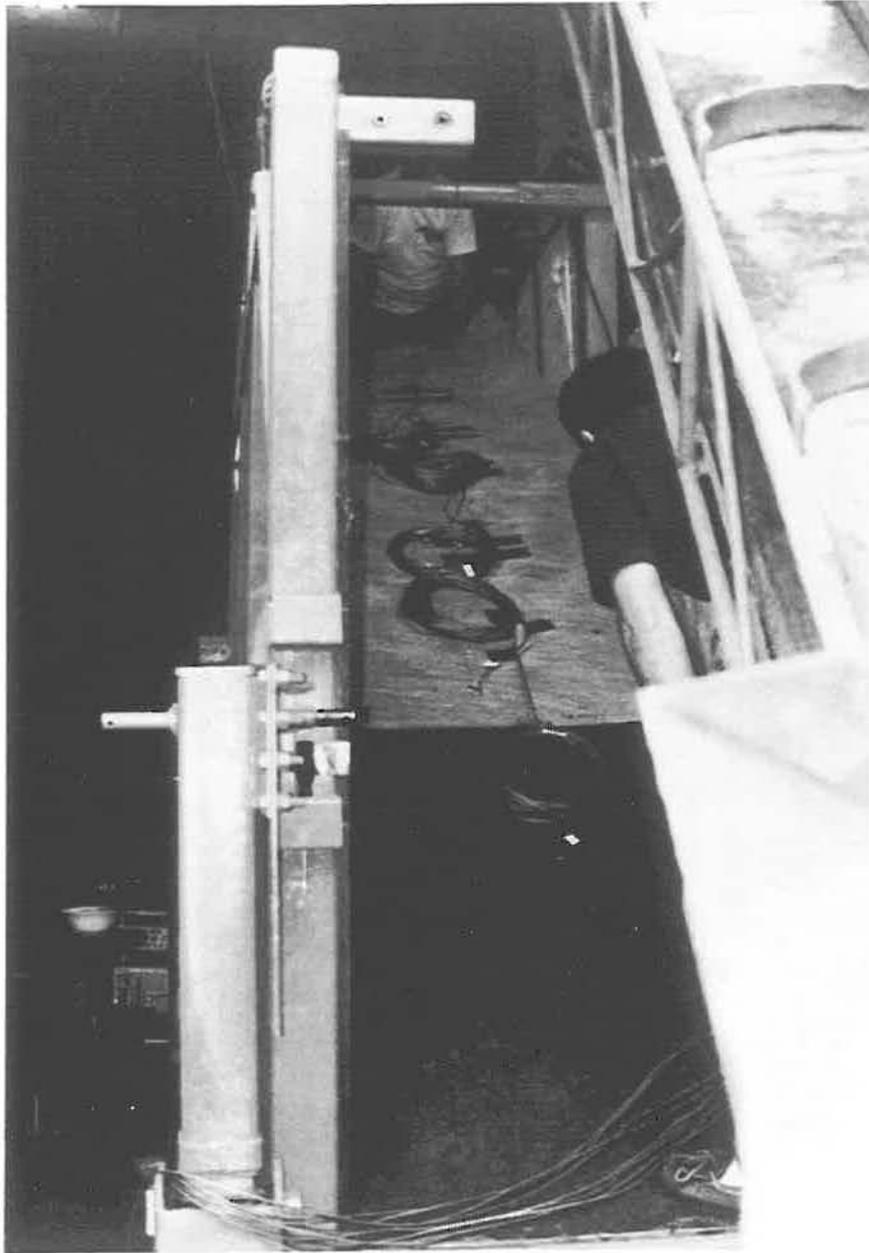
Figure 2.29 Geotextile Layer Instrumented with Strain Gages

The mounting procedure of a strain gage on the geotextile sheet involves gluing the two extremities of the strain gage to the geotextile using high strength epoxy (5-ton clear epoxy). The epoxy is left to cure for at least 8 hours, thereafter, a 0.6 cm (0.25 inch)-thick layer of the protective mixture is used to cover the strain gage and its terminal. Another 0.6 cm (0.25 inch)-thick layer of the protective mixture is used to cover the strain gage and its terminal from the opposite side of the geotextile to provide complete protection against the moisture seeping through the geotextile. For further environmental and mechanical protection a layer of Neoprene rubber was used on top of the protective mixture as shown in Figure 2.28. Figure 2.29 shows a geotextile layer instrumented with five strain gages being placed in the test apparatus.

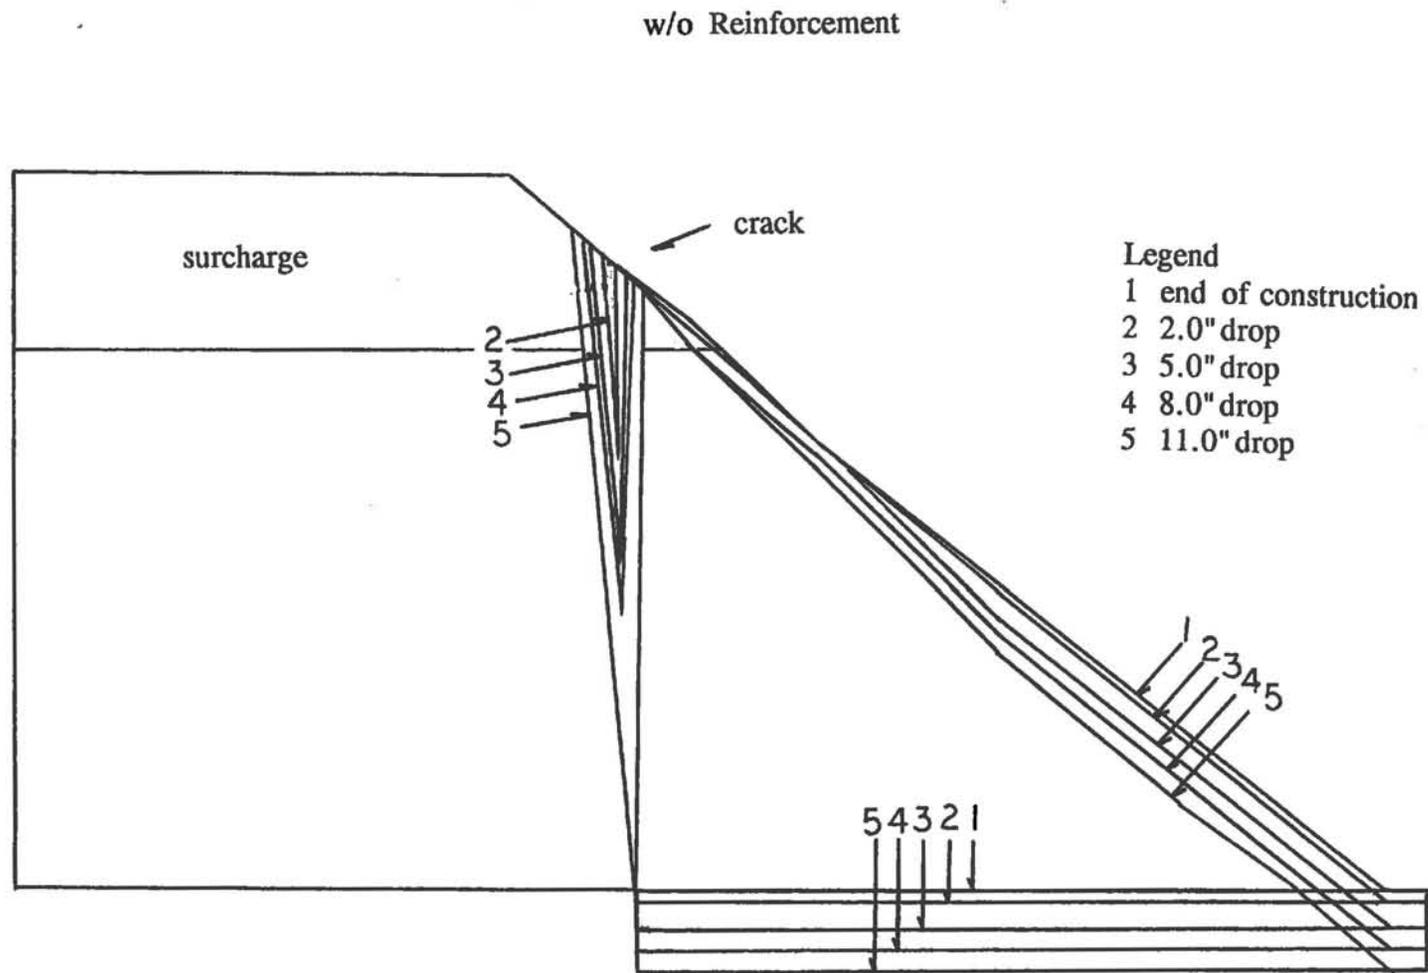
Figure 2.32 Displacement Field of the Backfill in the Unreinforced USFS Deep Patch Test

The displacement of the slope, the bottom panel, and the top surface in the USFS unreinforced test, as measured by the lubricated latex grid, is shown in Figure 2.32. A near vertical crack emanating from a point on the slope nearly above the inner end of the moveable part of the bottom panel is shown in the figure. The crack started with the first drop of 0.2 inch and propagated throughout the test due to further drops of the moveable part of the bottom panel. The depth of the crack was approximately 70 inches and its width was approximately 12 inches due to the 11 inch drop in the moveable part of the bottom panel (see Figure 2.33).

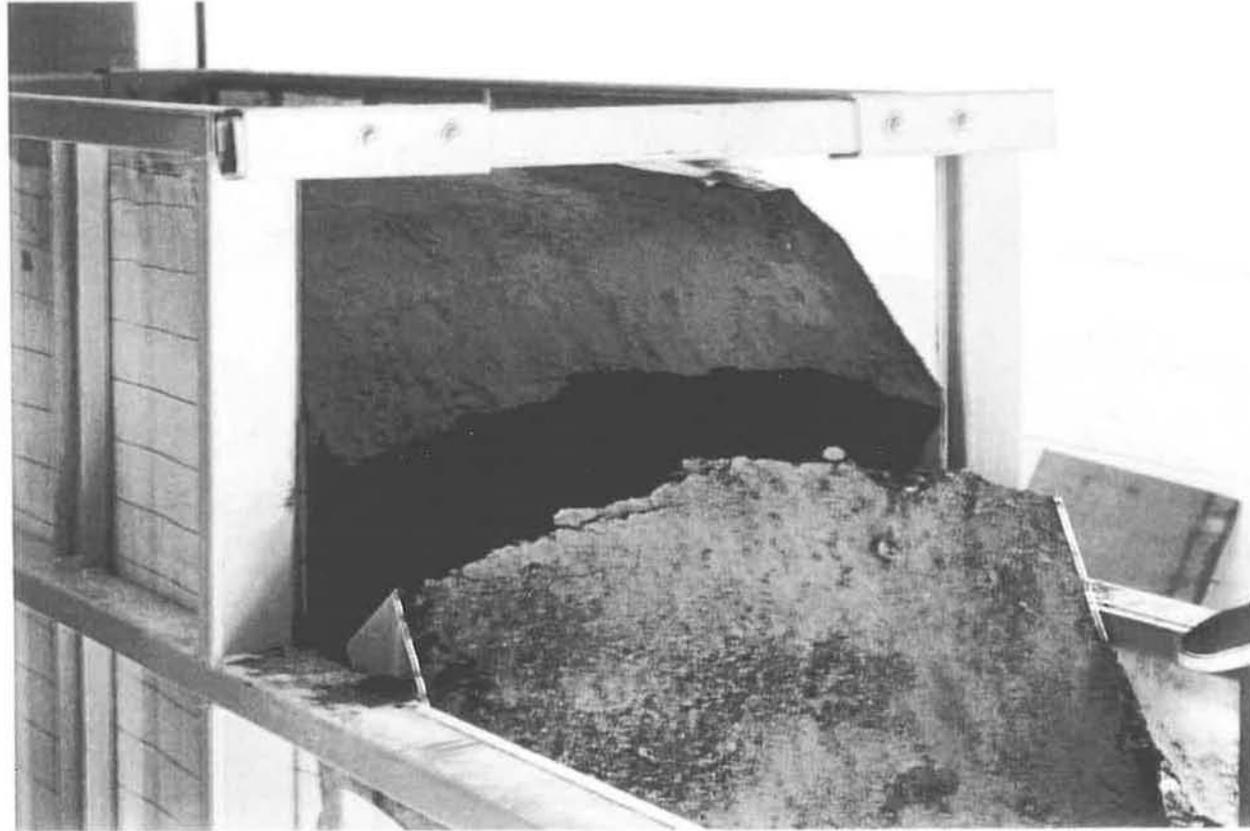
Figure 2.33 The Crack Corresponding to 11 inch-Drop in the Unreinforced USFS Deep Patch Test

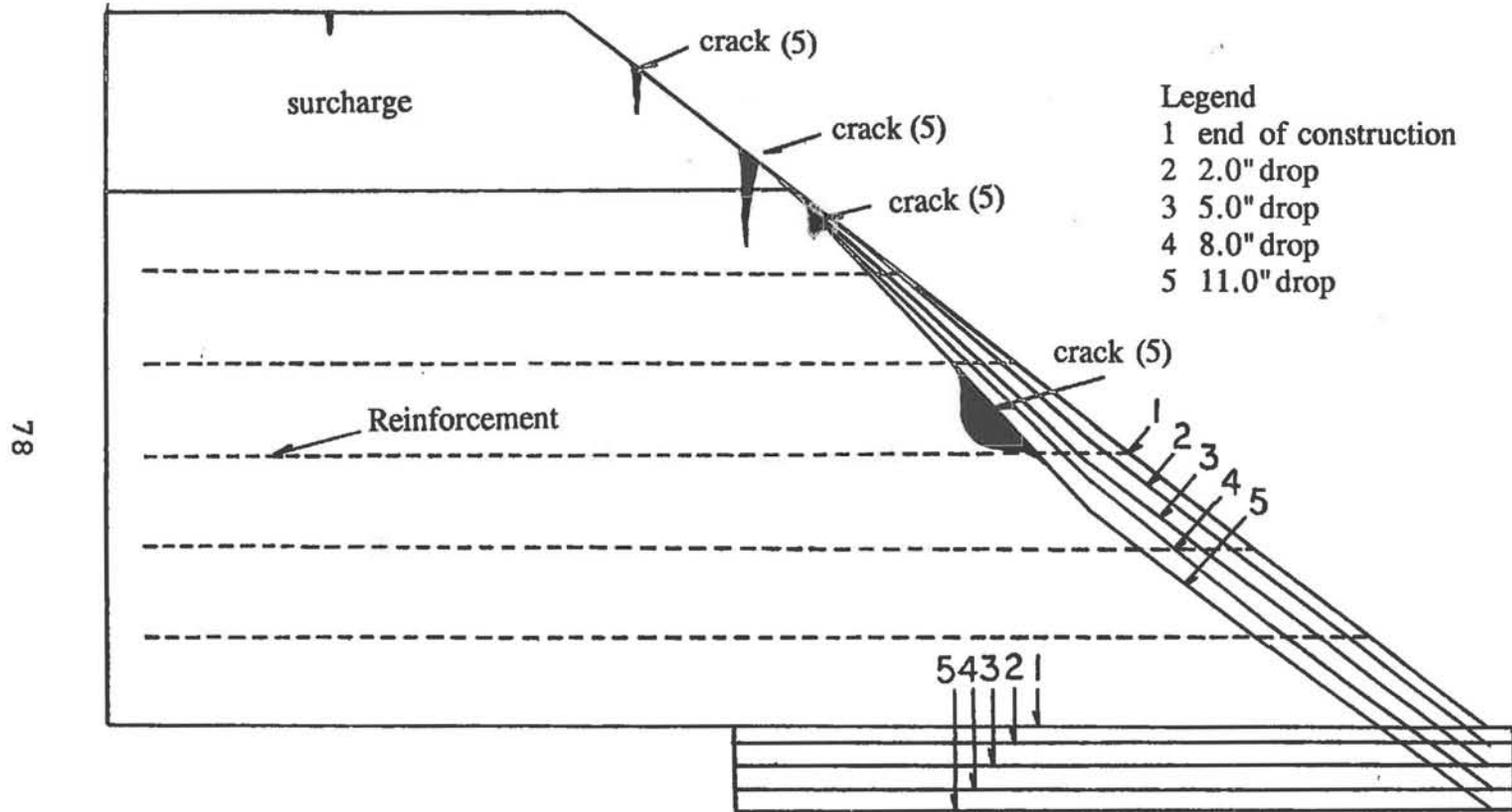
Figure 2.34 Displacement Field of the Backfill in the Reinforced USFS Deep Patch Test

In contrast, the deformation behavior of the backfill in the USFS reinforced test was much more favorable than the one in the USFS unreinforced test. Several small cracks, shown in Figure 2.34, were detected in the beginning of the USFS reinforced test, however, their propagation was very limited due to the soil reinforcement. The deepest crack measured about 10 inches (deep) due to the 11 inch drop in the moveable part of the bottom panel. A detailed comparison of crack propagation of the two tests for different drops of the moveable part of the bottom panel is shown in Figure 2.35

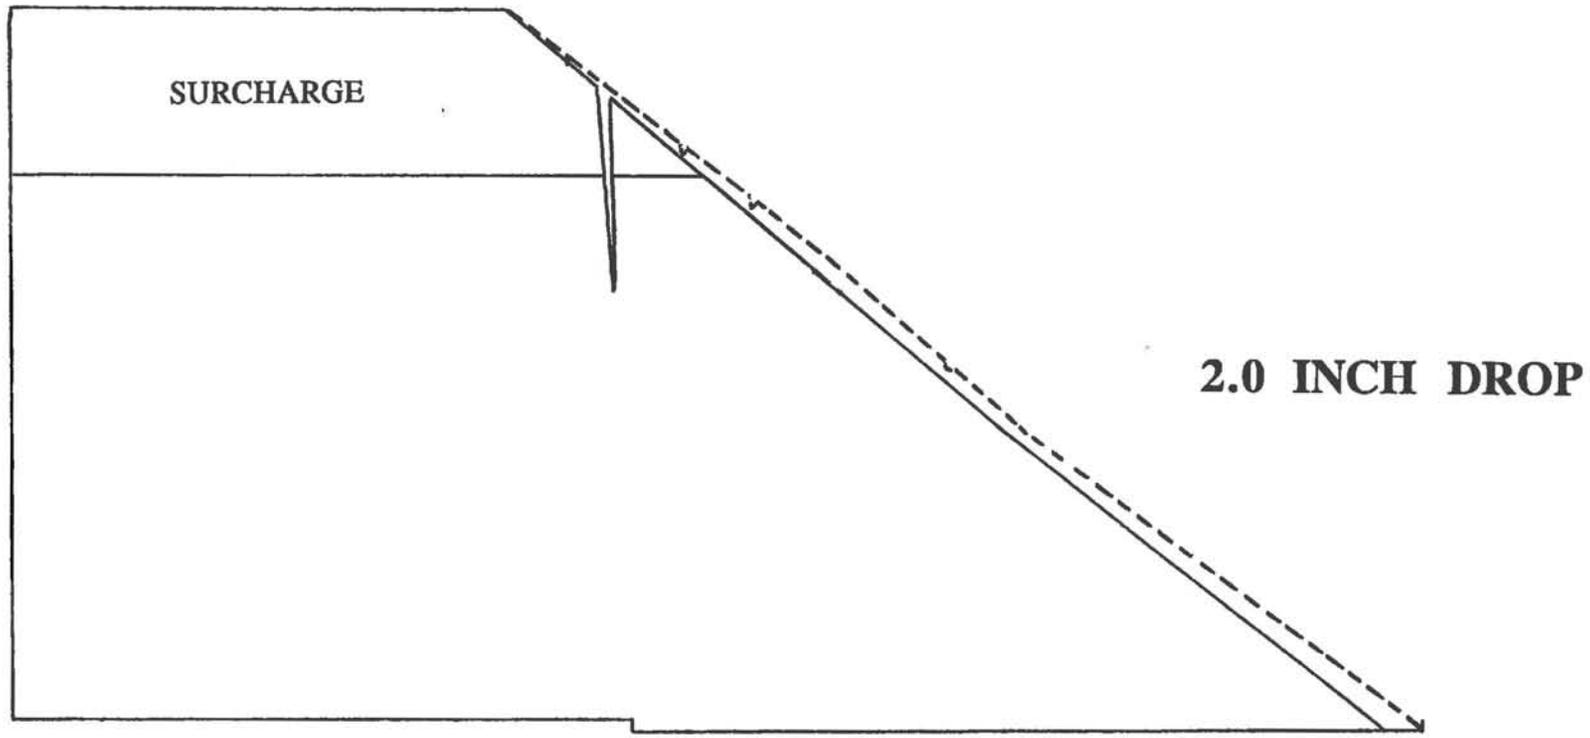
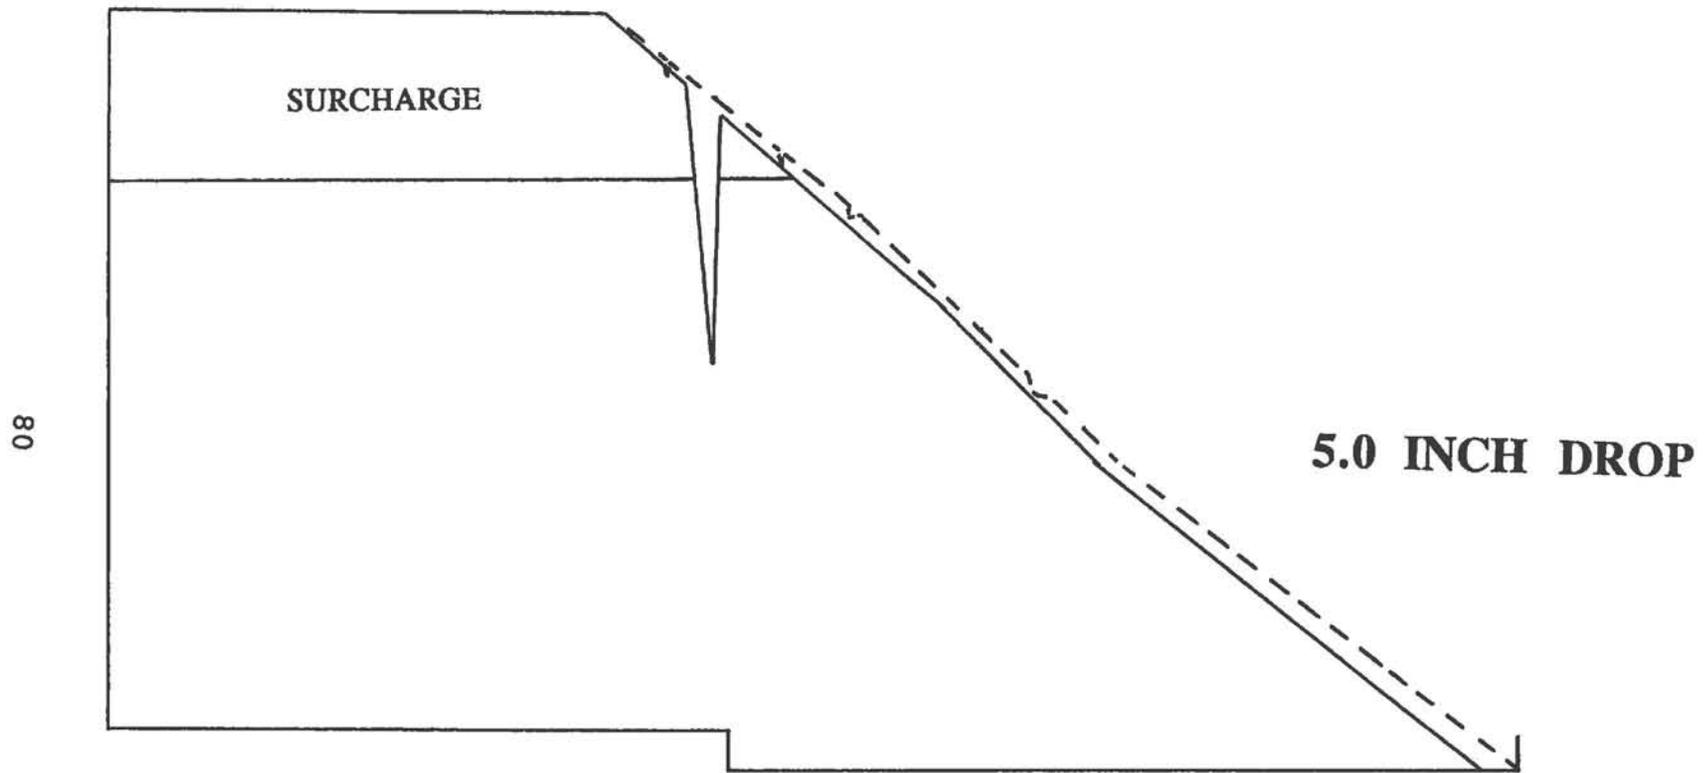
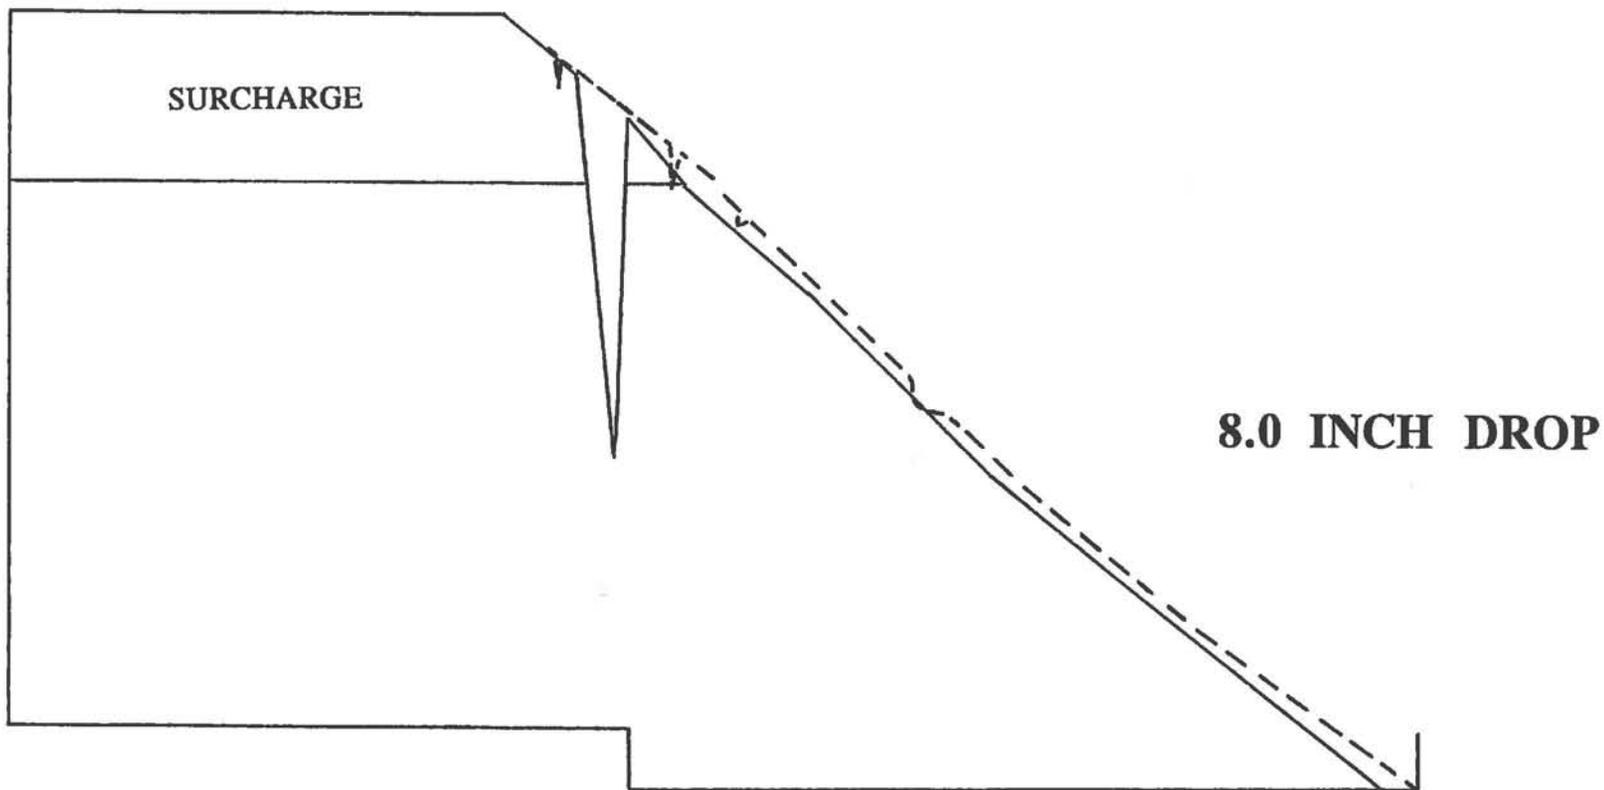
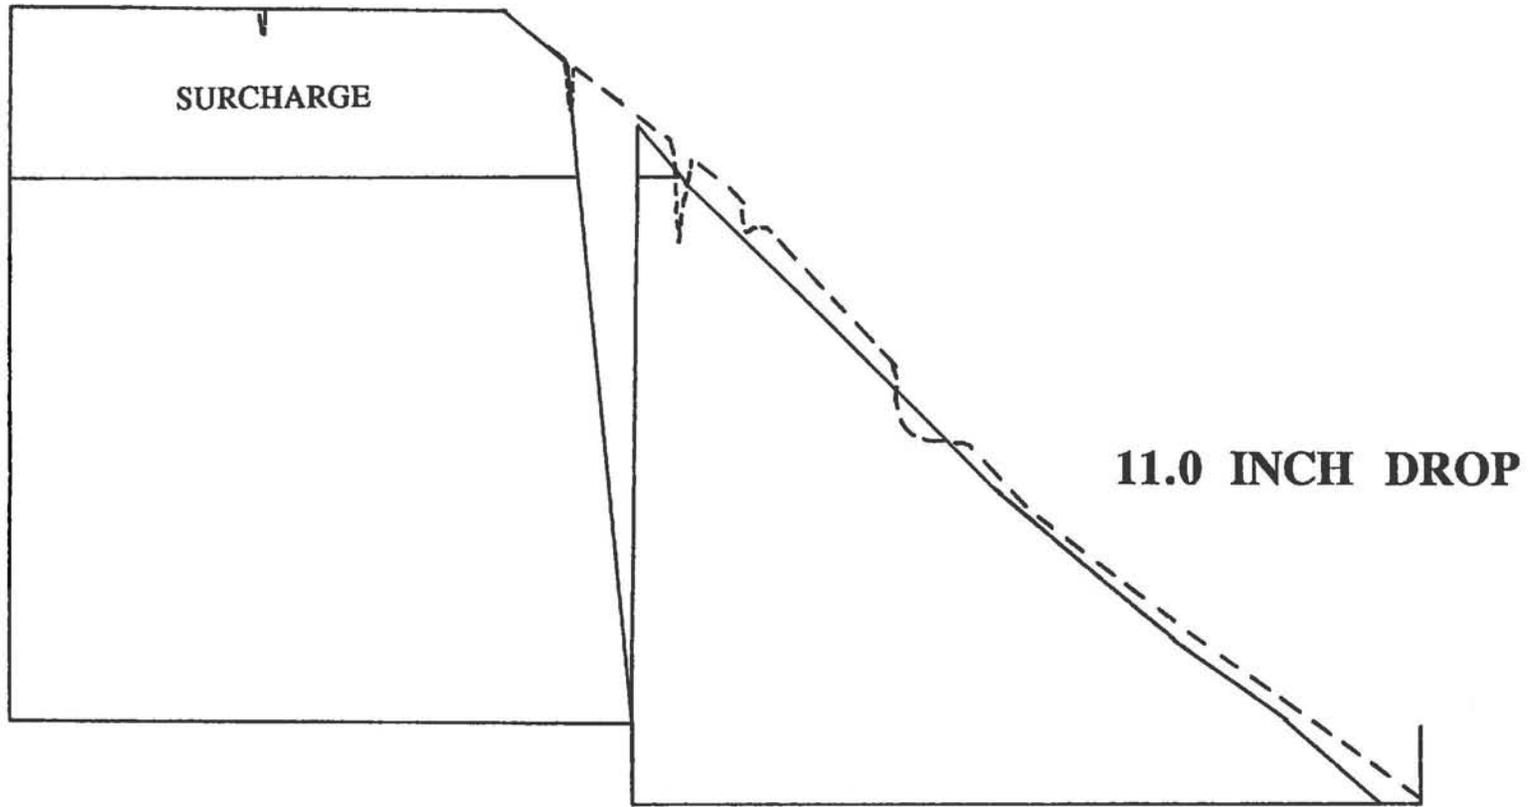
Figure 2.35(a) Comparison of Crack Propagation in the Two Tests at 2 inch-Drop

Figure 2.35(b) Comparison of Crack Propagation in the Two Tests at 5 inch-Drop

Figure 2.35(c) Comparison of Crack Propagation in the Two Tests at 8 inch-Drop

Figure 2.35(d) Comparison of Crack Propagation in the Two Tests at 11 inch-Drop

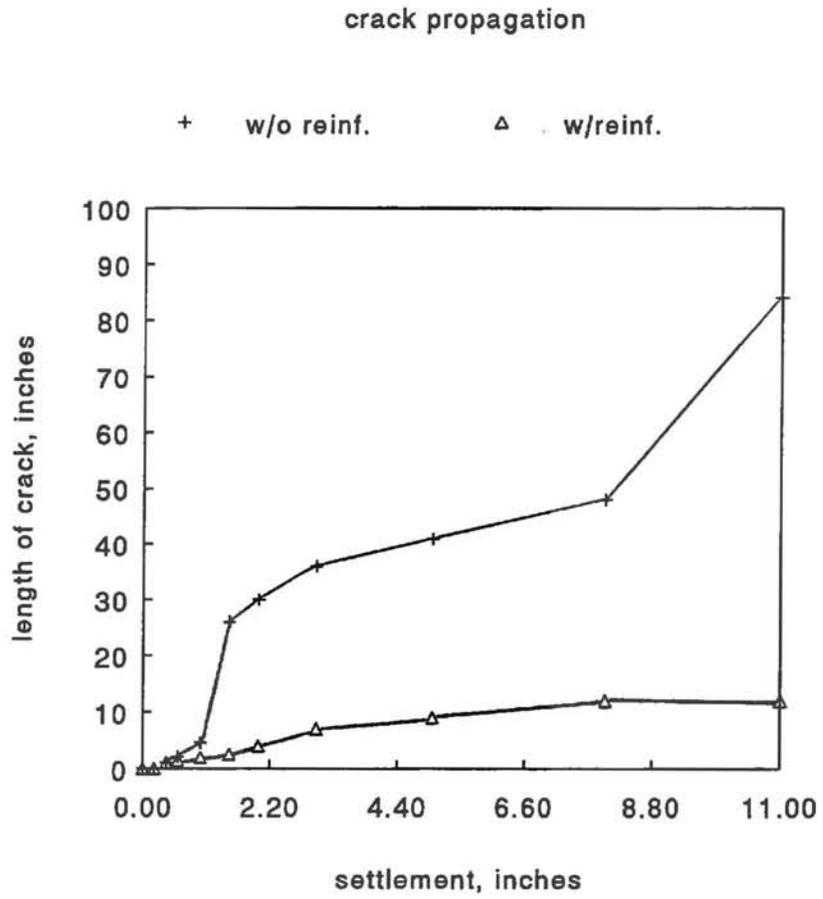
Figure 2.36 Comparison of Crack Propagation in the Two Tests

A comparison between the crack in the USFS unreinforced test and the largest

crack in the USFS reinforced test is shown in Figure 2.36. The crack in the unreinforced case was at least 8 times deeper than the one in the reinforced case.

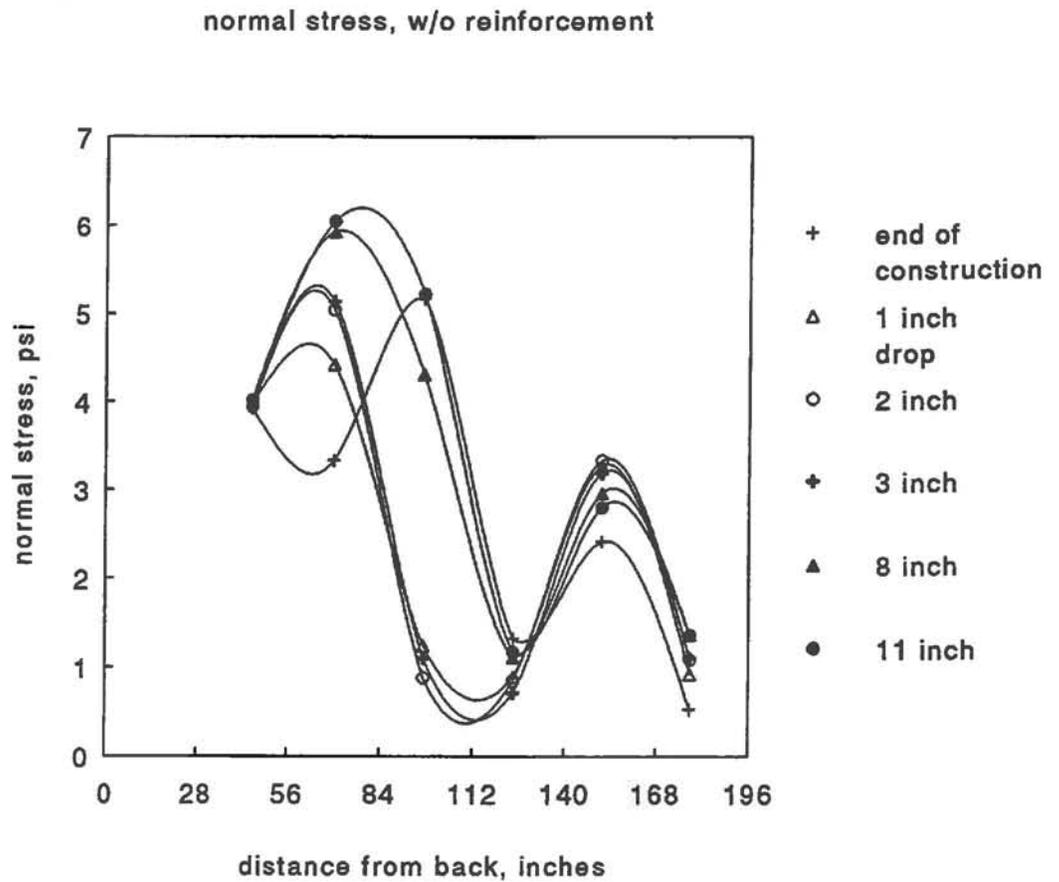
Figure 2.37 Distribution of Normal Stresses along the Bottom Panel in the Unreinforced USFS Deep Patch Test

The measured normal stress distribution in the USFS unreinforced test along the bottom panel is depicted in Figure 2.37. It is to be noted from the figure that the normal stress has substantially increased with the increase of drop of the moveable part of the bottom panel in load cell #5 (located at 70 inches from the back panel, close to the moveable part of the bottom panel). On the other hand, the normal stress in load cell #4 (located at 97 inches from the back panel) decreased with increasing the drop until the drop of 3 inches was reached. Thereafter, the normal stress in load cell #4 drastically increased with increasing the drop. This is may be attributed to the total separation of the backfill, due to the aforementioned vertical crack, into two soil masses located above the moveable and the stationary parts of the bottom panel.

It is to be noted that the initial stresses measured in the CTI deep patch test are higher than the initial stresses measured in the USFS unreinforced test (Figure 2.37). This is obviously due to the odd shape of the CTI deep patch.

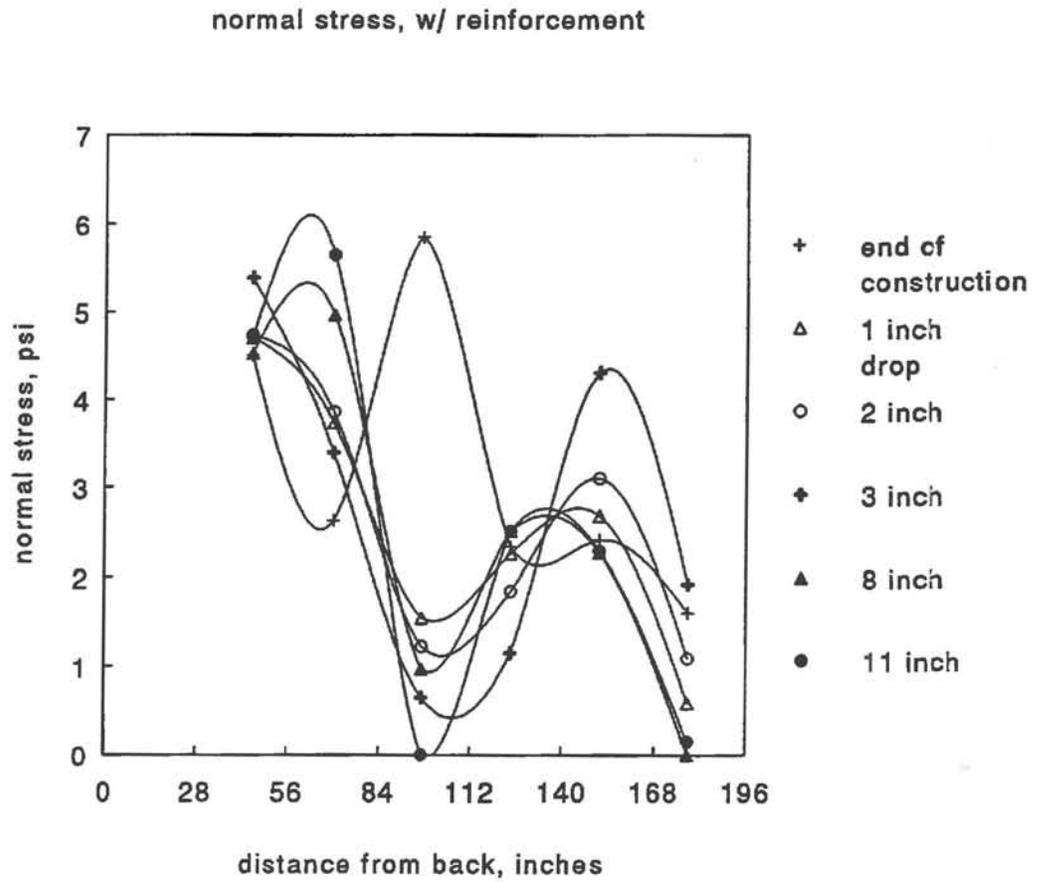
Figure 2.38 Distribution of Normal Stresses along the Bottom Panel in the Reinforced USFS Deep Patch Test

The measured normal stress distribution in the USFS reinforced test along the bottom panel is depicted in Figure 2.38. A substantial reduction in normal stress is measured along the moveable part of the bottom panel as shown in the figure. The sudden increase in normal stress in load cell #4, noted in the USFS unreinforced test, is not encountered in the USFS reinforced test. Obviously, the geosynthetic reinforcement was able to absorb the tension crack which occurred

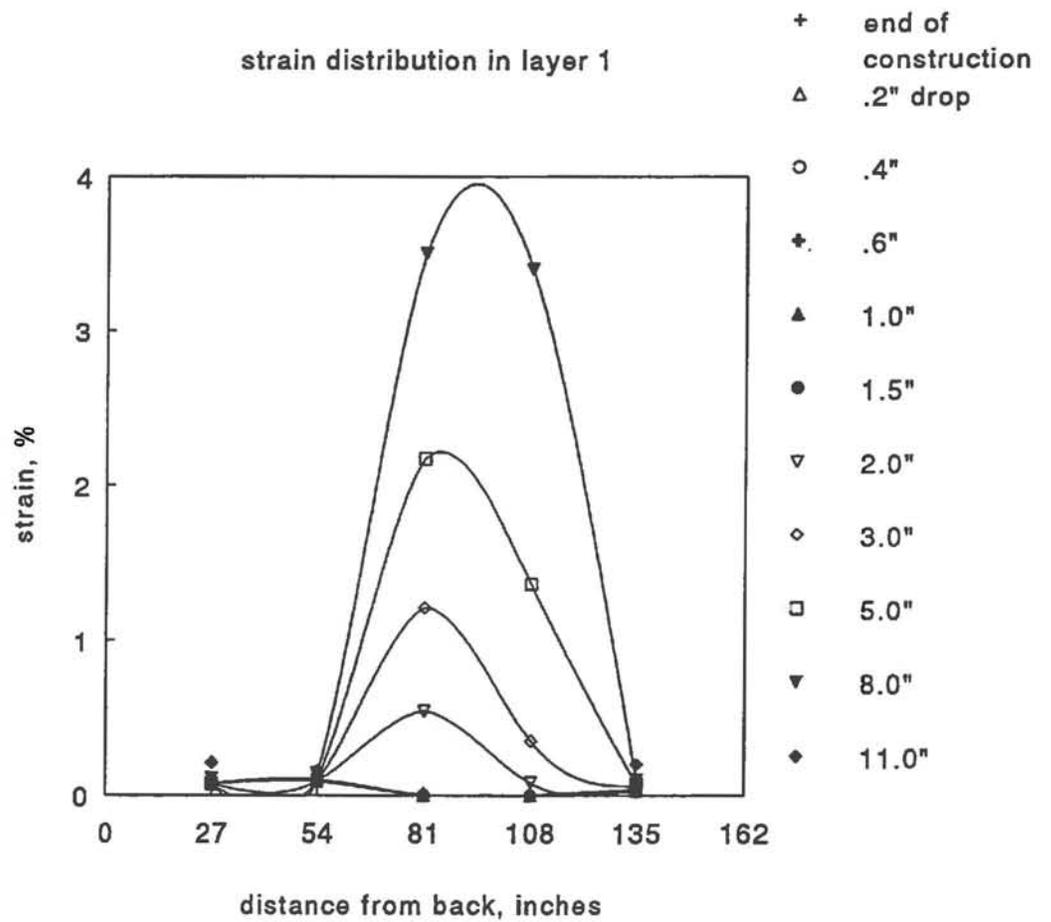
Figure 2.39(a) Distribution of Strain along the Geosynthetic Reinforcement Layer 1 in the Reinforced USFS Deep Patch Test

The measured strain distribution along the geosynthetic layers 1, 3 and 5 located at elevations 1, 3 and 5 feet are shown in Figures 2.39(a), 2.39(b), and 2.39(c), respectively. The maximum strain of approximately 4%, corresponding to 8 inches drop of the moveable part of the bottom panel, was observed nearly in the center of the geosynthetic layer 1. Unfortunately, the three central strain gages in this layer were lost after the 8 inch-drop due to excessive straining.

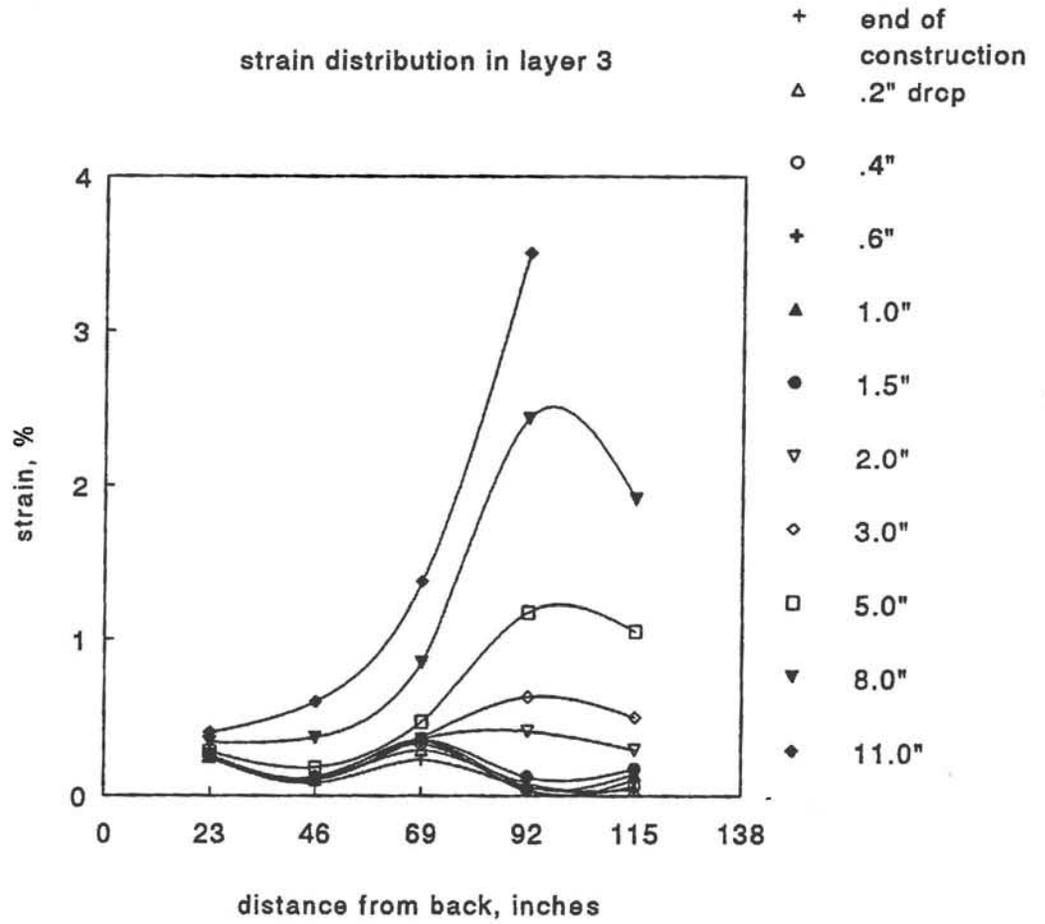
Figure 2.39(b) Distribution of Strain along the Geosynthetic Reinforcement Layer 3 in the Reinforced USFS Deep Patch Test

At 8 inch-drop, the maximum strain of approximately 2.4% was observed in the geosynthetic layer 3. Again, the strain gage located at 115 inches from the back panel was lost due to excessive straining when the drop exceeded 8 inches.

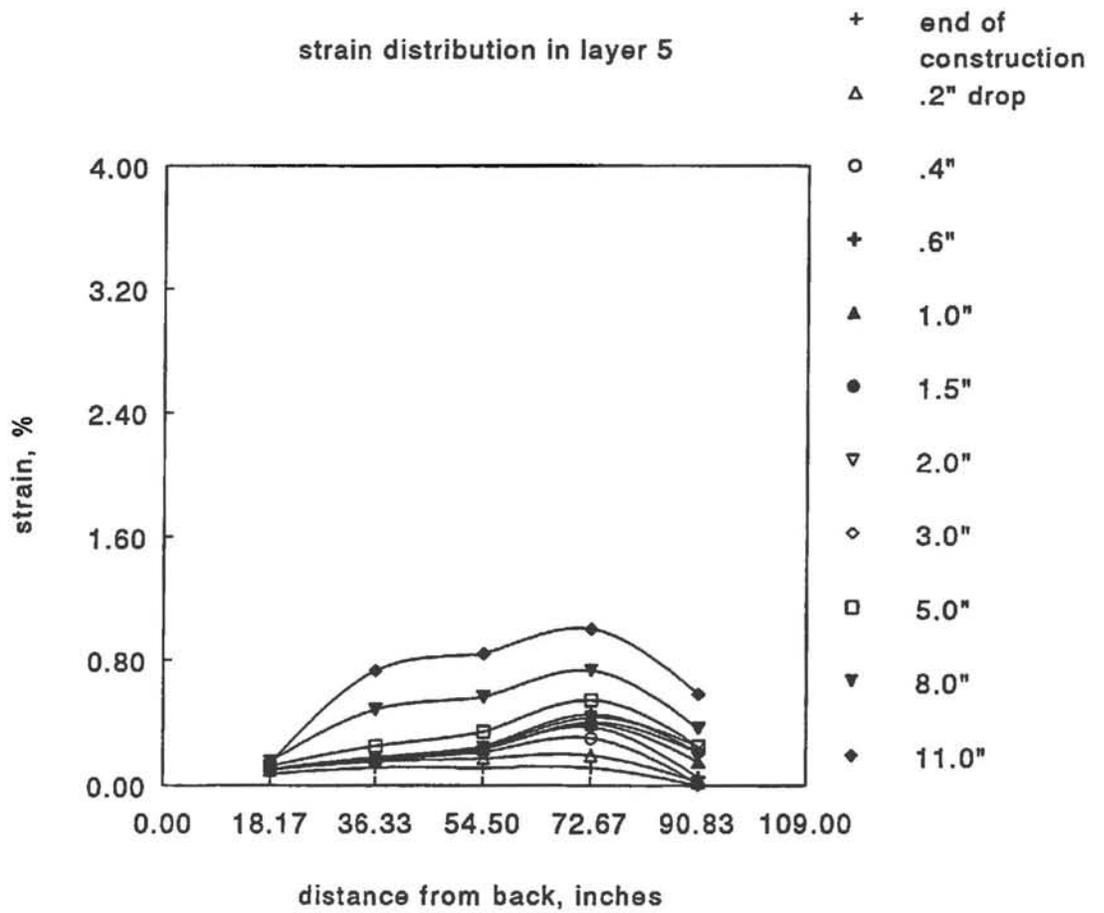
Figure 2.39(c)

Distribution of Strain along the Geosynthetic Reinforcement Layer 5 in the Reinforced USFS Deep Patch Test

Relatively smaller strains were observed in the geosynthetic layer 5. The maximum strain of approximately 1.0% was measured in the strain gage located at 72.7 inch from the back panel.

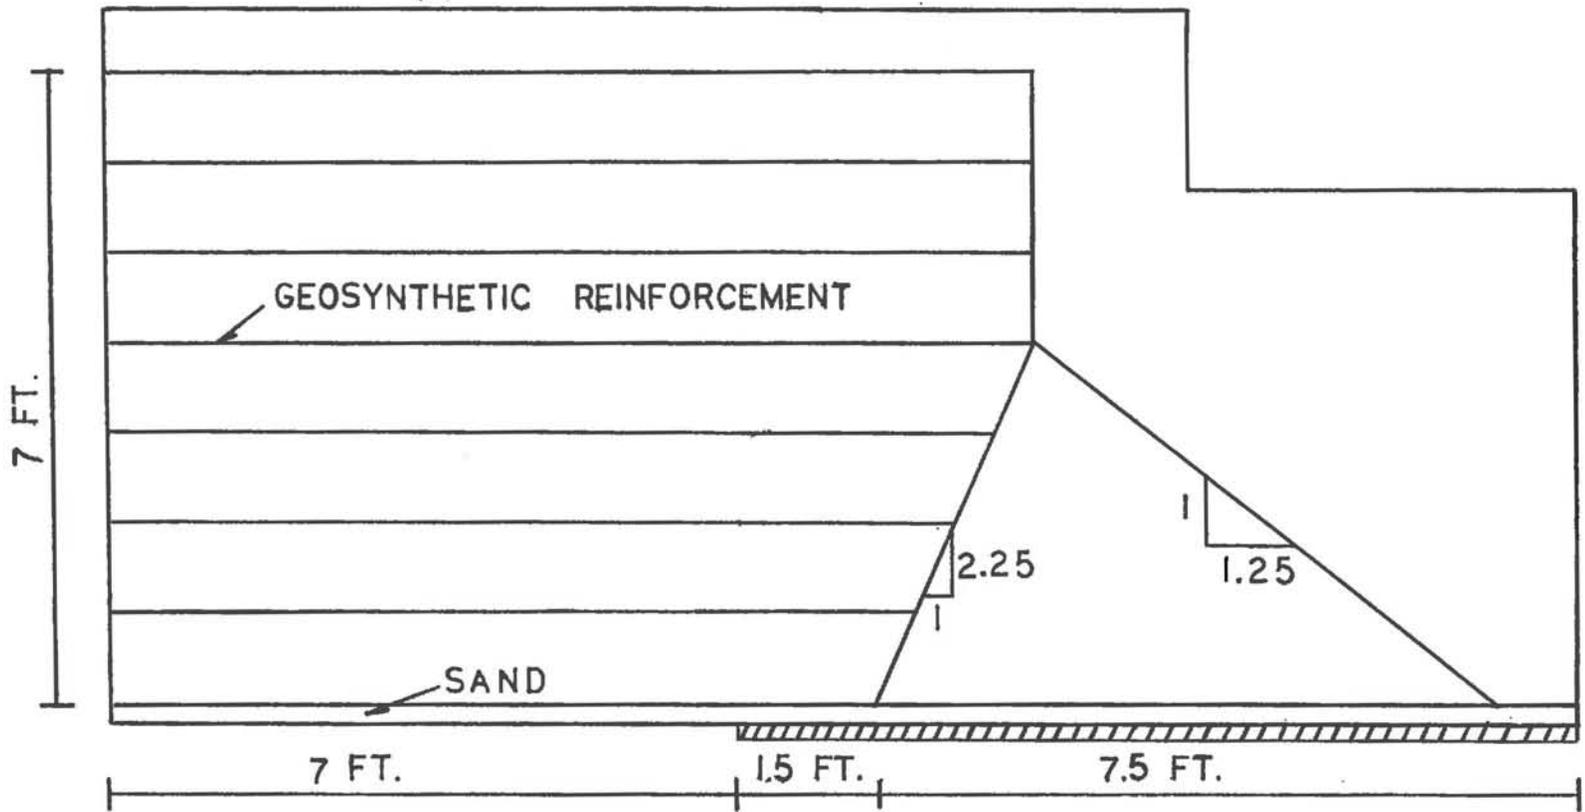
Figure 3.1 Schematic Diagram of the CTI Deep Patch Test

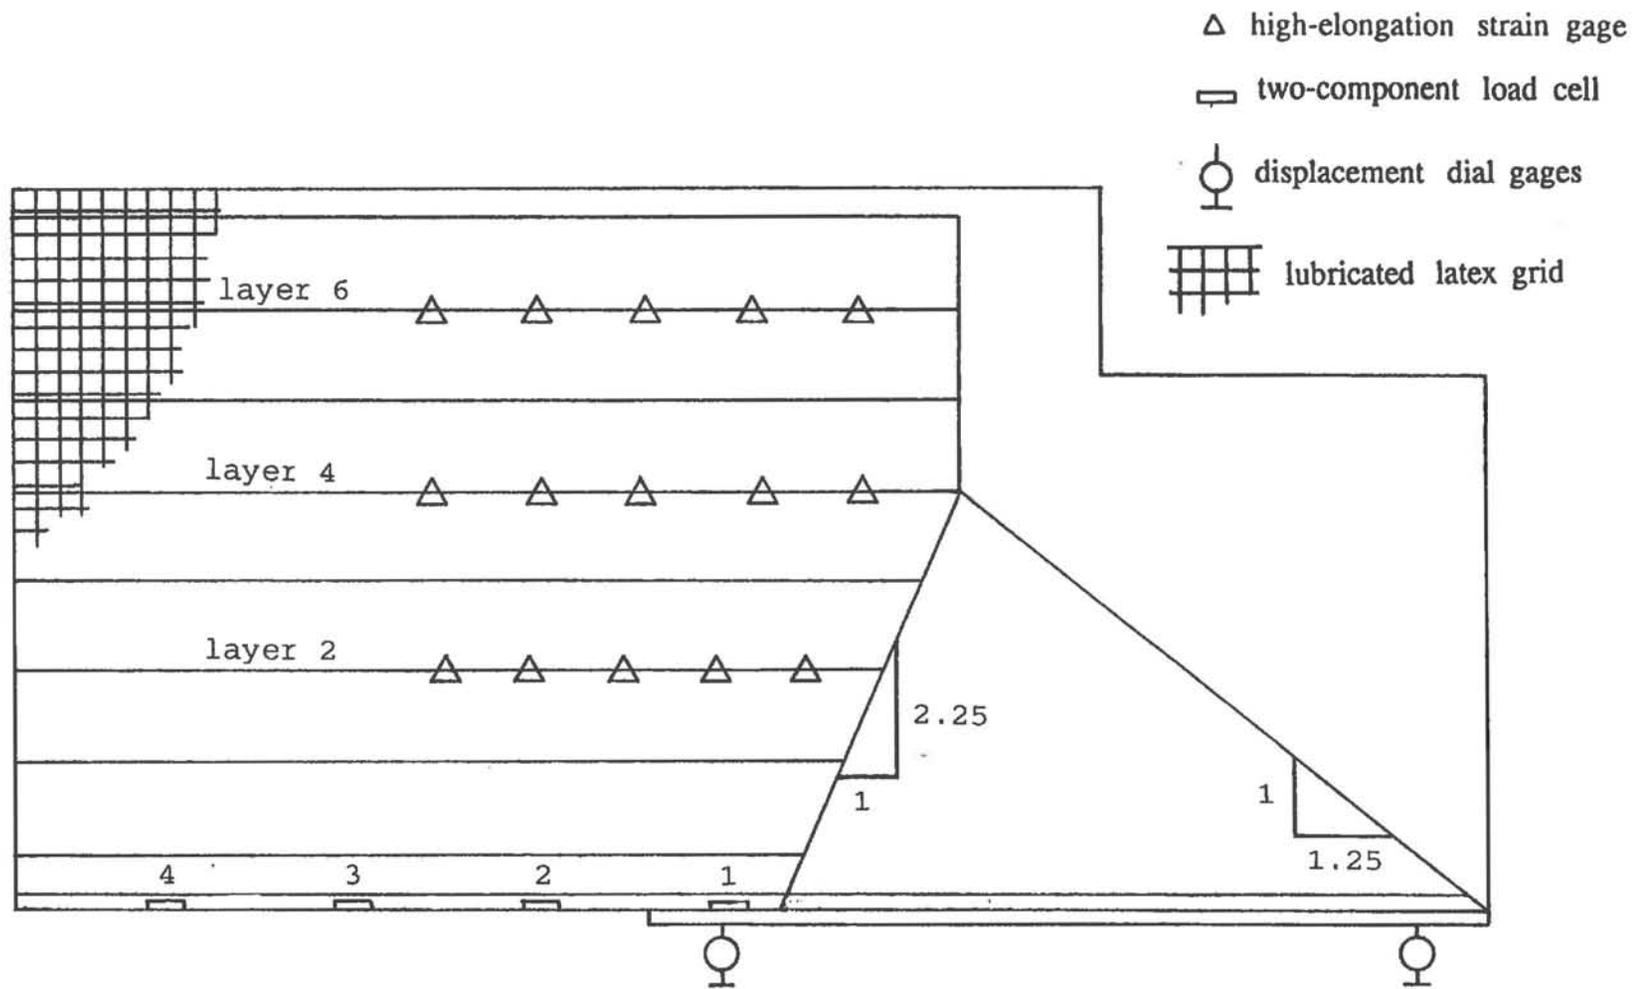
Figure 3.3 Instrumentation of the CTI Deep Patch Test
