The Deep Patch Technique for Landslide Repair

Bassam M. Helwany
Colorado Transportation Institute
4201 East Arkansas Avenue
Denver, CO 80222

Final Report
October, 1994

1. Report No. CTI-UCD-2-94		2. Government Accession No.		3. Recipient's Catalog No.	
4. Title and Subtitle The Deep Patch Technique for Landslide Repair				5. Report Date October, 1994

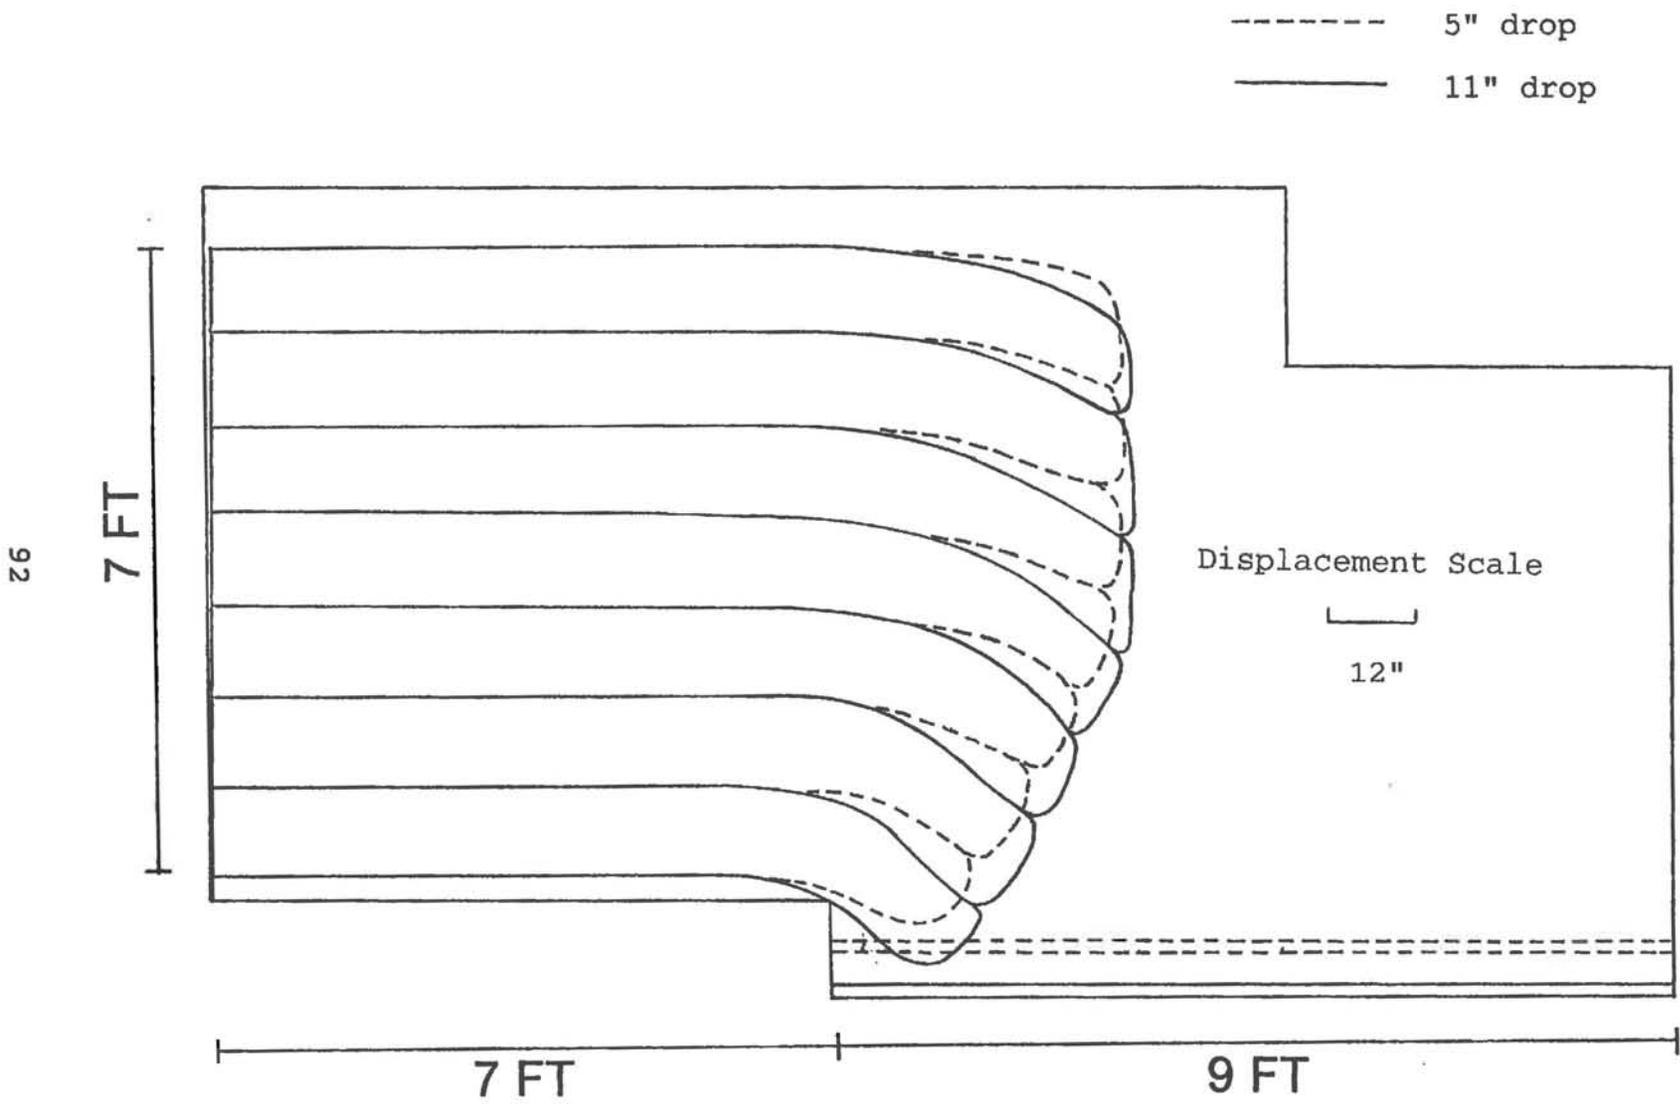
Figure 3.4 Displacement Field of the Backfill in the CTI Deep Patch Test with Road Base Backfill

The displacement of the CTI deep patch and the bottom panel, as measured by the lubricated latex grid, is shown in Figure 3.4 . It is noted from the figure that the vertical part of the face of the CTI deep patch remains vertical (with very limited lateral displacement) throughout the test. The maximum settlements of 7 and 16 inches were measured at the top of the wall corresponding, respectively, to the 5 and 11 inches drop in the moveable part of the bottom panel. Figure 3.5 shows the CTI deep patch after removing the berm which followed the 11 inch drop of the moveable part of the bottom panel. A gab between the bottom of the structure and the moveable part of the bottom panel is to be noted in the figure.

A vertical crack emanating from a point on the top of the CTI deep patch near the back panel is shown in the Figure 3.4. The crack started with the first drop of 0.2 inch and propagated throughout the test due to further drops of the moveable part of the bottom panel. The depth of the crack was approximately 7 ft and its width was approximately 1 inch due to the 11 inch drop in the moveable part of the bottom panel.

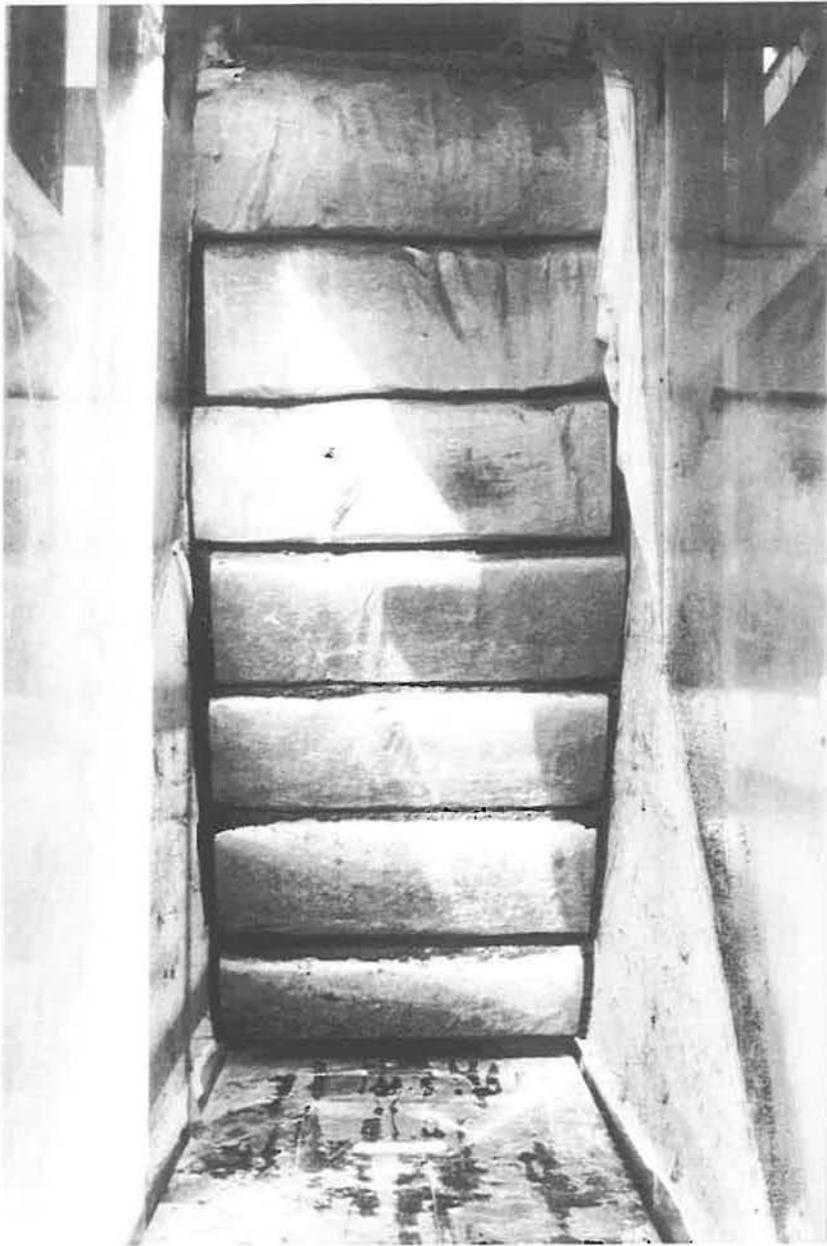
Figure 3.5 The Deformed Face of the CTI Deep Patch Test with Road Base Backfill after Removing the Berm

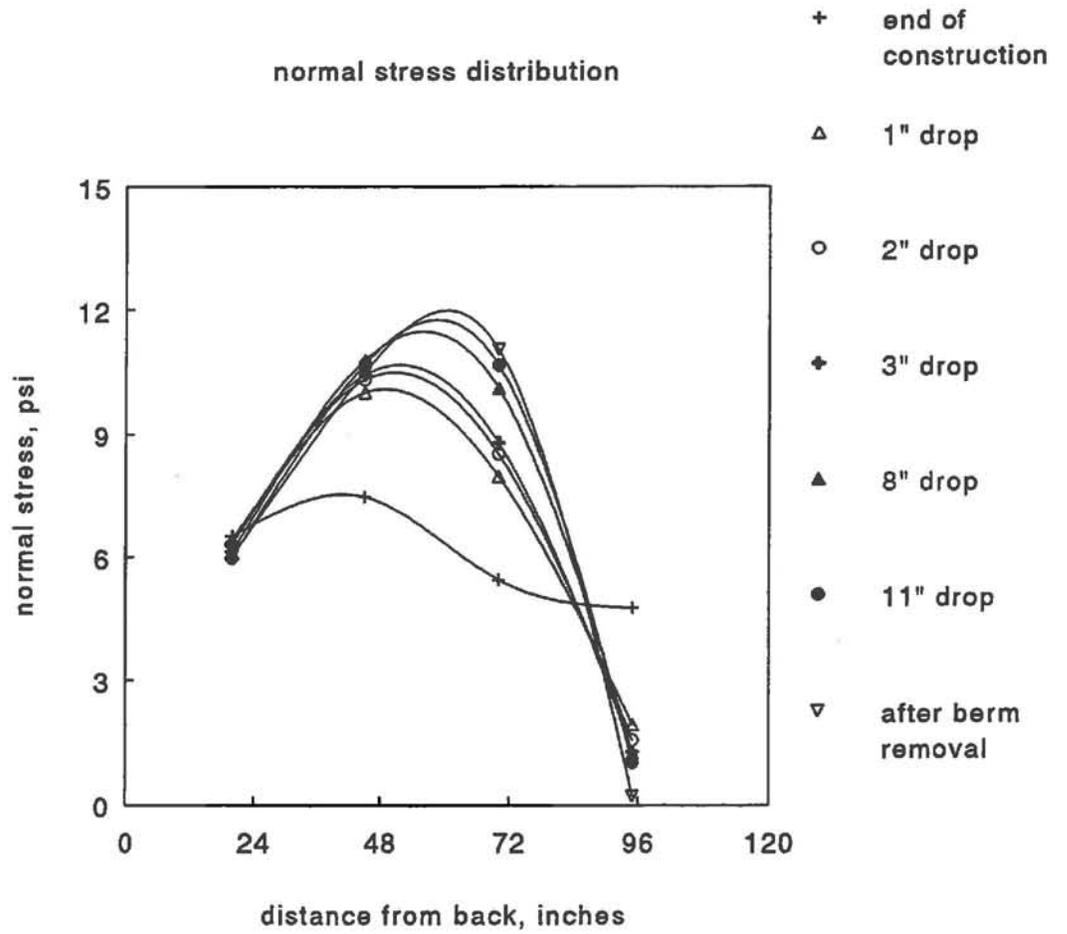
Figure 3.6 Distribution of Normal Stresses along the Bottom Panel in the CTI Deep Patch Test with Road Base Backfill

The measured normal stress distribution in the CTI test along the bottom panel is depicted in Figure 3.6. It is to be noted from the figure that the normal stress has substantially increased with the increase of drop of the moveable part of the

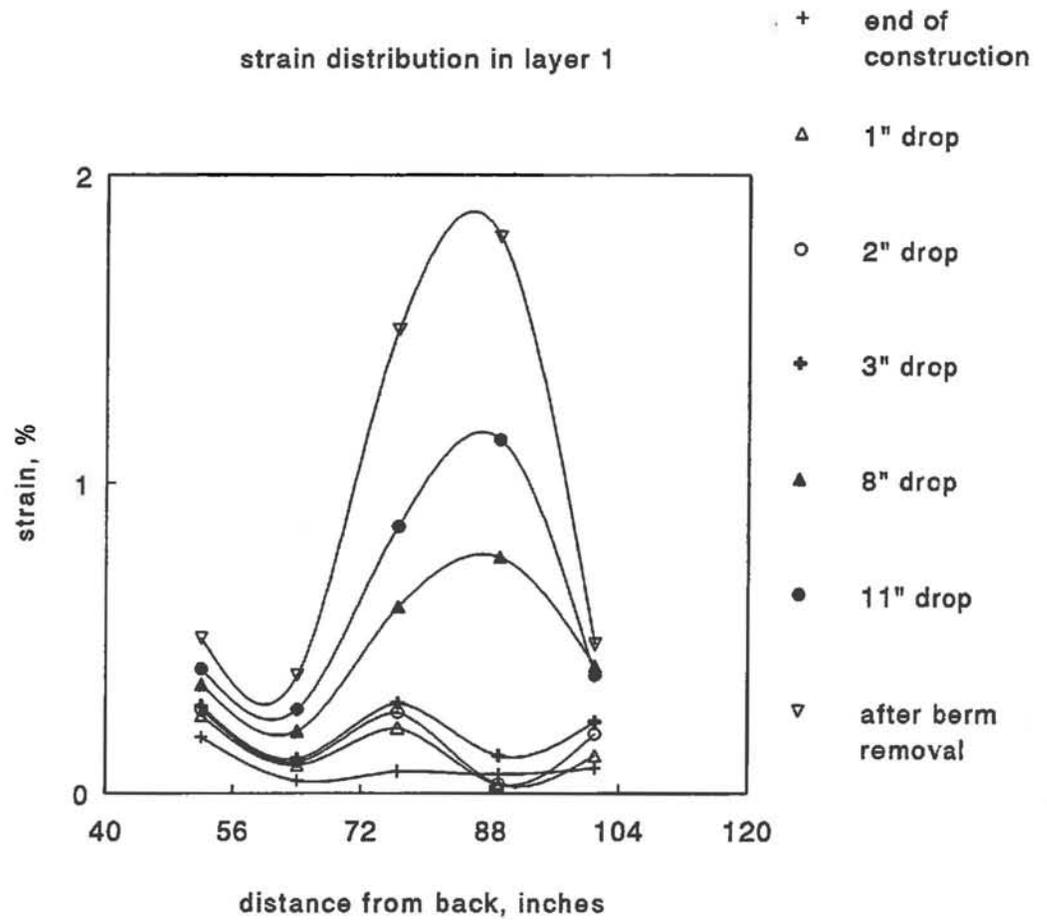
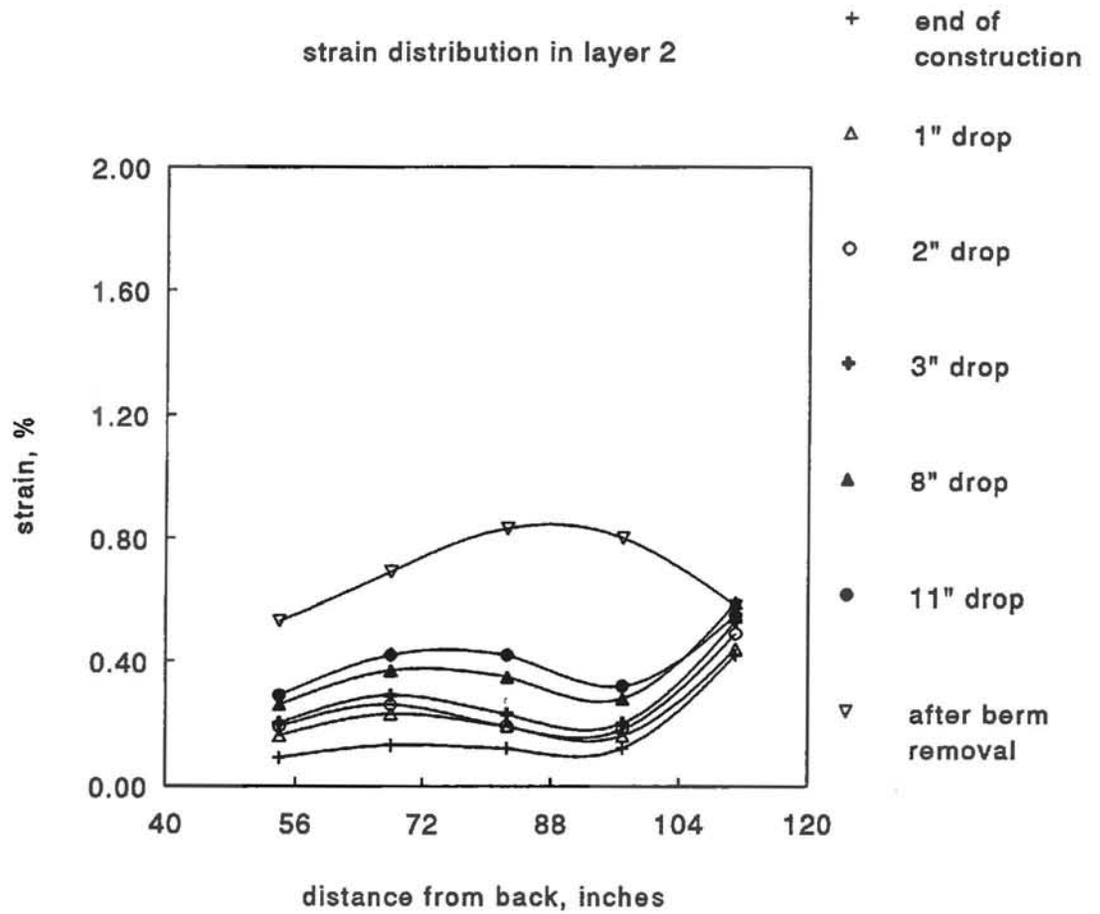
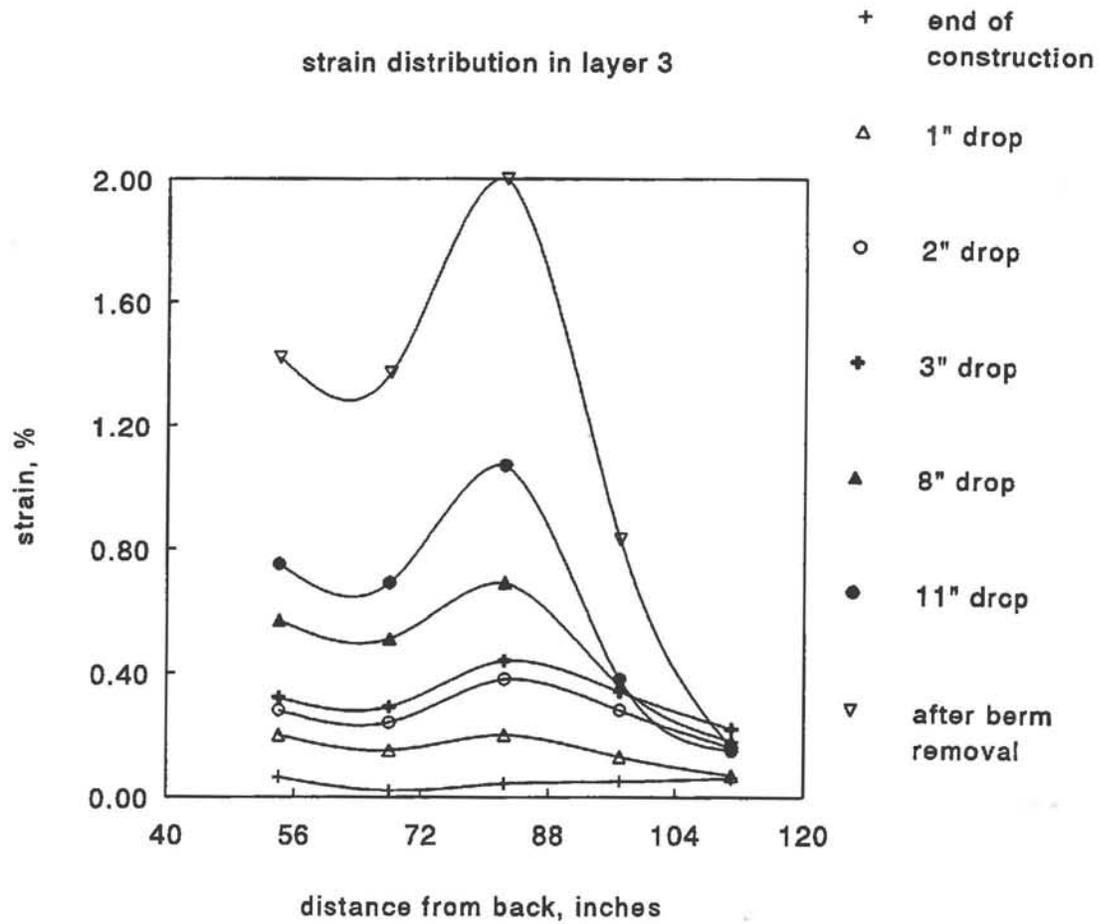
Figure 3.7(a) Distribution of Strain along the Geosynthetic Reinforcement Layer 2 in the CTI Deep Patch Test with Road Base Backfill

Figure 3.7(b) Distribution of Strain along the Geosynthetic Reinforcement Layer 2 in the CTI Deep Patch Test with Road Base Backfill

Figure 3.7(c) Distribution of Strain along the Geosynthetic Reinforcement Layer 6 in the CTI Deep Patch Test with Road Base Backfill

The measured strain distribution along the geosynthetic layers 2, 4 and 6 located at elevations 2, 4 and 6 feet are shown in Figures 3.7(a), 3.7(b), and 3.7(c), respectively. The maximum strain of approximately 1.2%, corresponding to 11 inches drop of the moveable part of the bottom panel, was observed near the edge of geosynthetic layer 2. At 11 inch-drop, the maximum strain of approximately 0.7% was observed in geosynthetic layer 4, whereas the maximum strain of approximately 1% was observed in geosynthetic layer 6. A substantial increase in measured strains corresponding to the removal of the berm is noted in the figures. It is to be noted that the strains measured in the CTI deep patch test are smaller than those measured in the reinforced USFS deep patch test.

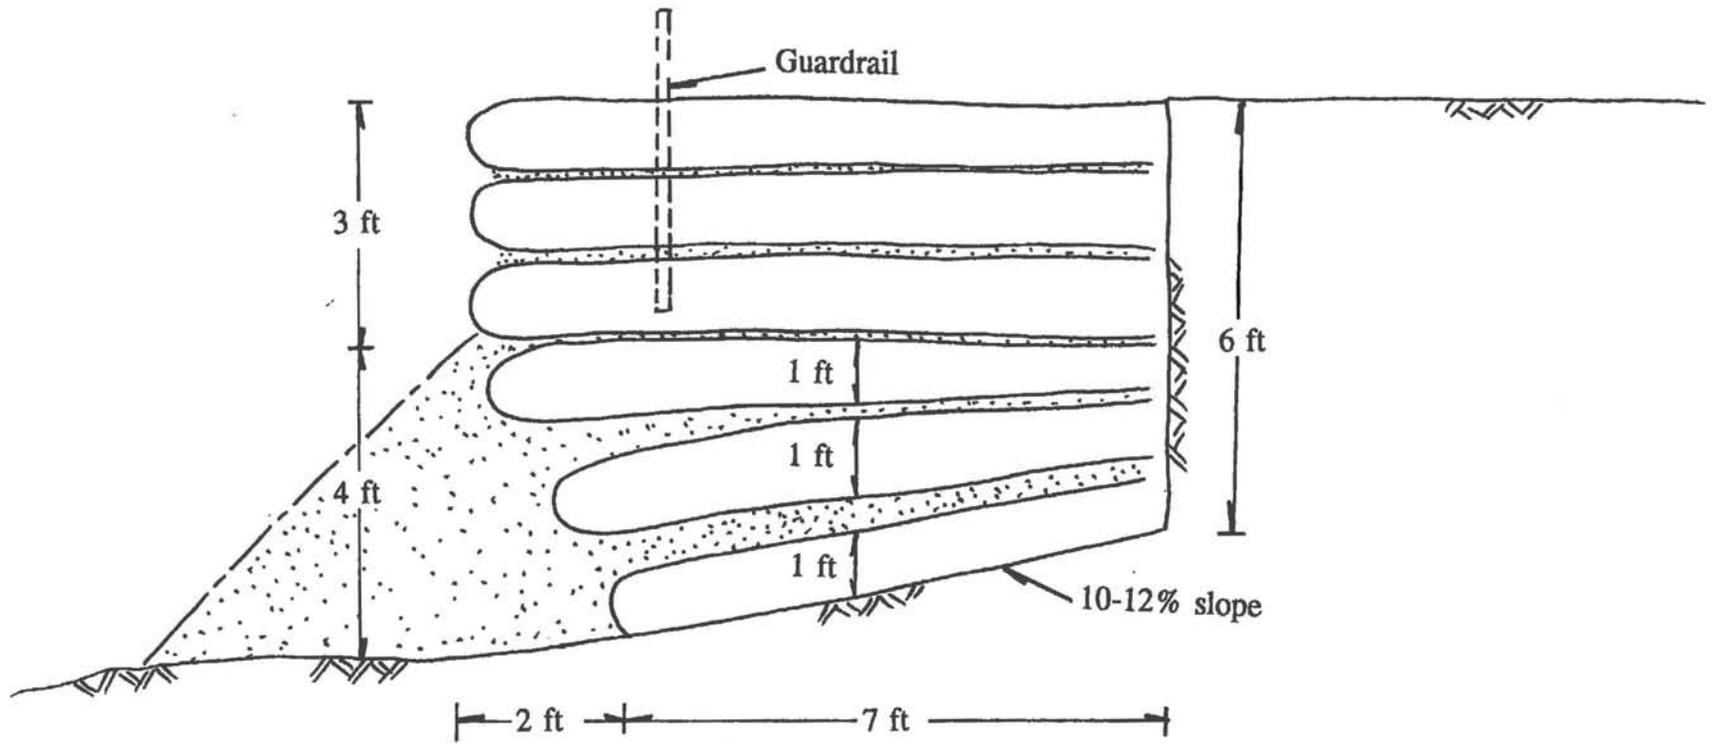
Figure 3.8 Configuration of the CTI Deep Patch in Silverthorne

The newly developed CTI deep patch technique was used to repair a landslide within the city of Silverthorne-Colorado in October, 1993. The cost of traditional repair for the landslide could have easily exceeded \$100,000, whereas the estimated cost of the CTI deep patch technique was less than \$15,000. This tremendous reduction in cost could result in repairs to many present and future landslides around Colorado that would go un-repaired or that would cost tremendous amount of money with traditional technologies of landslide repair.

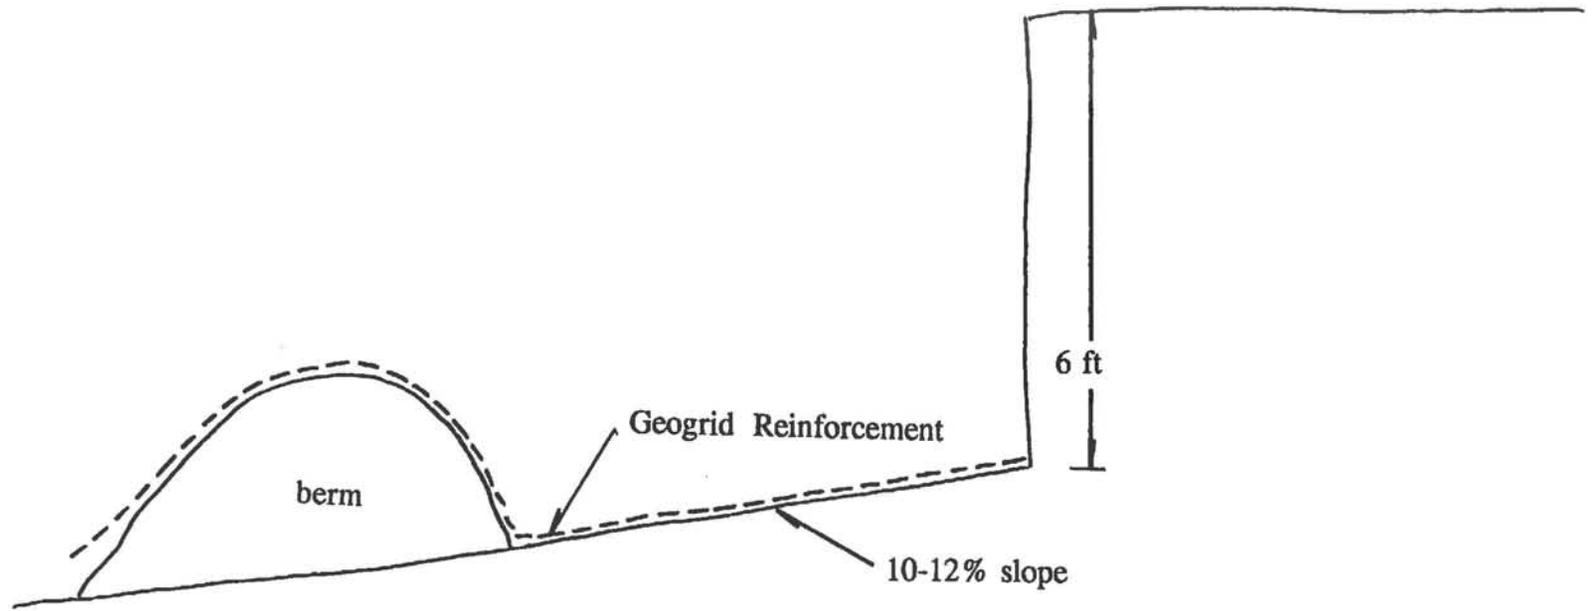
Figure 3.9 Construction Procedure of the CTI Deep Patch in Silverthorne

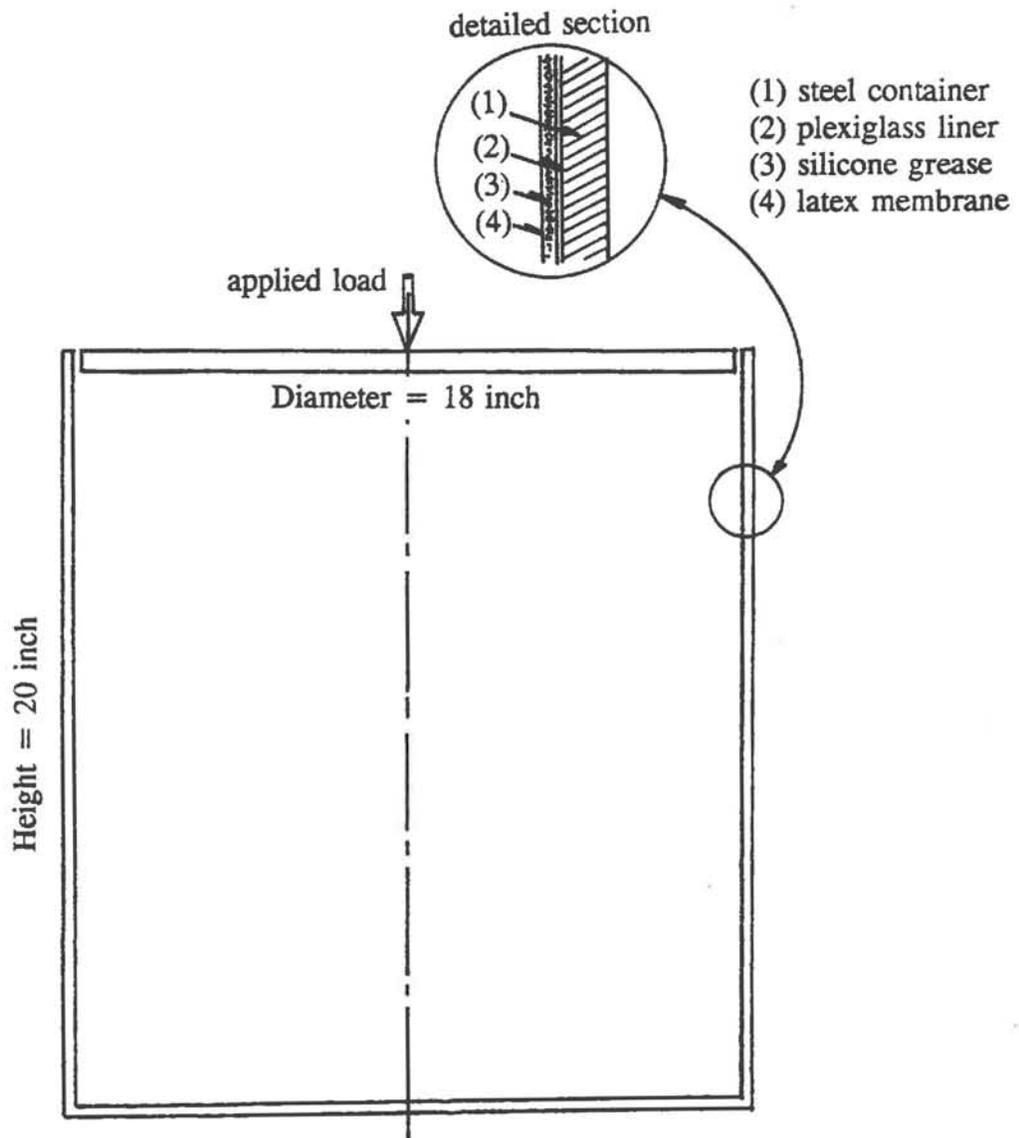
Figure 4.1 Schematic Diagram of the One-Dimensional Compression Test for Shredded Tire

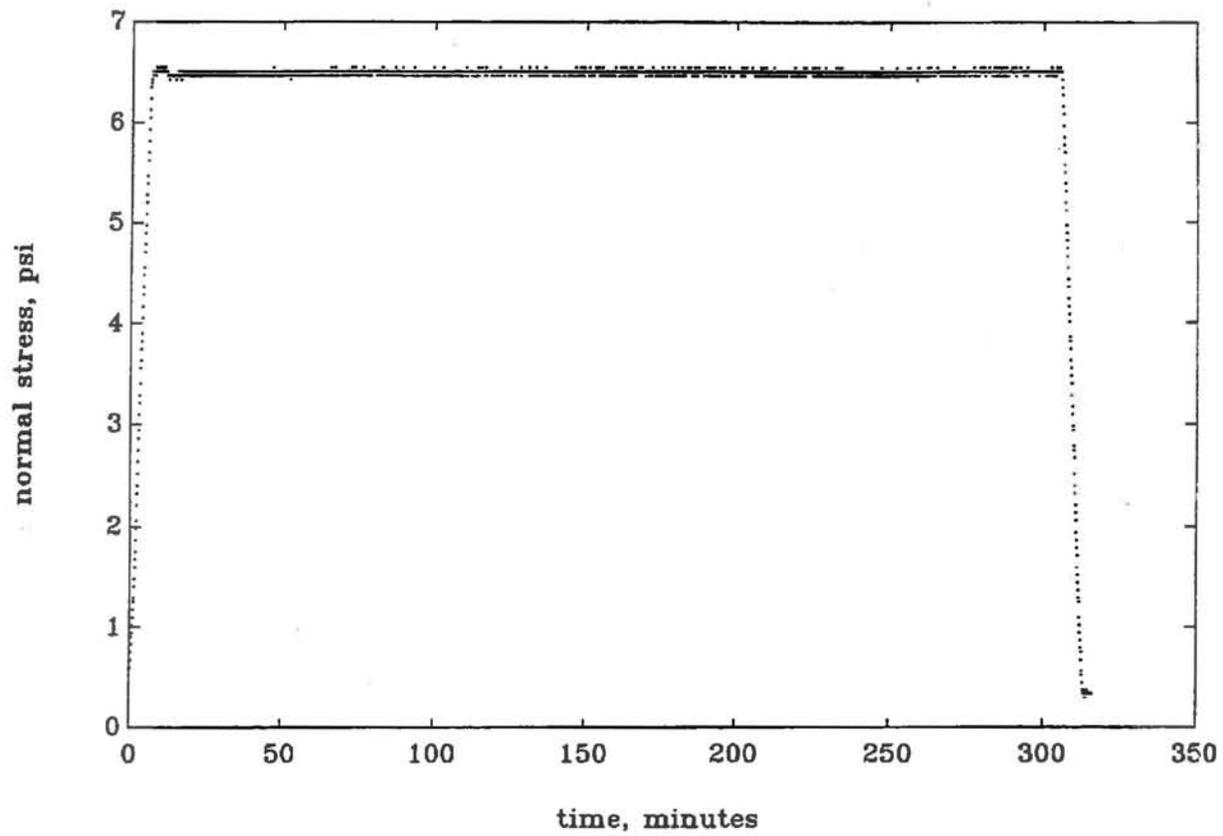
Figure 4.2 The Load History of the One-Dimensional Compression Test on Shredded Tire

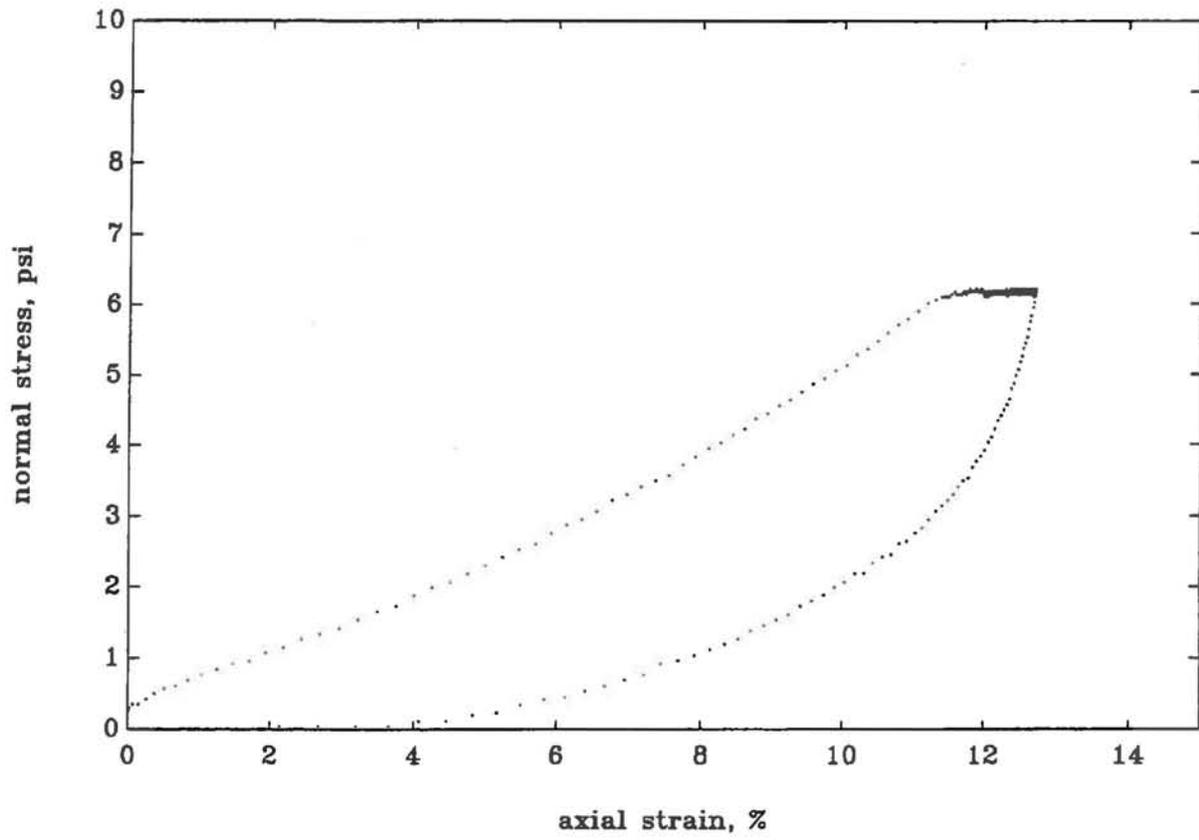
Figure 4.3 Stress-Strain Behavior of the Shredded Tire under One-Dimensional Compression

During the constant load stage, a significant creep can be noted in Figure 4.3. The creep strain which occurred during the 300 minutes-period was approximately 15% of the total axial strain. Figures 4.4 and 4.5 show in arithmetic and semi-logarithmic planes, respectively, the creep behavior of shredded tire under a constant stress of 6.3 psi.

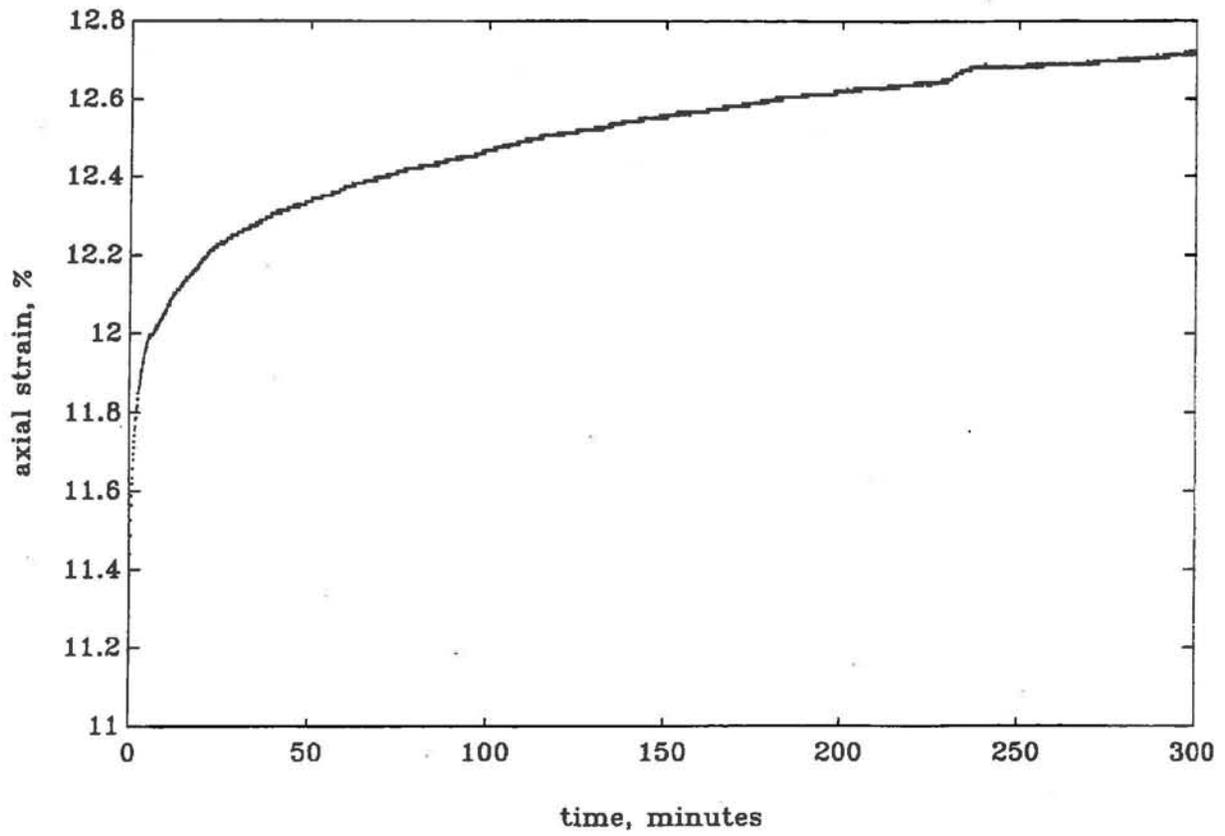
Figure 4.4 Creep Behavior of Shredded Tire under a Constant Stress of 6.3 psi (arithmetic)

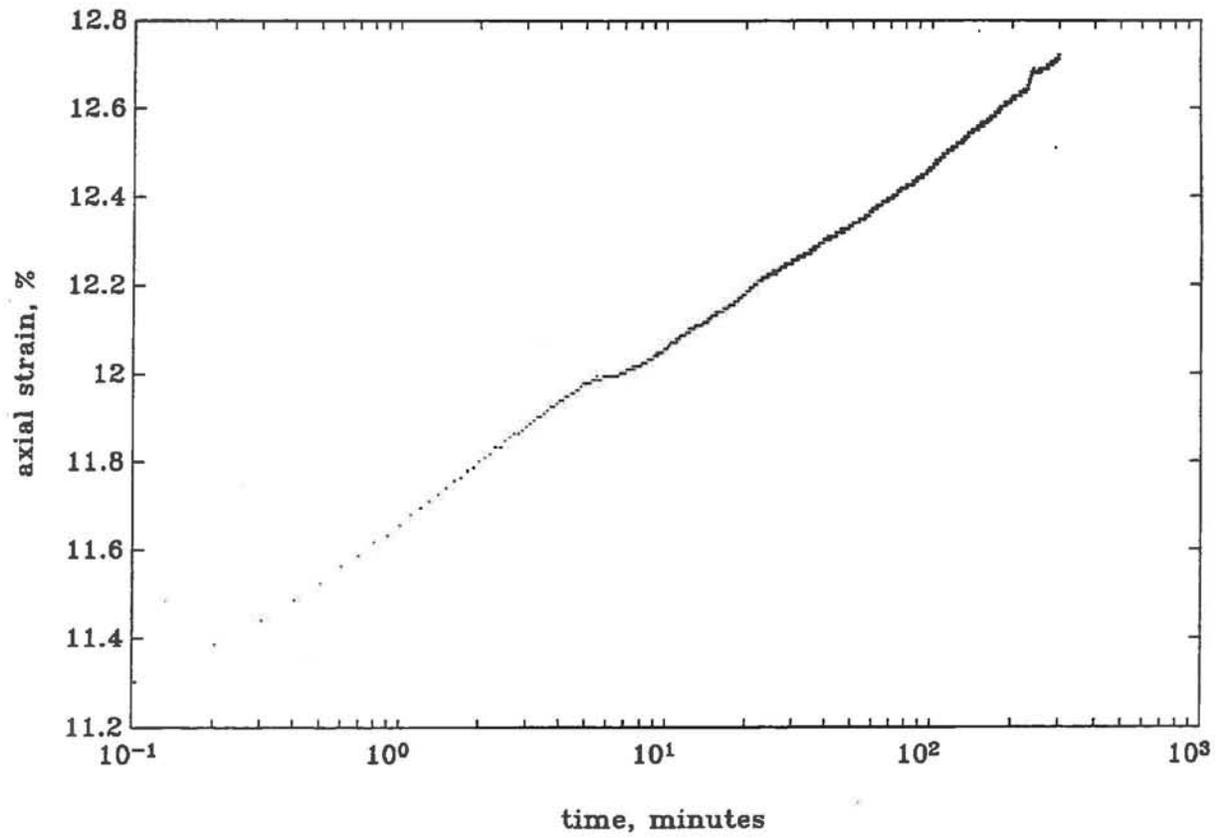
Figure 4.5 Creep Behavior of Shredded Tire under a Constant Stress of 6.3 psi (semi-logarithmic)

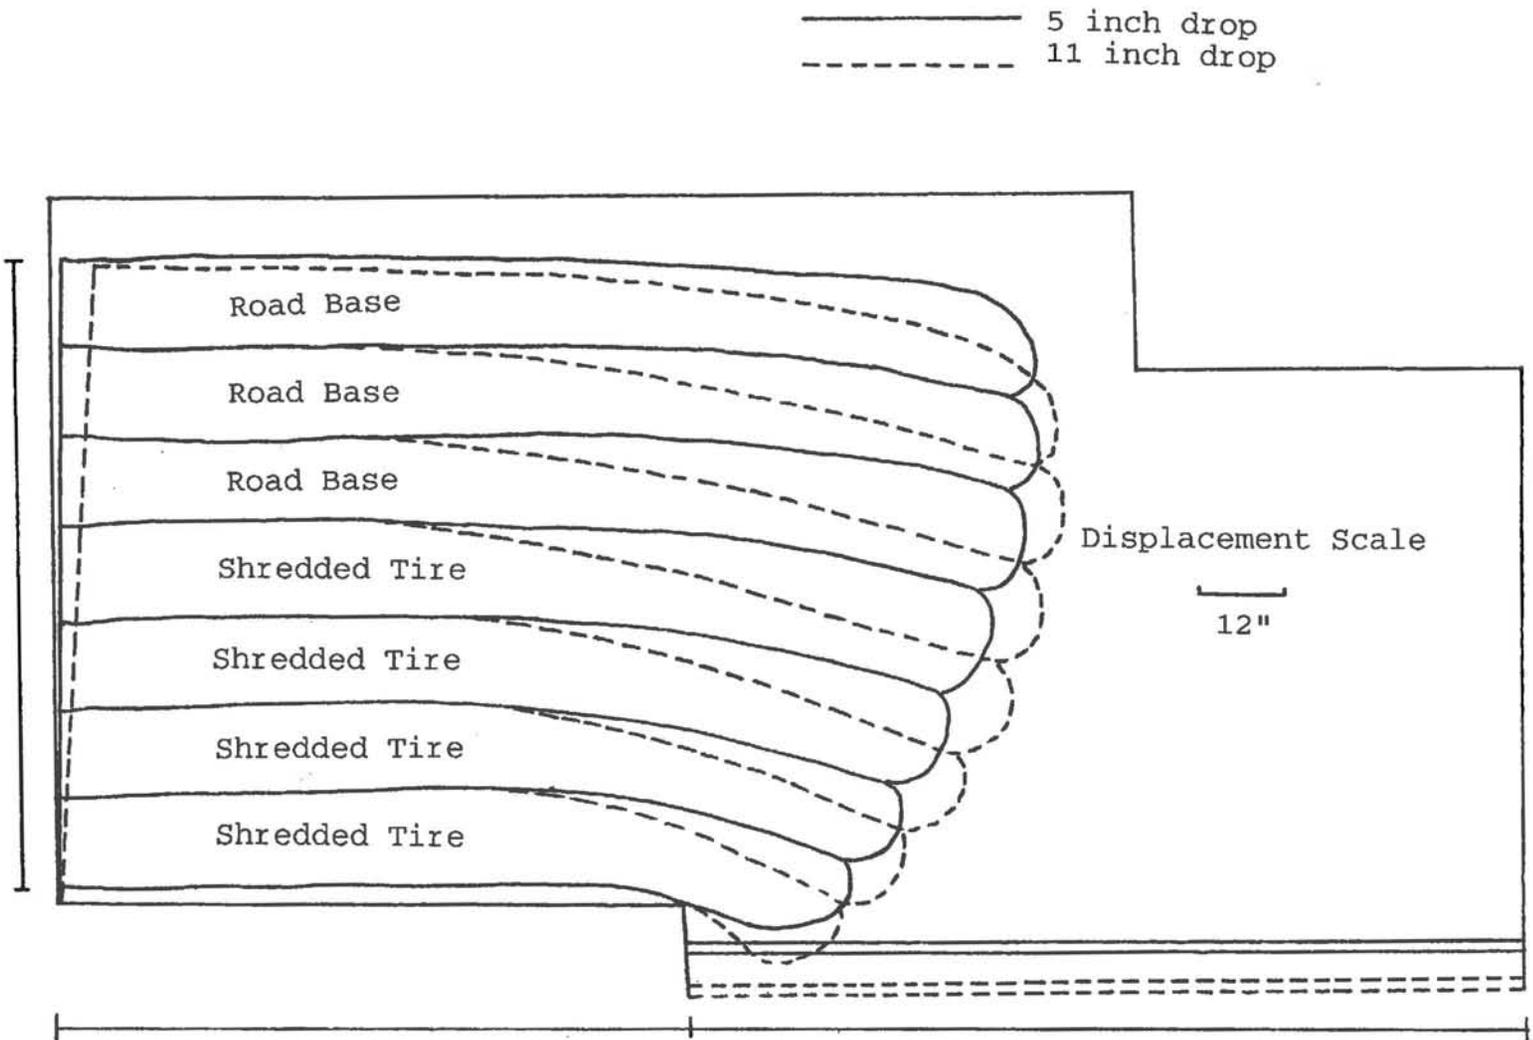
Figure 4.6 Displacement Field of the CTI Deep Patch Test with Shredded Tire Backfill

The displacement of the CTI deep patch and the bottom panel, as measured by the lubricated latex grid, is shown in Figure 4.6. It is noted from the figure that the face of the CTI deep patch suffers excessive vertical and lateral displacements throughout the test. The maximum settlements of 8 and 18 inches were measured at the top of the wall corresponding, respectively, to the 5 and 11 inches drop in the moveable part of the bottom panel. Lateral displacements in excess of 12 inches were measured corresponding to the 11 inch drop of the moveable part of the bottom panel.

A vertical crack emanating from a point on the top of the CTI deep patch near the back panel is shown in the Figure 4.6. The crack started with the first drop of 0.2 inch and propagated throughout the test due to further drops of the moveable part of the bottom panel. The depth of the crack was approximately 7 ft and its width was approximately 7 inches due to the 11 inch drop in the moveable part of the bottom panel. It is noted from the figure that the whole structure seems

to be rotating clockwise with further drops in the moveable part of the bottom panel. This rotation did not cease even after the maximum drop of 11 inches was reached. The excessive movements and the large crack in the backfill render the CTI deep patch technique with shredded tire as backfill unapplicable.
